# PROPERTY INSPECTION REPORT

**Property Address:** Sample Dr SW ,

**Date:** 10/13/2019

**Inspector:** Dwayne Boggs

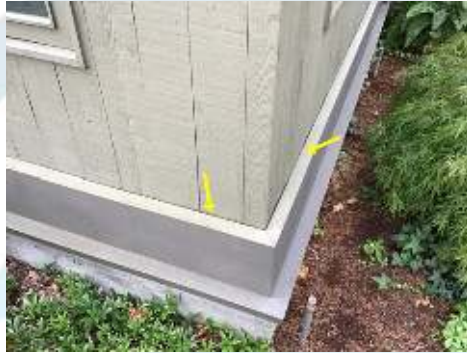
Page 22 Item: 3	Siding And Trim	<ul style="list-style-type: none"> <li>Caulking around exposed penetrations (doors, windows, nail heads, etc.) is a normal and extremely important maintenance task which needs to be performed on a regular basis. It is also extremely important to maintain caulking along the top edge of horizontal trim boards or belly boards. Failure to maintain caulking may result in rapid deterioration of composite wood sidings; always use a high quality paintable caulk such as OSI Quad. Be aware that on used structures, particularly older structures where caulking has been allowed to fail hidden conditions may exist. Noted: Primary Structure.</li> <li>Z-type metal flashing is missing: Where siding materials such as wood panels or trim meet at a horizontal joint, Z-type metal flashing is used to prevent water penetration. Retrofit flashing installation is generally not reasonable to do, so it will be important to maintain caulking as a defense against water penetration on older structures. Be aware hidden conditions may exist. Noted: All sides.</li> </ul>

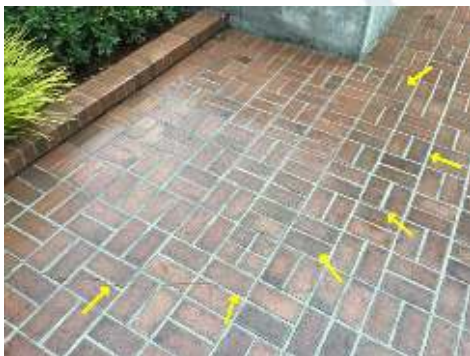
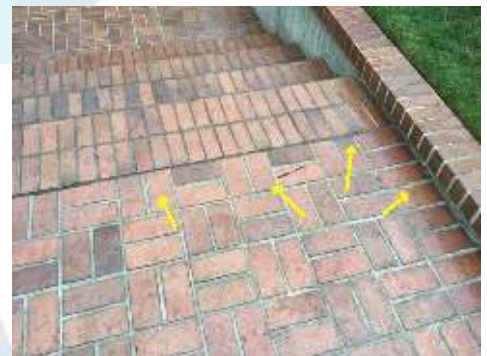
Page 23 Item: 4

• Erosion or settling of concrete surface is present. If this is a concern, following up with a licensed contractor specializing in patio installation and repair is advised. This condition was noted on the following patio slab(s): Front.

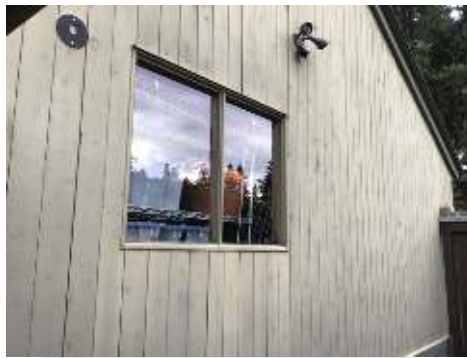
Page 24 Item: 6

• The exterior paint or finish is weathered or deteriorated. Painting is a normal and ongoing maintenance issue and, as would be expected, weathered sides of the house are the first to show signs of failure. The frequency of repainting depends largely upon the quality of the preparation, the quality of the paint and the quality of the application. Back rolling and back brushing is always preferred to simply spraying on the product. In general, flat paints do not seem to hold up as well as semigloss types. A paint supplier or painting contractor can explain more. It is especially important to maintain good paint coverage on composite wood products to prevent failure, which can happen very quickly without proper paint coverage. At this time, the weathering and deterioration might best be described as: Minor.

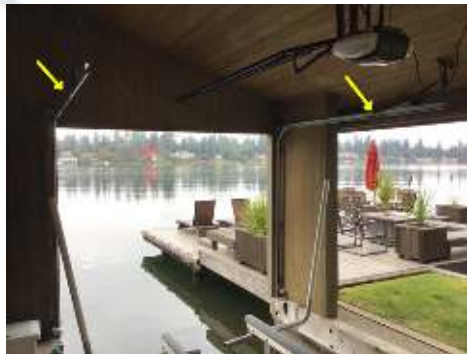
Page 24 Item: 8	Miscellaneous	<ul style="list-style-type: none"> <li>Door to the boat garage is missing. The springs and cables are attached to the roller brackets for now. Recommend repair.</li> </ul>
-----------------	---------------	---

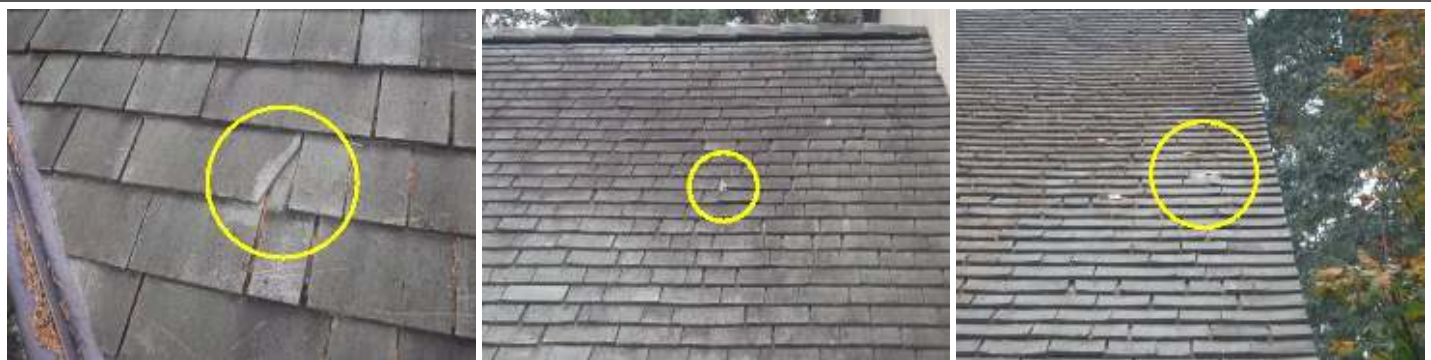
Page 25 Item: 2	General Defects	<ul style="list-style-type: none"> <li>Cedar shake/shingles showing some signs of wear. At this time, the signs of roofing wear include: Loose and/or missing shakes or shingles. Noted: Primary Structure.</li> </ul>
-----------------	-----------------	--

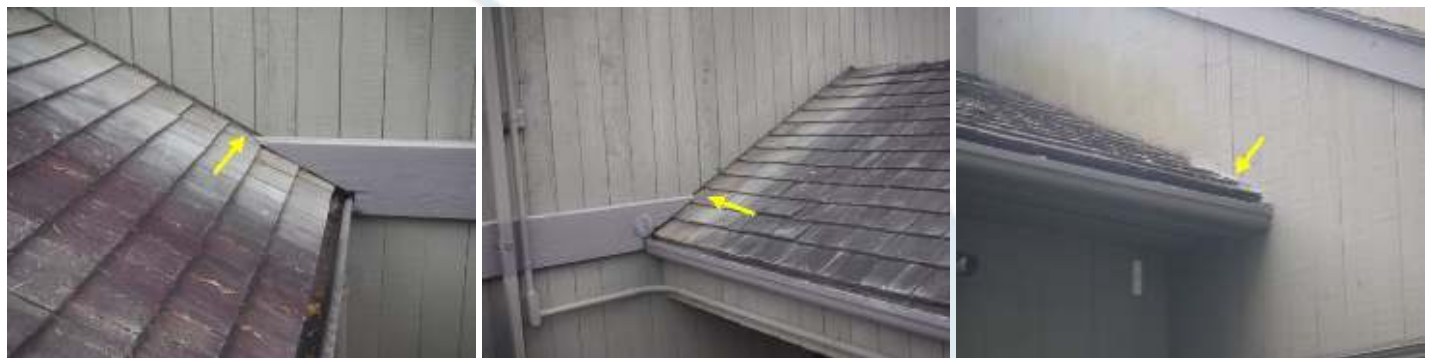
Page 26 Item: 4	Barriers	<ul style="list-style-type: none"> <li>When, "In the opinion of the inspector" the roof cannot be safely accessed or walked on for a hands on inspection, every reasonable effort will be made to visually evaluate the roof utilizing other vantage points. Regardless, conditions could exist which may not be detected. If you are not comfortable with the inspection findings or the method in which the roof was inspected, you are encouraged to have a licensed roofer with the proper safety equipment evaluate the roof more thoroughly.</li> </ul>
Page 27 Item: 12	Flashing	<ul style="list-style-type: none"> <li>Roof kick-out flashing is missing or inadequate. Where the gutter edge of a roof meets a wall, the last sidewall flashing above the gutter end should be installed so that water from the roof is directed into the gutter instead of behind the siding. This should be installed at the same height as the sidewall flashing (minimum of 4 inches). On older structures hidden conditions may exist. Caulking alone is not an acceptable substitute as it will fail overtime. Correction by a licensed professional roofer is recommended. Noted: Primary Structure.</li> </ul>

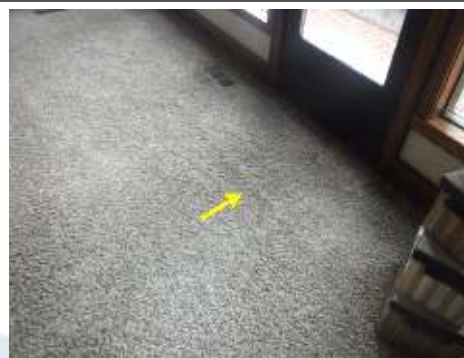
Page 29 Item: 2	Flooring Defects	<ul style="list-style-type: none"> <li>Some floor squeaking is noted: This is a common occurrence often due to nails in the sub floor having missed the floor joist and are rubbing against it. A hardware supply or contractor can suggest remedies if this is of concern to you. Noted: Utility room.</li> <li>The carpet is loose and needs restretched. This was noted in the Living room.</li> </ul>
-----------------	------------------	---

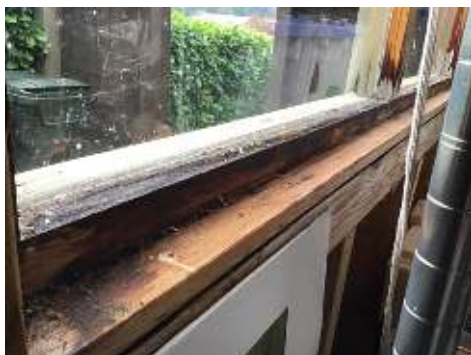
Page 29 Item: 4

- Damage or deterioration of the interior window framing/sill exists: Be aware hidden conditions may exist. Repair is recommended. Noted in the following area(s): Garage.

- The following window conditions are present: Some older windows are not safety glass. Older structures rarely meet the current standards. Exercise caution and consider changing to safety glass as a future upgrade or if windows should ever need replacing.. This was noted in the following area(s): Stairwell. Safety glass is currently required in the following circumstances: (1) If the window pane is > 9 sq. ft, < 18 inches above the floor, the top edge of the window is > 36 inches above the ground, and the window is within 36 inches of a walking surface. (2) The window is within 2 ft of a door and its bottom edge is < 60 inches over a walking surface. (3) The windows is in a wall enclosing a tub, shower or spa and the bottom edge is < 60 inches over a walking surface. (4) Windows within 60 inches of the bottom tread of a stairway if the exposed glass is < 60 inches from the nose of the tread. (5) All windows in railings. This requirement is often not met on older structures (which predate the code). Extreme caution is advised, particularly if small children are present. If these windows should ever be replaced, they should be changed to safety glass.

- Some or all window screens are missing: Repair is recommended. Noted in the following area(s): Several areas.

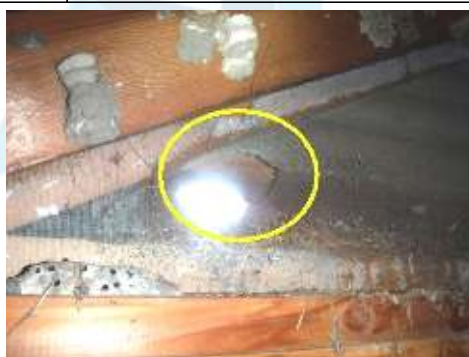
- There is an unsealed opening to the exterior observed in the attic. Recommend sealing to prevent possible entry by pests/vermin in the attic area. Noted: On the gable vent on the south side of the main structure.

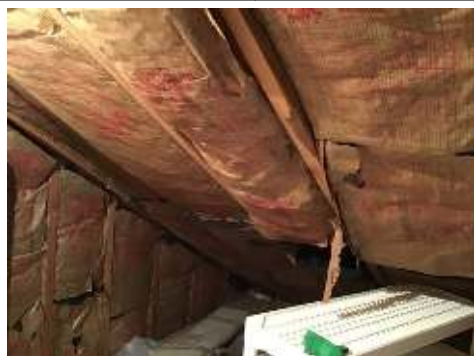
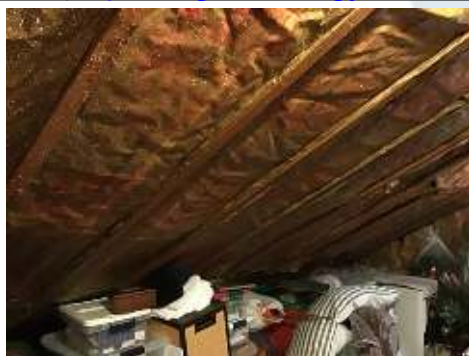
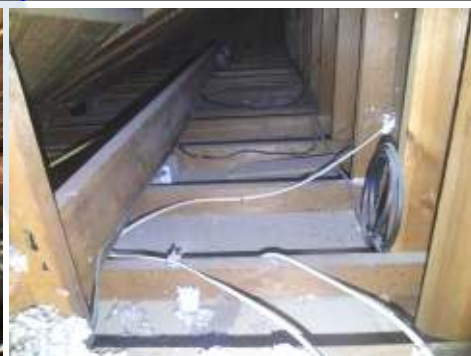
Page 31 Item: 7

- Insulation has been installed directly on bottom of the roof sheathing. Recommend removal of insulation to allow proper air flow along the underside of roof. Note that all affected areas of the roof sheathing are specifically excluded from the report.
- Portions of the attic are not insulated: Recommend installing insulation to current standards as an energy saving upgrade. Noted: Above end of hallway and bathroom on second floor on north side of the structure.
- The attic is not insulated to current standards: Recommend improving for energy efficiency.

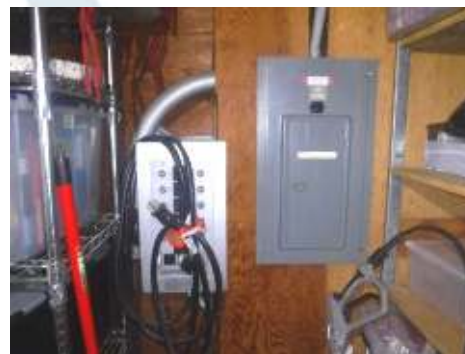
Page 34 Item: 2	Panel	<ul style="list-style-type: none"> <li>The electrical panel(s) are a Federal Pacific Electric (FPE) brand: FPE panels have had conditions documented that include breaker failure and are considered by some to be a possible latent fire hazard. Considerable information is available on the internet by visiting <a href="https://inspectapedia.com/fpe/FPE_Stab_Lok_Hazards.php">https://inspectapedia.com/fpe/FPE_Stab_Lok_Hazards.php</a>. It is recommended a licensed electrician evaluate the panel for safety and possible replacement. Noted: Garage.</li> <li>The electrical panel(s) have a mechanism in place to manage a generator. It is important for the buyer to understand how the system works. Therefore, having either the seller explain the proper operation or a licensed electrician explain the system will aide in the proper usage of the mechanism. Noted: Garage.</li> <li>The newer generator panel(s) lack a permit sticker. Recommend further review to see if a permit was pulled. Noted: Garage.</li> </ul>

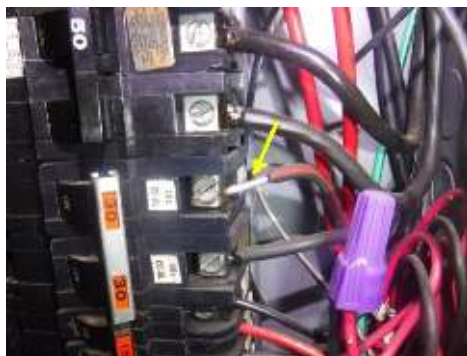
Page 35 Item: 3	Panel Wiring	<ul style="list-style-type: none"> <li>Single stranded aluminum branch wiring is present: Older single stranded aluminum wiring is known for having issues with oxidation, overheating and the tendency to break due to fatigue. Recommend full evaluation by electrician. Also recommend following up with your homeowner's insurance company to verify coverage will be available with this type of wiring. Noted: Garage.</li> </ul>
-----------------	--------------	---

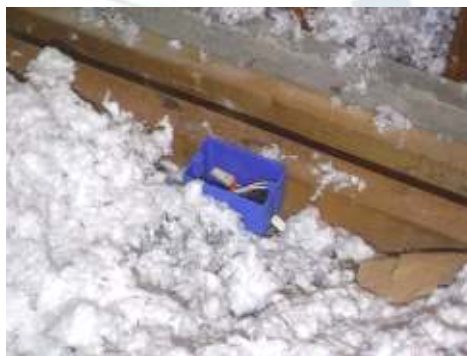
- Missing electric junction box covers are noted: Junction boxes should always have covers in place. Repair/replacement is recommended. Noted: Attic.

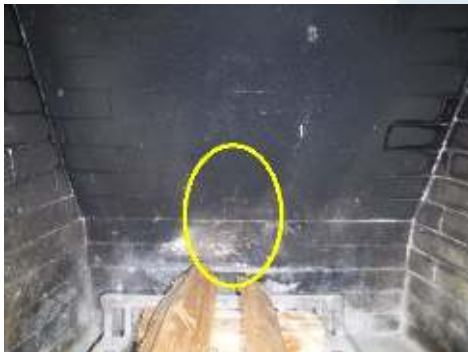
Page 39 Item: 3	Fireplace/Insert	<ul style="list-style-type: none"> <li>There are cracked, loose and/or damaged firebricks in the fireplace: Recommend further evaluation and repair. This was observed on the unit in the following area(s): Master bedroom.</li> </ul>

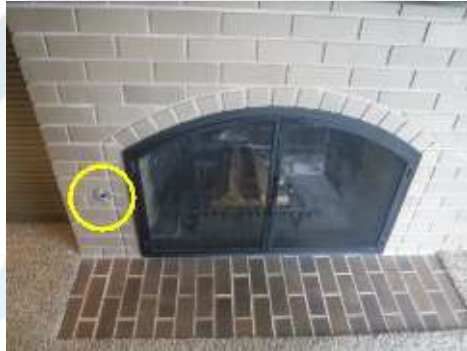
Page 39 Item: 4	Gas Supply :	<ul style="list-style-type: none"> <li>• The gas hookup is equipped with a shutoff valve that requires a wrench to operate. Modern building standards recommend the use of a hand shutoff type gas control valve. Recommend further review. This was observed on the unit(s) in the following area(s): Master bedroom.</li> <li>• The gas shutoff valve cannot be located: Every gas appliance should have a readily accessible shutoff near the appliance. Followup with the seller to locate the gas shutoff. If none exists, recommend further professional evaluation. This was observed on the unit(s) in the following area(s): Living room.</li> </ul>
-----------------	--------------	---

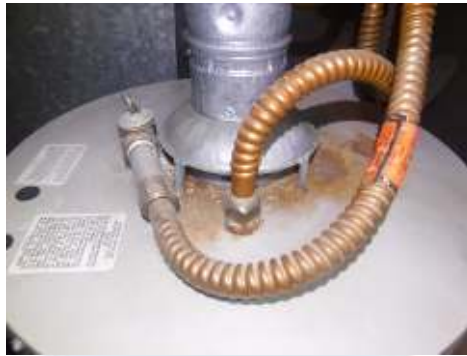
Page 40 Item: 3	Water Heater General	<ul style="list-style-type: none"> <li>• Rusting, corrosion, and leakage has occurred: On older units in particular, the water heater may not be reliable. Recommend professional evaluation.</li> <li>• The drip pan is missing under the water heater: Where the water heater is installed inside the living area, especially on a second or third floor, or in the attic, a drip pan installed under the unit would help prevent water damage should the unit ever leak. This is a common finding on older homes and should be considered as an improvement.</li> <li>• Water temperature is high: "Typical", water temperature is usually observed at 105 to 120 deg F. Sometimes this is adjusted upward by the homeowner for personal reasons, however, this cannot be determined during the inspection. While this finding is subjective in nature, be aware that when temperatures above 120 deg F are recorded, risk of burn injury increases and caution is advised. Noted temperature reading is 135 F. Water heater location:</li> <li>• Water heater appears older, (&gt;10 years old): Be aware the unit may be nearing its end of useful life and may need to be replaced soon and may not be reliable. Determining the life expectancy of plumbing related equipment is outside the scope of inspection.</li> </ul>

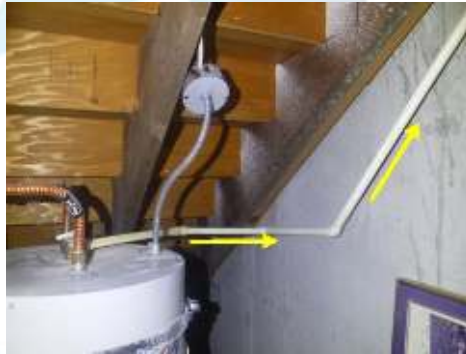
Page 42 Item: 2	Water Heater General	<ul style="list-style-type: none"> <li>The drip pan is missing under the water heater: Where the water heater is installed inside the living area, especially on a second or third floor, or in the attic, a drip pan installed under the unit would help prevent water damage should the unit ever leak. This is a common finding on older homes and should be considered as an improvement.</li> <li>Water heater appears older, (&gt;10 years old): Be aware the unit may be nearing its end of useful life and may need to be replaced soon and may not be reliable. Determining the life expectancy of plumbing related equipment is outside the scope of inspection.</li> </ul>
Page 42 Item: 3	Water heater TPR :	<ul style="list-style-type: none"> <li>The temperature pressure relief (TPR) line is improperly sloped. For safety, the manufacturer's installation requirements of the TPR line from the water heater are very specific: The inside diameter of the line should never be downsized; The line should always be sloped downhill; The line should terminate at an elbow pointing downward close to the ground; There should not be more than four elbows in the line. Any conditions noted should be corrected for safety.</li> </ul>

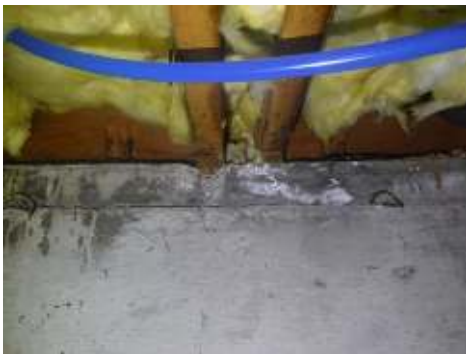
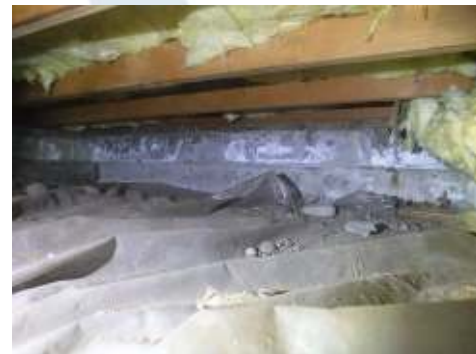
Page 44 Item: 2	Foundation	<ul style="list-style-type: none"> <li>There is efflorescence in the crawlspace: Efflorescence is a white powdery residue left behind when moisture migrates through concrete, brick, or mortar and evaporates leaving mineral deposits behind. Typically, this is seen on concrete stem walls where there may be inadequate management of exterior drainage or roof runoff. There is no specific mitigation other than correcting issues related to drainage, roof runoff or other water related issues contained in this report. Regular pest inspections are advised. Noted: Right side and rear.</li> </ul>
-----------------	------------	---

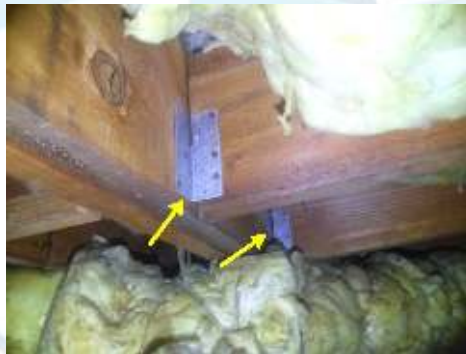
Page 44 Item: 4	Vermin/Animals :	<ul style="list-style-type: none"> <li>There is rodent evidence seen as droppings. Recommend contacting a licensed pest controller. Noted: In the crawl space.</li> </ul>
Page 44 Item: 5	Joists or Trusses :	<ul style="list-style-type: none"> <li>The following conditions should be further evaluated by a licensed contractor: The joist hangers appear too small for the joist they're supporting. Load bearing may be an issue. These conditions were noted in the following area(s): Under the Living room.</li> </ul>

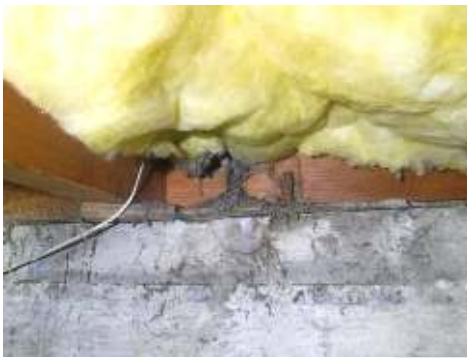
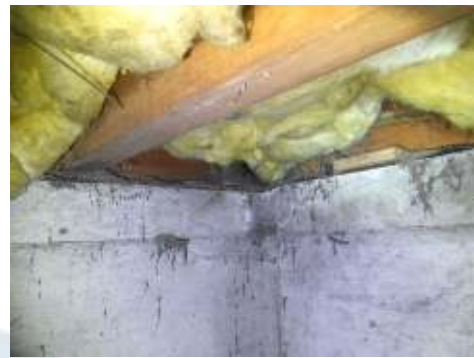
Page 50 Item: 3	Moisture Ants	<ul style="list-style-type: none"> <li>A moisture ant gallery or tube formation is observed. No live insects are seen, no damage is perceived and the immediate area does not appear wet or damp. It is likely that the previous condition which facilitated the infestation is no longer present, the condition has been corrected and/or professional treatment was performed. The seller should be contacted to determine if any other history is available, particularly with regard to professional treatment. Regular and periodic pest inspections are always advised. There are no treatment recommendations. This observation was made in the following area(s): See WDO Diagram. Note: A Washington State licensed applicator should be called to provide chemical treatment for Moisture Ants for the comfort of workers who will need to perform repairs. A licensed tradesperson should be called to identify and remediate the source of the moisture. In addition, hidden or concealed spaces in and around the vicinity of the colony should be exposed sufficiently enough to reasonably identify and repair any hidden damages.</li> </ul>

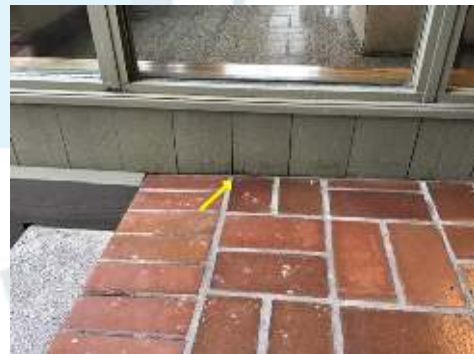
- Damage/decay present on the lower siding. Be aware hidden conditions may exist. This was seen in the following area(s):Rear.

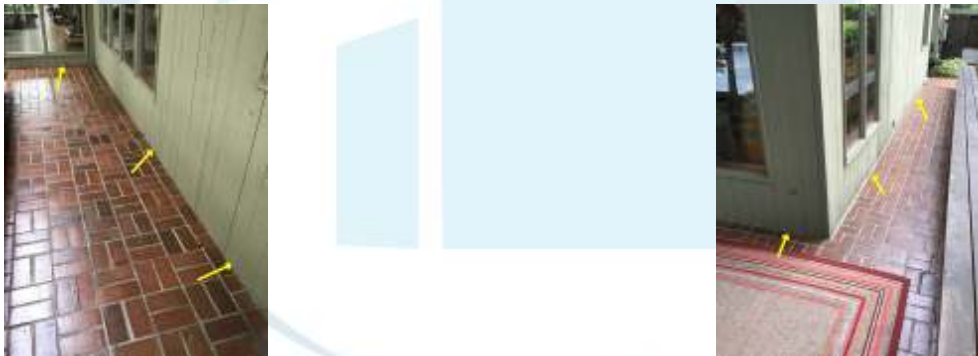
Page 51 Item: 2	Foliage	<ul style="list-style-type: none"> <li>Foliage should be maintained so it is at least 10 to 12 inches away from house as it may cause mechanical damage to the siding and promote high moisture conditions and/or infestation. Where foliage is dense and access limited, hidden conditions may exist which should be reported to the inspecting firm if discovered. Where there is decorative, established foliage against the structure such as climbing vines, cutting the foliage back may be detrimental to the aesthetic appearance of the home. If the foliage is left in place, be aware that infestation and high moisture conditions may occur. Regular and periodic inspections are suggested.</li> </ul>
Page 51 Item: 3	Hard Surface Contact	<ul style="list-style-type: none"> <li>The exterior siding is in contact with a concrete, masonry or asphalt surface. This may allow decay to occur to the siding as well as to the wood members behind it. Even if the area in question is covered by a roof structure, placing potted plants nearby and watering them may cause decay to occur. A contractor may be able to suggest some measures, such as caulking, to prevent water penetration. Be aware that on used structures, particularly older ones, hidden damages may exist and are outside the scope of inspection. This condition was noted in the following area(s): Rear and left side.</li> </ul>

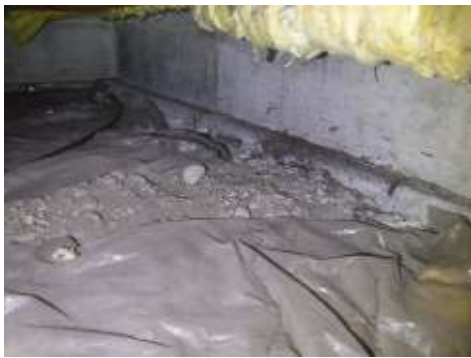
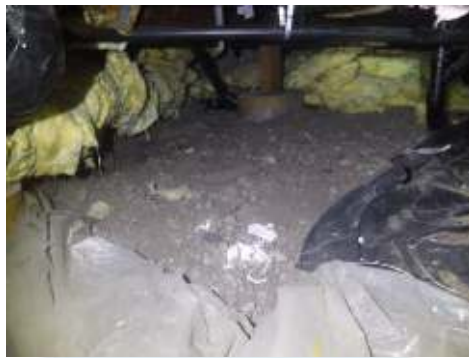
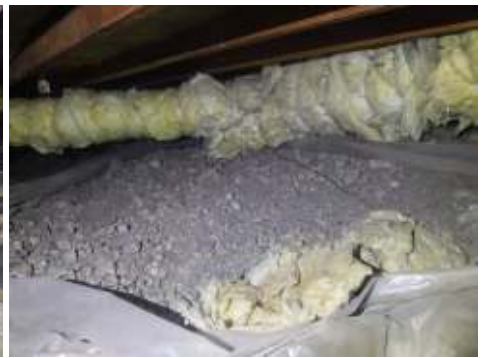
<b>Conductive/Sub-Structure</b>		
Page 52 Item: 1	Vapor Barrier	<ul style="list-style-type: none"> <li>The crawl space has inadequate and/or damaged vapor barrier coverage. Spread existing crawl space vapor barrier as able and install additional 6 mm black plastic vapor barriers as needed to meet current building requirements with provision for appropriate overlap at seams, (12 inches). This was noted in the following area(s): Scattered.</li> </ul>

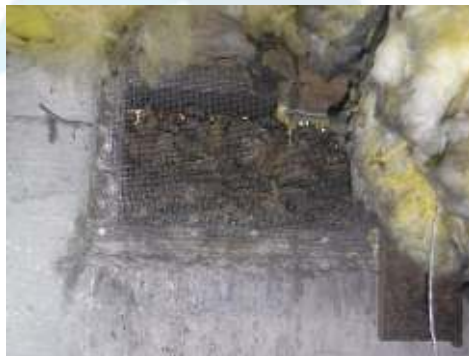
- Foundation vents are blocked. Unblock any and all foundation vents which have been either purposefully blocked and/or are blocked by landscaping material or dirt. Repair any damaged screen with 1/4 inch, non-louvered, galvanized hardware cloth. If vent is below grade, a foundation vent well should be installed to keep dirt and landscaping material clear of the vent. This was noted in the following area(s) : Front.

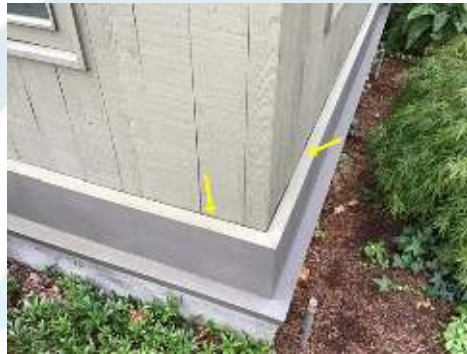
- Z-type metal flashing is missing: Where siding materials such as wood panels or trim meet at a horizontal joint, Z-type metal flashing is used to prevent water penetration. Retrofit flashing installation is generally not reasonable to do, so it will be important to maintain caulking as a defense against water penetration on older structures. Be aware hidden conditions may exist. Noted: All sides.

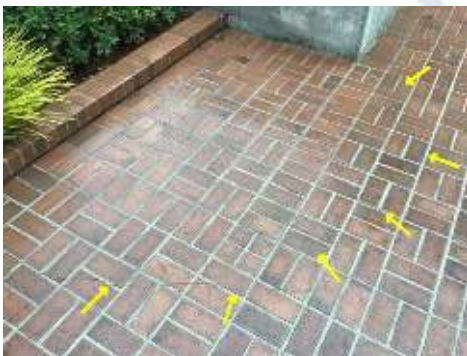
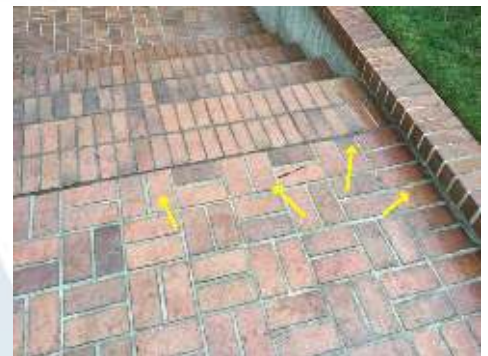
#### 4. Concrete, Masonry Patio

- Erosion or settling of concrete surface is present. If this is a concern, following up with a licensed contractor specializing in patio installation and repair is advised. This condition was noted on the following patio slab(s): Front.

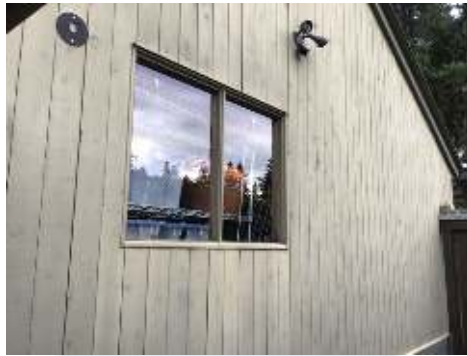
#### 6. Paint defects

- The exterior paint or finish is weathered or deteriorated. Painting is a normal and ongoing maintenance issue and, as would be expected, weathered sides of the house are the first to show signs of failure. The frequency of repainting depends largely upon the quality of the preparation, the quality of the paint and the quality of the application. Back rolling and back brushing is always preferred to simply spraying on the product. In general, flat paints do not seem to hold up as well as semigloss types. A paint supplier or painting contractor can explain more. It is especially important to maintain good paint coverage on composite wood products to prevent failure, which can happen very quickly without proper paint coverage. At this time, the weathering and deterioration might best be described as: Minor.

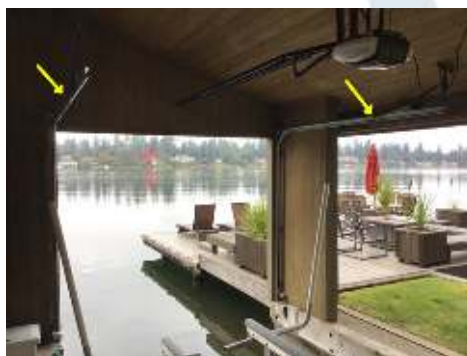
- Door to the boat garage is missing. The springs and cables are attached to the roller brackets for now. Recommend repair.

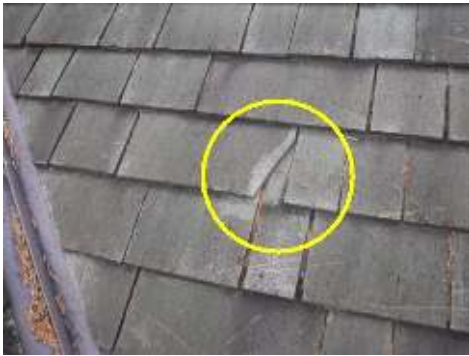
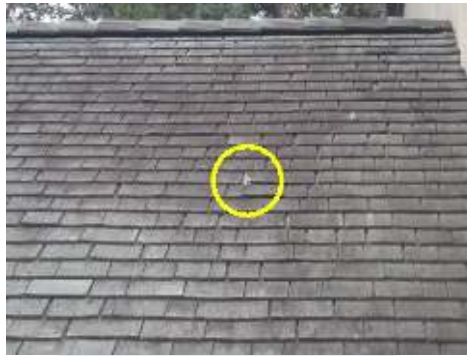
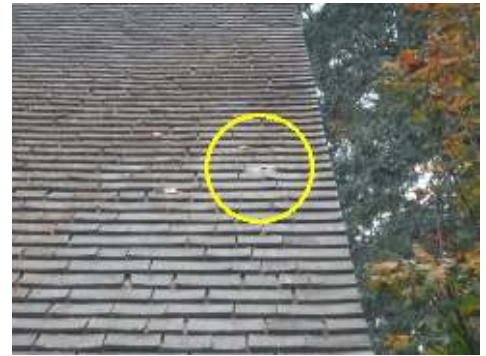
- Cedar shake/shingles showing some signs of wear. At this time, the signs of roofing wear include: Loose and/or missing shakes or shingles. Noted: Primary Structure.

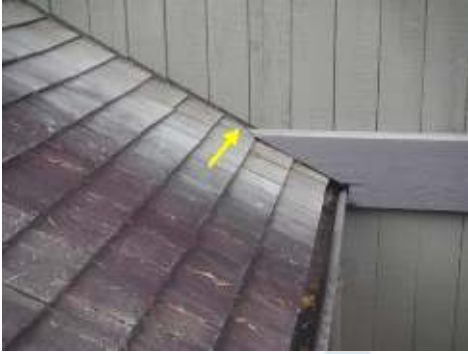
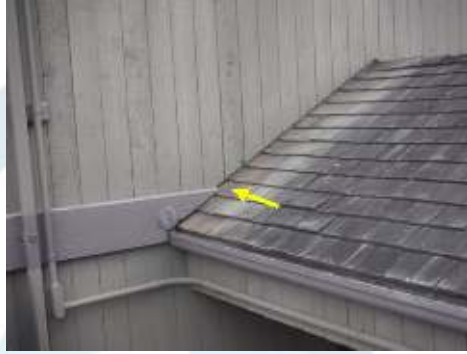
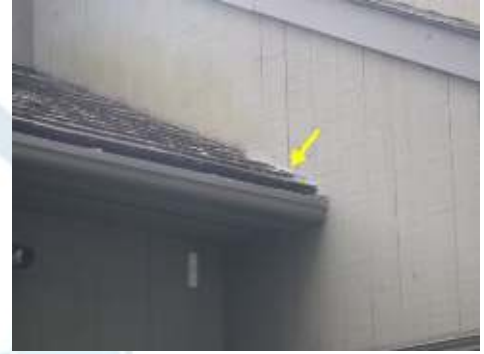
- Roof kick-out flashing is missing or inadequate. Where the gutter edge of a roof meets a wall, the last sidewall flashing above the gutter end should be installed so that water from the roof is directed into the gutter instead of behind the siding. This should be installed at the same height as the sidewall flashing (minimum of 4 inches). On older structures hidden conditions may exist. Caulking alone is not an acceptable substitute as it will fail overtime. Correction by a licensed professional roofer is recommended. Noted: Primary Structure.

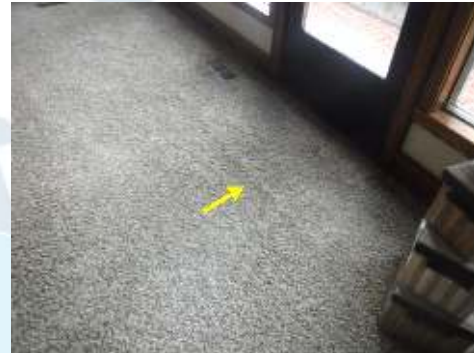
- Some floor squeaking is noted: This is a common occurrence often due to nails in the sub floor having missed the floor joist and are rubbing against it. A hardware supply or contractor can suggest remedies if this is of concern to you. Noted: Utility room.
- The carpet is loose and needs restretched. This was noted in the Living room.

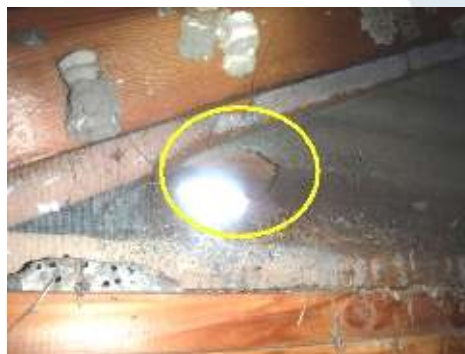
- There is an unsealed opening to the exterior observed in the attic. Recommend sealing to prevent possible entry by pests/vermin in the attic area. Noted: On the gable vent on the south side of the main structure.

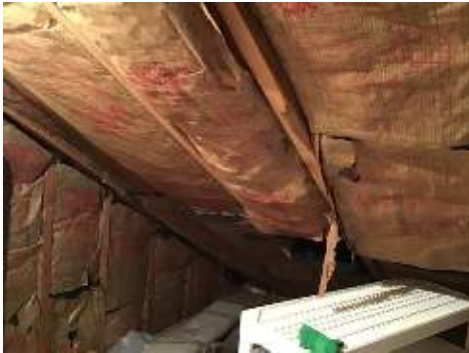
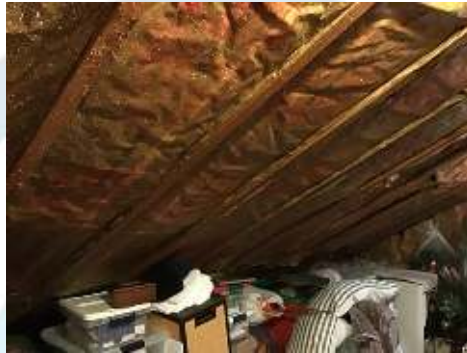
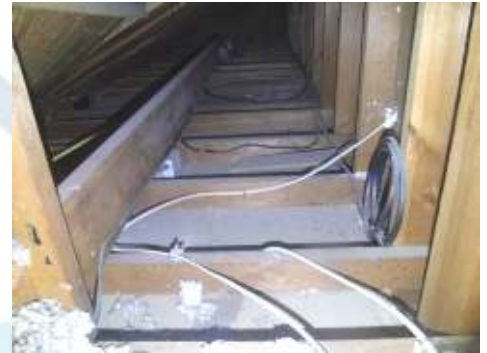
## 7. Insulation

- Insulation has been installed directly on bottom of the roof sheathing. Recommend removal of insulation to allow proper air flow along the underside of roof. Note that all affected areas of the roof sheathing are specifically excluded from the report.
- Portions of the attic are not insulated: Recommend installing insulation to current standards as an energy saving upgrade. Noted: Above end of hallway and bathroom on second floor on north side of the structure.
- The attic is not insulated to current standards: Recommend improving for energy efficiency.

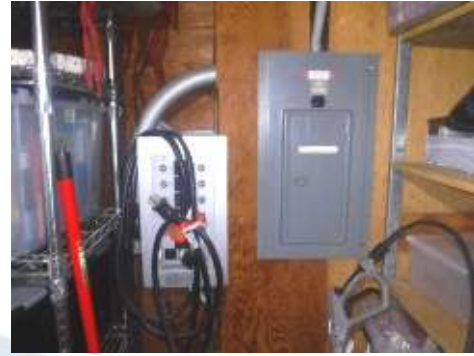
- The newer generator panel(s) lack a permit sticker. Recommend further review to see if a permit was pulled. Noted: Garage.

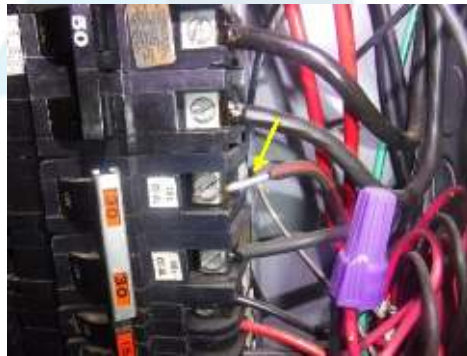
### 3. Panel Wiring

- Single stranded aluminum branch wiring is present: Older single stranded aluminum wiring is known for having issues with oxidation, overheating and the tendency to break due to fatigue. Recommend full evaluation by electrician. Also recommend following up with your homeowner's insurance company to verify coverage will be available with this type of wiring. Noted: Garage.

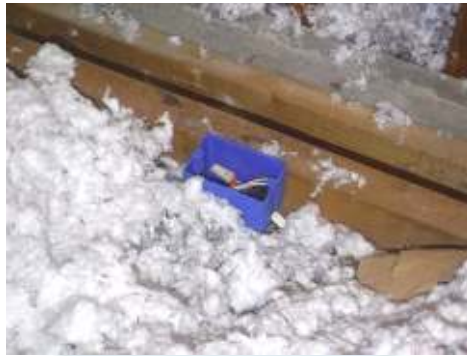
- Missing electric junction box covers are noted: Junction boxes should always have covers in place. Repair/replacement is recommended. Noted: Attic.

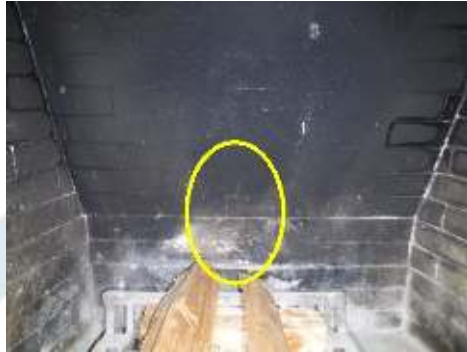
- There are cracked, loose and/or damaged firebricks in the fireplace: Recommend further evaluation and repair. This was observed on the unit in the following area(s): Master bedroom.

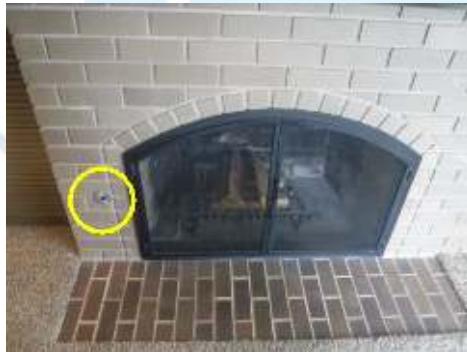
### 4. Gas Supply :

- The gas hookup is equipped with a shutoff valve that requires a wrench to operate. Modern building standards recommend the use of a hand shutoff type gas control valve. Recommend further review. This was observed on the unit(s) in the following area(s): Master bedroom.
- The gas shutoff valve cannot be located: Every gas appliance should have a readily accessible shutoff near the appliance. Followup with the seller to locate the gas shutoff. If none exists, recommend further professional evaluation. This was observed on the unit(s) in the following area(s): Living room.

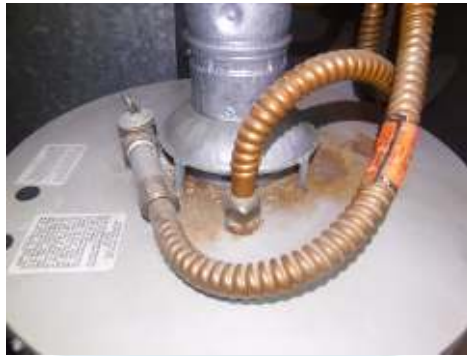
- Water heater appears older, (>10 years old): Be aware the unit may be nearing its end of useful life and may need to be replaced soon and may not be reliable. Determining the life expectancy of plumbing related equipment is outside the scope of inspection.

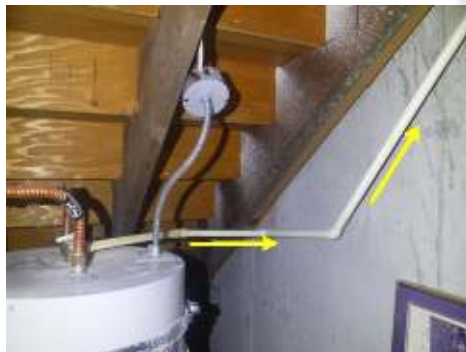
- The temperature pressure relief (TPR) line is improperly sloped. For safety, the manufacturer's installation requirements of the TPR line from the water heater are very specific: The inside diameter of the line should never be downsized; The line should always be sloped downhill; The line should terminate at an elbow pointing downward close to the ground; There should not be more than four elbows in the line. Any conditions noted should be corrected for safety.

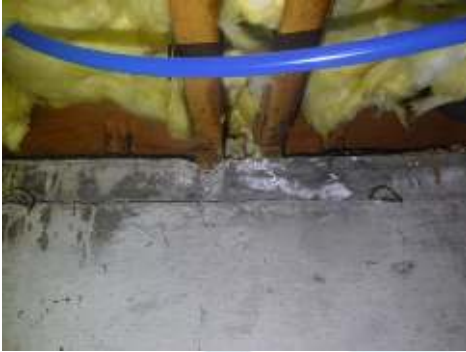
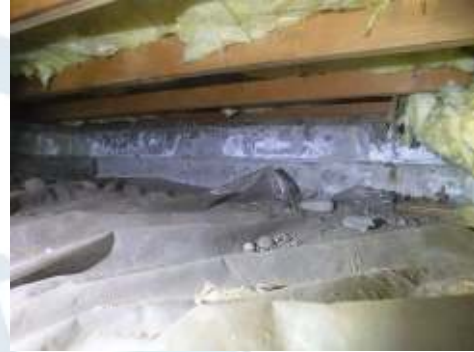
## 2. Foundation

- There is efflorescence in the crawlspace: Efflorescence is a white powdery residue left behind when moisture migrates through concrete, brick, or mortar and evaporates leaving mineral deposits behind. Typically, this is seen on concrete stem walls where there may be inadequate management of exterior drainage or roof runoff. There is no specific mitigation other than correcting issues related to drainage, roof runoff or other water related issues contained in this report. Regular pest inspections are advised. Noted: Right side and rear.

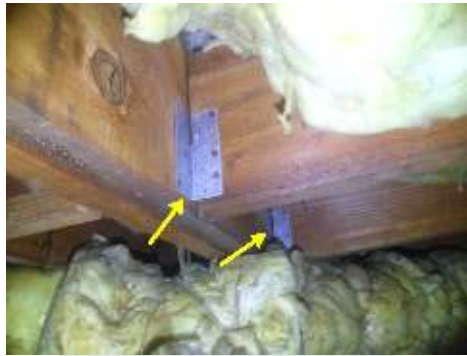
- The following conditions should be further evaluated by a licensed contractor: The joist hangers appear too small for the joist they're supporting. Load bearing may be an issue. These conditions were noted in the following area(s): Under the Living room.

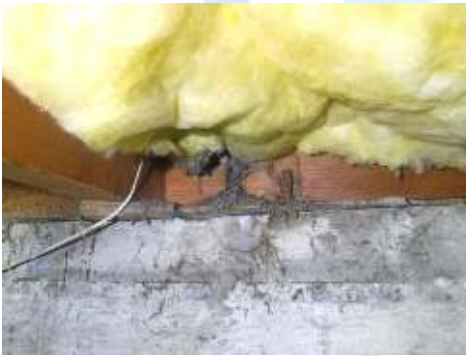
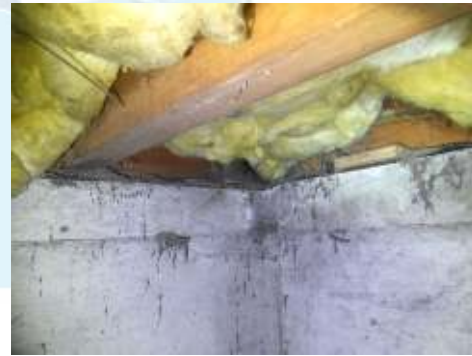
- A moisture ant gallery or tube formation is observed. No live insects are seen, no damage is perceived and the immediate area does not appear wet or damp. It is likely that the previous condition which facilitated the infestation is no longer present, the condition has been corrected and/or professional treatment was performed. The seller should be contacted to determine if any other history is available, particularly with regard to professional treatment. Regular and periodic pest inspections are always advised. There are no treatment recommendations. This observation was made in the following area(s): See WDO Diagram. Note: A Washington State licensed applicator should be called to provide chemical treatment for Moisture Ants for the comfort of workers who will need to perform repairs. A licensed tradesperson should be called to identify and remediate the source of the moisture. In addition, hidden or concealed spaces in and around the vicinity of the colony should be exposed sufficiently enough to reasonably identify and repair any hidden damages.

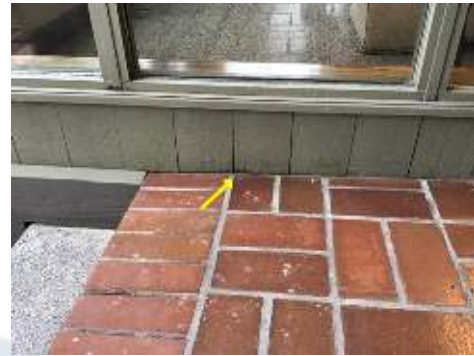
- Damage/decay present on the lower siding. Be aware hidden conditions may exist. This was seen in the following area(s):Rear.
