PROPERTY INSPECTION REPORT

Property Address: Sample Dr SW ,

Date: 10/13/2019

Inspector: Dwayne Boggs

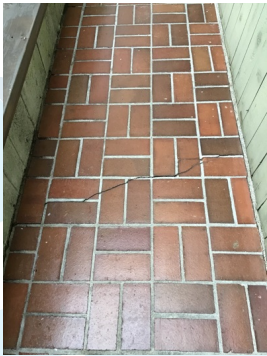
Exterior		
Page 22 Item: 2	Walkways	<ul style="list-style-type: none"> Spalling or deterioration of walkway is present: Repair/replacement may be necessary. Follow up with a licensed concrete contractor is advised. These conditions were noted in the following areas: Left side.

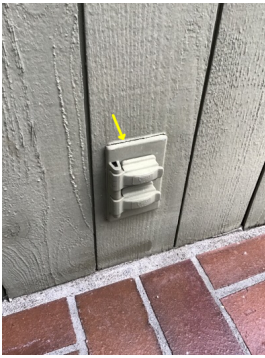
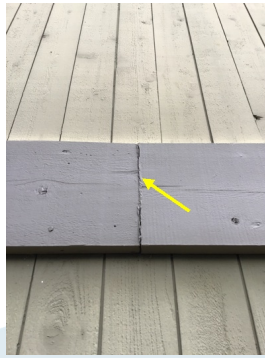
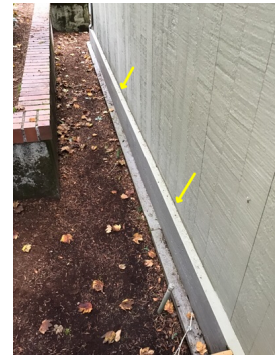
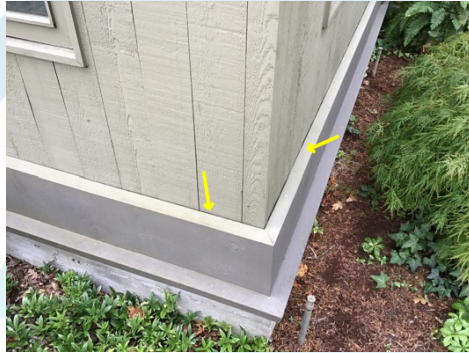
Page 22 Item: 3	Siding And Trim	<ul style="list-style-type: none"> Caulking around exposed penetrations (doors, windows, nail heads, etc.) is a normal and extremely important maintenance task which needs to be performed on a regular basis. It is also extremely important to maintain caulking along the top edge of horizontal trim boards or belly boards. Failure to maintain caulking may result in rapid deterioration of composite wood sidings; always use a high quality paintable caulk such as OSI Quad. Be aware that on used structures, particularly older structures where caulking has been allowed to fail hidden conditions may exist. Noted: Primary Structure. Z-type metal flashing is missing: Where siding materials such as wood panels or trim meet at a horizontal joint, Z-type metal flashing is used to prevent water penetration. Retrofit flashing installation is generally not reasonable to do, so it will be important to maintain caulking as a defense against water penetration on older structures. Be aware hidden conditions may exist. Noted: All sides.

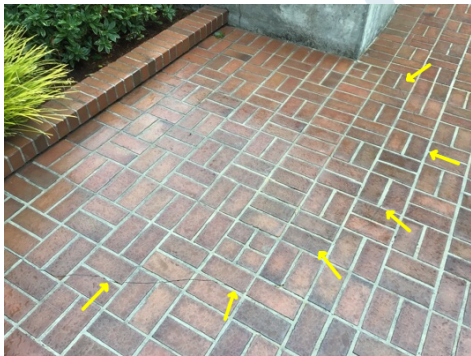
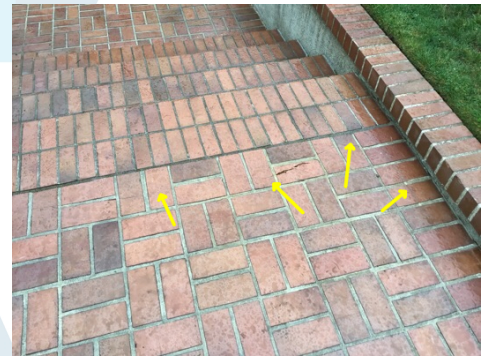
Page 23 Item: 4

• Erosion or settling of concrete surface is present. If this is a concern, following up with a licensed contractor specializing in patio installation and repair is advised. This condition was noted on the following patio slab(s): Front.

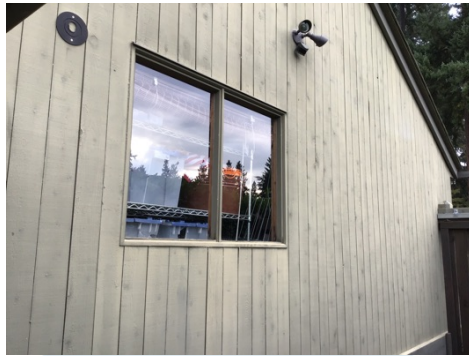
Page 24 Item: 6

• The exterior paint or finish is weathered or deteriorated. Painting is a normal and ongoing maintenance issue and, as would be expected, weathered sides of the house are the first to show signs of failure. The frequency of repainting depends largely upon the quality of the preparation, the quality of the paint and the quality of the application. Back rolling and back brushing is always preferred to simply spraying on the product. In general, flat paints do not seem to hold up as well as semigloss types. A paint supplier or painting contractor can explain more. It is especially important to maintain good paint coverage on composite wood products to prevent failure, which can happen very quickly without proper paint coverage. At this time, the weathering and deterioration might best be described as: Minor.

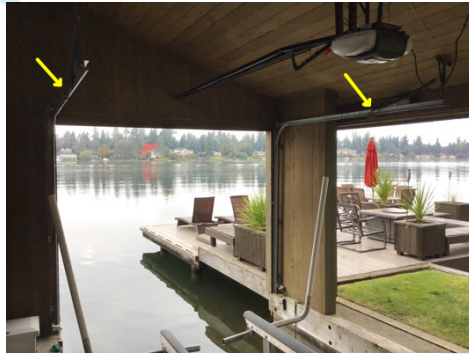
Page 24 Item: 8	Miscellaneous	<ul style="list-style-type: none"> Door to the boat garage is missing. The springs and cables are attached to the roller brackets for now. Recommend repair.
-----------------	---------------	---

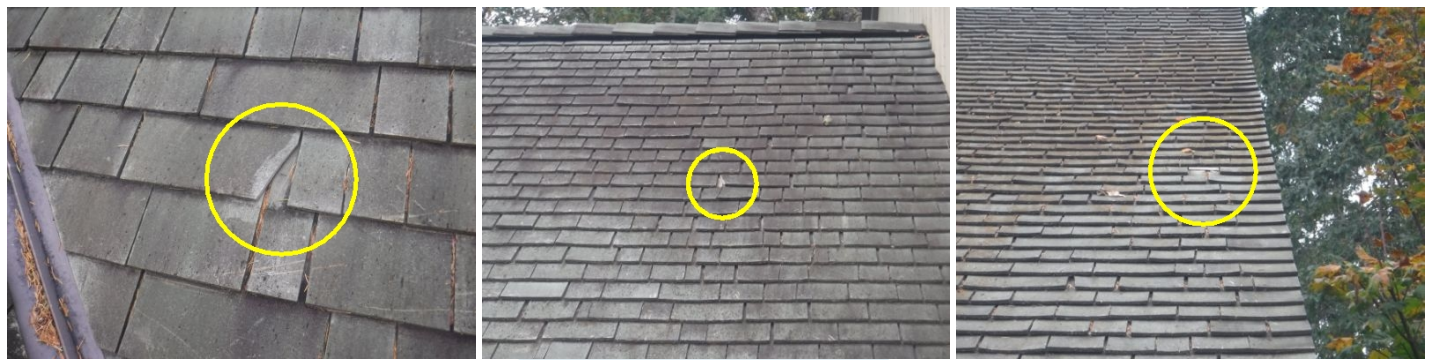
Roof		
Page 25 Item: 2	General Defects	<ul style="list-style-type: none"> Cedar shake/shingles showing some signs of wear. At this time, the signs of roofing wear include: Loose and/or missing shakes or shingles. Noted: Primary Structure.

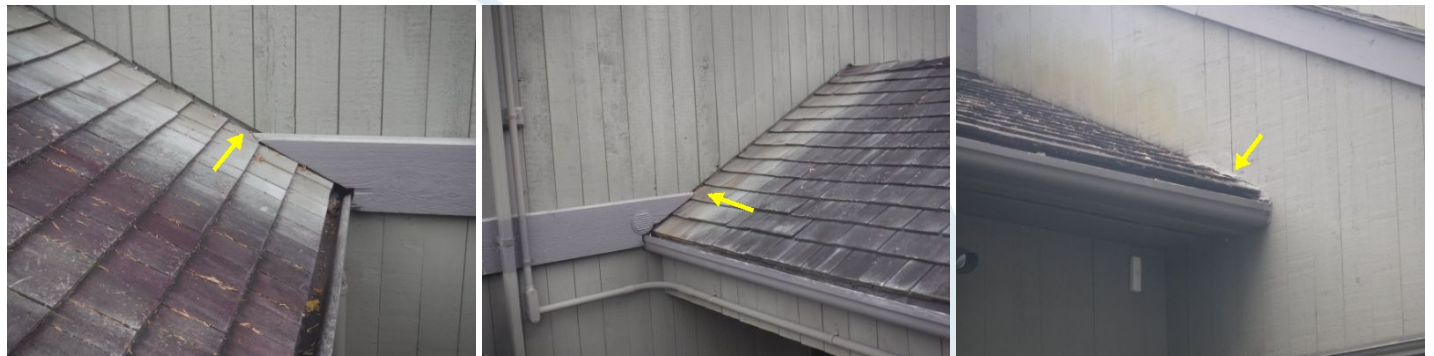
Page 27 Item: 12	Flashing	<ul style="list-style-type: none"> Roof kick-out flashing is missing or inadequate. Where the gutter edge of a roof meets a wall, the last sidewall flashing above the gutter end should be installed so that water from the roof is directed into the gutter instead of behind the siding. This should be installed at the same height as the sidewall flashing (minimum of 4 inches). On older structures hidden conditions may exist. Caulking alone is not an acceptable substitute as it will fail overtime. Correction by a licensed professional roofer is recommended. Noted: Primary Structure.
------------------	----------	---

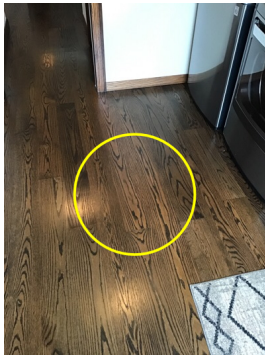
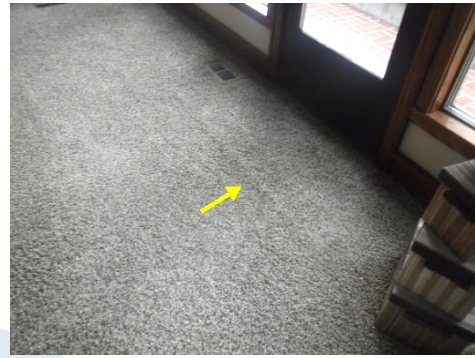
Page 29 Item: 2	Flooring Defects	<ul style="list-style-type: none"> Some floor squeaking is noted: This is a common occurrence often due to nails in the sub floor having missed the floor joist and are rubbing against it. A hardware supply or contractor can suggest remedies if this is of concern to you. Noted: Utility room. The carpet is loose and needs restretched. This was noted in the Living room.
-----------------	------------------	---

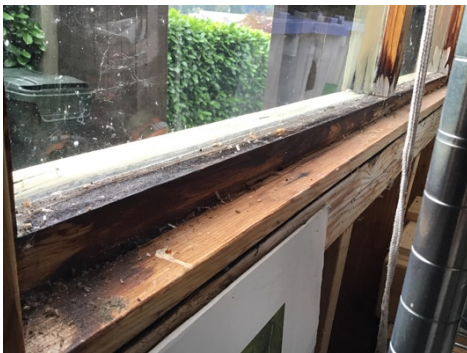
Page 29 Item: 4

- Damage or deterioration of the interior window framing/sill exists: Be aware hidden conditions may exist. Repair is recommended. Noted in the following area(s): Garage.

- The following window conditions are present: Some older windows are not safety glass. Older structures rarely meet the current standards. Exercise caution and consider changing to safety glass as a future upgrade or if windows should ever need replacing.. This was noted in the following area(s): Stairwell. Safety glass is currently required in the following circumstances: (1) If the window pane is > 9 sq. ft, < 18 inches above the floor, the top edge of the window is > 36 inches above the ground, and the window is within 36 inches of a walking surface. (2) The window is within 2 ft of a door and its bottom edge is < 60 inches over a walking surface. (3) The windows is in a wall enclosing a tub, shower or spa and the bottom edge is < 60 inches over a walking surface. (4) Windows within 60 inches of the bottom tread of a stairway if the exposed glass is < 60 inches from the nose of the tread. (5) All windows in railings. This requirement is often not met on older structures (which predate the code). Extreme caution is advised, particularly if small children are present. If these windows should ever be replaced, they should be changed to safety glass.

- Some or all window screens are missing: Repair is recommended. Noted in the following area(s): Several areas.

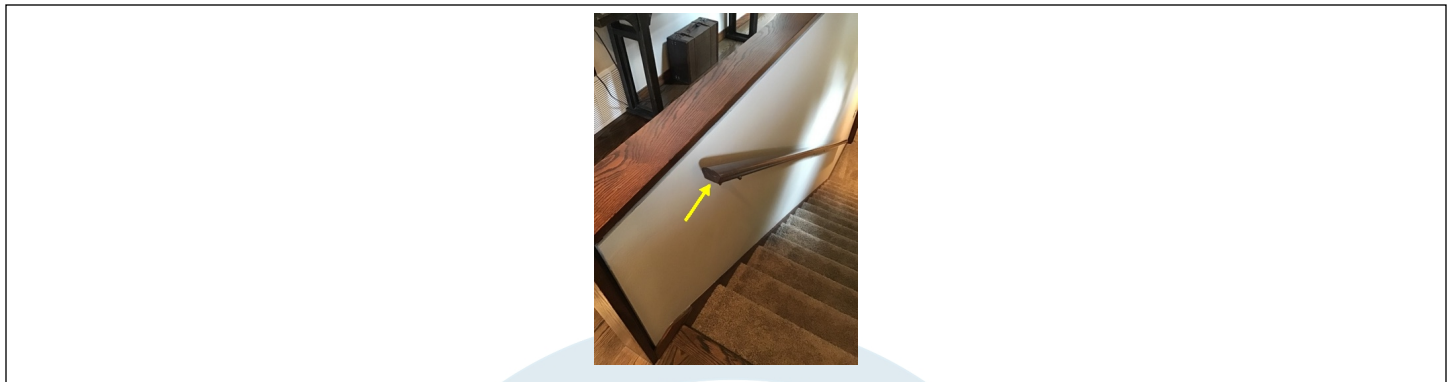
Page 30 Item: 5

- Stair hand rail ends are exposed: This is a common finding in older homes which predates the requirements to have the rail ends return to the wall. Be aware rail ends can snag clothes and cause falls.

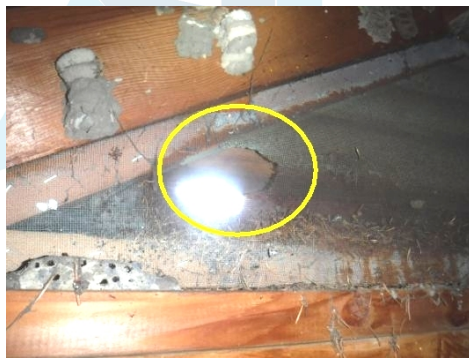
Page 30 Item: 6	Attic	<ul style="list-style-type: none"> • There is an unsealed opening to the exterior observed in the attic. Recommend sealing to prevent possible entry by pests/vermin in the attic area. Noted: On the gable vent on the south side of the main structure.
-----------------	-------	--

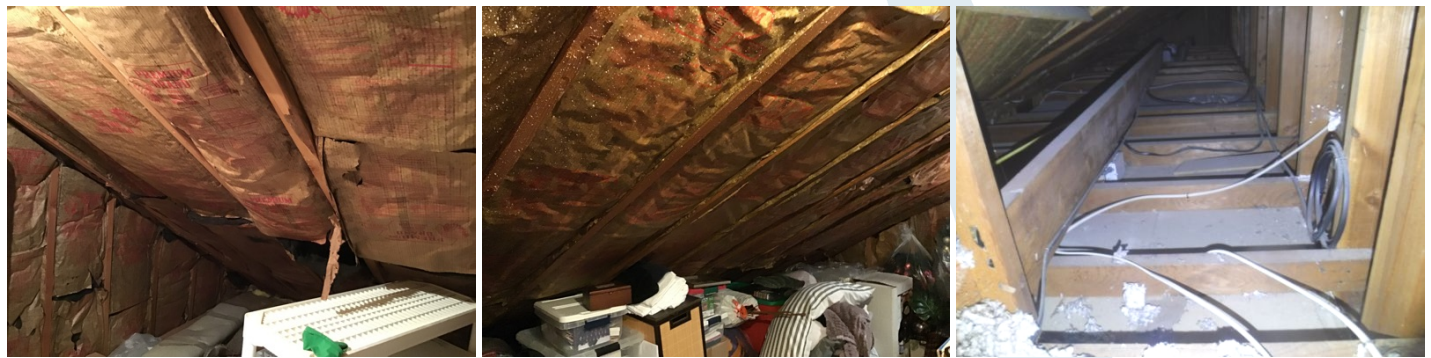
Page 31 Item: 7	Insulation	<ul style="list-style-type: none"> • Insulation has been installed directly on bottom of the roof sheathing. Recommend removal of insulation to allow proper air flow along the underside of roof. Note that all affected areas of the roof sheathing are specifically excluded from the report. • Portions of the attic are not insulated: Recommend installing insulation to current standards as an energy saving upgrade. Noted: Above end of hallway and bathroom on second floor on north side of the structure. • The attic is not insulated to current standards: Recommend improving for energy efficiency.
-----------------	------------	---

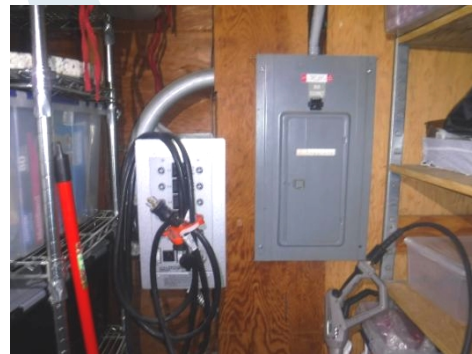
- The electrical panel(s) are a Federal Pacific Electric (FPE) brand: FPE panels have had conditions documented that include breaker failure and are considered by some to be a possible latent fire hazard. Considerable information is available on the internet by visiting https://inspectapedia.com/fpe/FPE_Stab_Lok_Hazards.php . It is recommended a licensed electrician evaluate the panel for safety and possible replacement. Noted: Garage.
- The electrical panel(s) have a mechanism in place to manage a generator. It is important for the buyer to understand how the system works. Therefore, having either the seller explain the proper operation or a licensed electrician explain the system will aid in the proper usage of the mechanism. Noted: Garage.
- The newer generator panel(s) lack a permit sticker. Recommend further review to see if a permit was pulled. Noted: Garage.

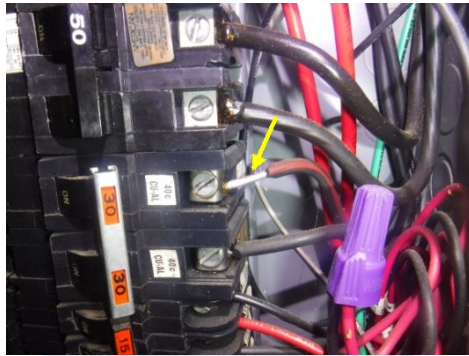
Page 35 Item: 3

- Single stranded aluminum branch wiring is present: Older single stranded aluminum wiring is known for having issues with oxidation, overheating and the tendency to break due to fatigue. Recommend full evaluation by electrician. Also recommend following up with your homeowner's insurance company to verify coverage will be available with this type of wiring. Noted: Garage.

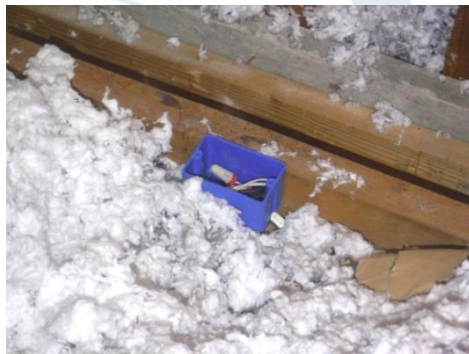
- Missing electric junction box covers are noted: Junction boxes should always have covers in place. Repair/replacement is recommended. Noted: Attic.

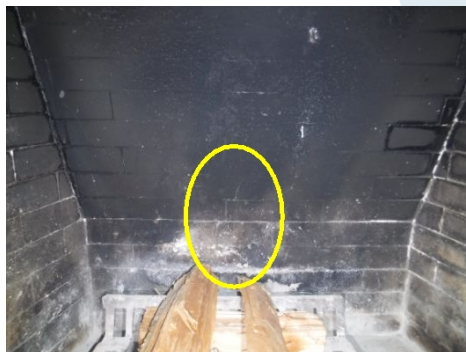
Page 39 Item: 3	Fireplace/Insert	<ul style="list-style-type: none"> There are cracked, loose and/or damaged firebricks in the fireplace: Recommend further evaluation and repair. This was observed on the unit in the following area(s): Master bedroom.
-----------------	------------------	---

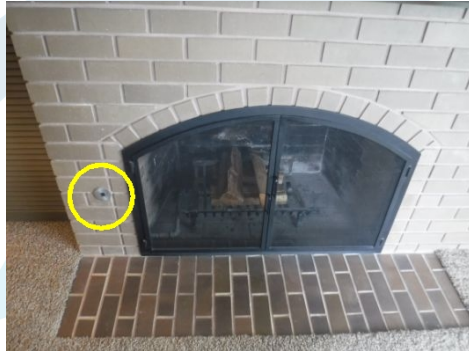
Page 39 Item: 4	Gas Supply :	<ul style="list-style-type: none"> • The gas hookup is equipped with a shutoff valve that requires a wrench to operate. Modern building standards recommend the use of a hand shutoff type gas control valve. Recommend further review. This was observed on the unit(s) in the following area(s): Master bedroom. • The gas shutoff valve cannot be located: Every gas appliance should have a readily accessible shutoff near the appliance. Followup with the seller to locate the gas shutoff. If none exists, recommend further professional evaluation. This was observed on the unit(s) in the following area(s): Living room.
-----------------	--------------	---

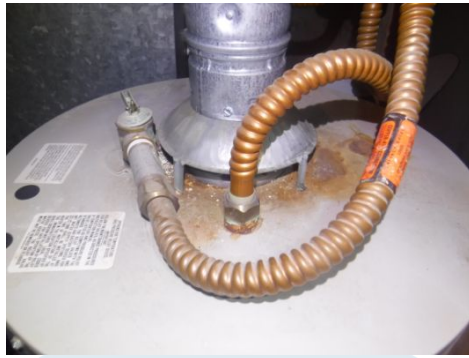
Page 40 Item: 3	Water Heater General	<ul style="list-style-type: none"> • Rusting, corrosion, and leakage has occurred: On older units in particular, the water heater may not be reliable. Recommend professional evaluation. • The drip pan is missing under the water heater: Where the water heater is installed inside the living area, especially on a second or third floor, or in the attic, a drip pan installed under the unit would help prevent water damage should the unit ever leak. This is a common finding on older homes and should be considered as an improvement. • Water temperature is high: "Typical", water temperature is usually observed at 105 to 120 deg F. Sometimes this is adjusted upward by the homeowner for personal reasons, however, this cannot be determined during the inspection. While this finding is subjective in nature, be aware that when temperatures above 120 deg F are recorded, risk of burn injury increases and caution is advised. Noted temperature reading is 135 F. Water heater location: • Water heater appears older, (>10 years old): Be aware the unit may be nearing its end of useful life and may need to be replaced soon and may not be reliable. Determining the life expectancy of plumbing related equipment is outside the scope of inspection.

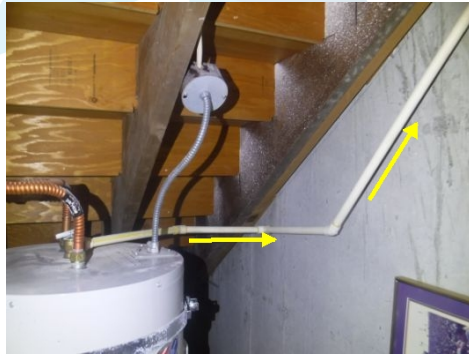
Page 42 Item: 2	Water Heater General	<ul style="list-style-type: none"> The drip pan is missing under the water heater: Where the water heater is installed inside the living area, especially on a second or third floor, or in the attic, a drip pan installed under the unit would help prevent water damage should the unit ever leak. This is a common finding on older homes and should be considered as an improvement. Water heater appears older, (>10 years old): Be aware the unit may be nearing its end of useful life and may need to be replaced soon and may not be reliable. Determining the life expectancy of plumbing related equipment is outside the scope of inspection.
Page 42 Item: 3	Water heater TPR :	<ul style="list-style-type: none"> The temperature pressure relief (TPR) line is improperly sloped. For safety, the manufacturer's installation requirements of the TPR line from the water heater are very specific: The inside diameter of the line should never be downsized; The line should always be sloped downhill; The line should terminate at an elbow pointing downward close to the ground; There should not be more than four elbows in the line. Any conditions noted should be corrected for safety.

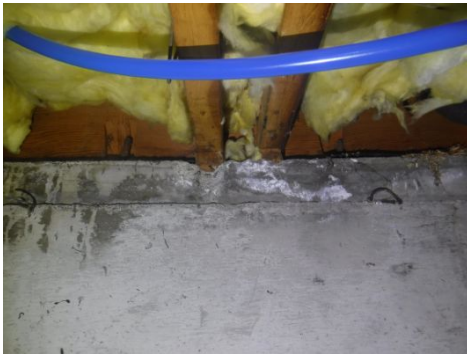
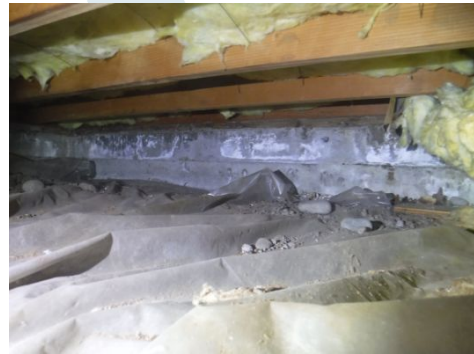
Page 44 Item: 2	Foundation	<ul style="list-style-type: none"> There is efflorescence in the crawlspace: Efflorescence is a white powdery residue left behind when moisture migrates through concrete, brick, or mortar and evaporates leaving mineral deposits behind. Typically, this is seen on concrete stem walls where there may be inadequate management of exterior drainage or roof runoff. There is no specific mitigation other than correcting issues related to drainage, roof runoff or other water related issues contained in this report. Regular pest inspections are advised. Noted: Right side and rear.
-----------------	------------	---

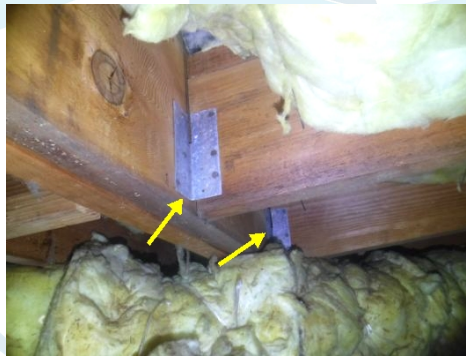
Page 44 Item: 4	Vermin/Animals :	<ul style="list-style-type: none"> • There is rodent evidence seen as droppings. Recommend contacting a licensed pest controller. Noted: In the crawl space.
Page 44 Item: 5	Joists or Trusses :	<ul style="list-style-type: none"> • The following conditions should be further evaluated by a licensed contractor: The joist hangers appear too small for the joist they're supporting. Load bearing may be an issue. These conditions were noted in the following area(s): Under the Living room.

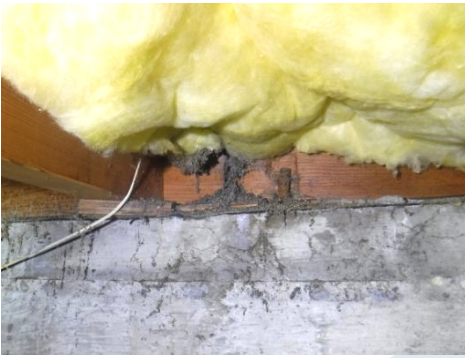
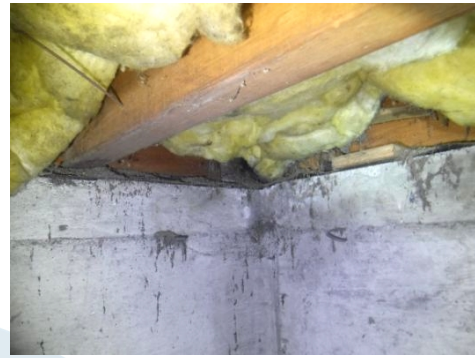
Page 50 Item: 3	Moisture Ants	<ul style="list-style-type: none"> • A moisture ant gallery or tube formation is observed. No live insects are seen, no damage is perceived and the immediate area does not appear wet or damp. It is likely that the previous condition which facilitated the infestation is no longer present, the condition has been corrected and/or professional treatment was performed. The seller should be contacted to determine if any other history is available, particularly with regard to professional treatment. Regular and periodic pest inspections are always advised. There are no treatment recommendations. This observation was made in the following area(s): See WDO Diagram. Note: A Washington State licensed applicator should be called to provide chemical treatment for Moisture Ants for the comfort of workers who will need to perform repairs. A licensed tradesperson should be called to identify and remediate the source of the moisture. In addition, hidden or concealed spaces in and around the vicinity of the colony should be exposed sufficiently enough to reasonably identify and repair any hidden damages.

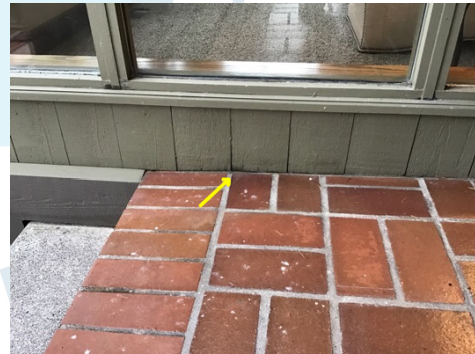
Page 50 Item: 1	Exterior Siding	<ul style="list-style-type: none"> Damage/decay present on the lower siding. Be aware hidden conditions may exist. This was seen in the following area(s):Rear.
-----------------	-----------------	--

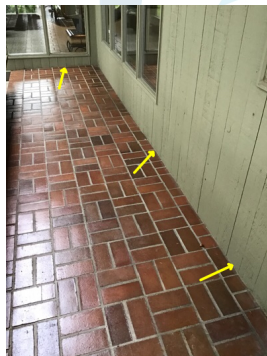
Page 51 Item: 2	Foliage	<ul style="list-style-type: none"> Foliage should be maintained so it is at least 10 to 12 inches away from house as it may cause mechanical damage to the siding and promote high moisture conditions and/or infestation. Where foliage is dense and access limited, hidden conditions may exist which should be reported to the inspecting firm if discovered. Where there is decorative, established foliage against the structure such as climbing vines, cutting the foliage back may be detrimental to the aesthetic appearance of the home. If the foliage is left in place, be aware that infestation and high moisture conditions may occur. Regular and periodic inspections are suggested.
Page 51 Item: 3	Hard Surface Contact	<ul style="list-style-type: none"> The exterior siding is in contact with a concrete, masonry or asphalt surface. This may allow decay to occur to the siding as well as to the wood members behind it. Even if the area in question is covered by a roof structure, placing potted plants nearby and watering them may cause decay to occur. A contractor may be able to suggest some measures, such as caulking, to prevent water penetration. Be aware that on used structures, particularly older ones, hidden damages may exist and are outside the scope of inspection. This condition was noted in the following area(s): Rear and left side.

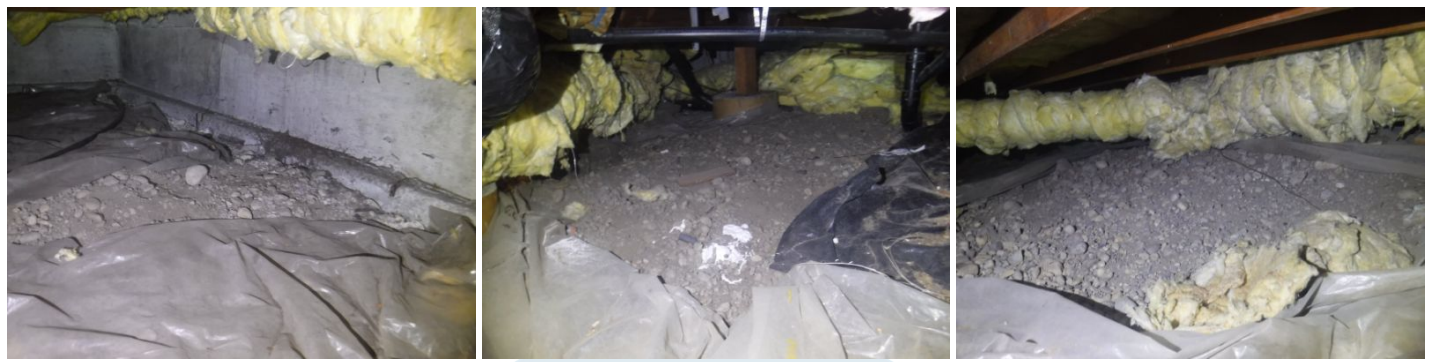
Page 52 Item: 1	Vapor Barrier	<ul style="list-style-type: none"> The crawl space has inadequate and/or damaged vapor barrier coverage. Spread existing crawl space vapor barrier as able and install additional 6 mm black plastic vapor barriers as needed to meet current building requirements with provision for appropriate overlap at seams, (12 inches). This was noted in the following area(s): Scattered.
-----------------	---------------	--

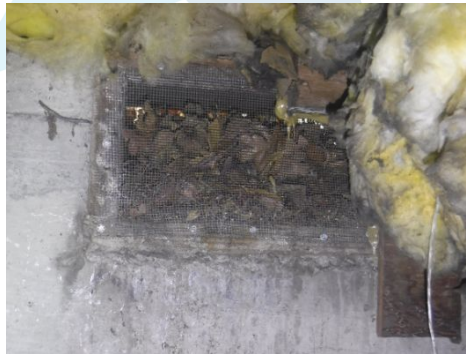
Page 53 Item: 2

- Foundation vents are blocked. Unblock any and all foundation vents which have been either purposefully blocked and/or are blocked by landscaping material or dirt. Repair any damaged screen with 1/4 inch, non-louvered, galvanized hardware cloth. If vent is below grade, a foundation vent well should be installed to keep dirt and landscaping material clear of the vent. This was noted in the following area(s) : Front.

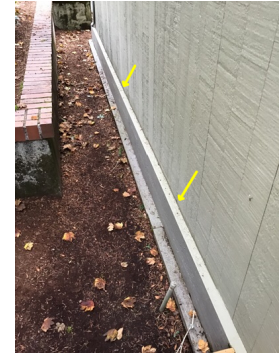
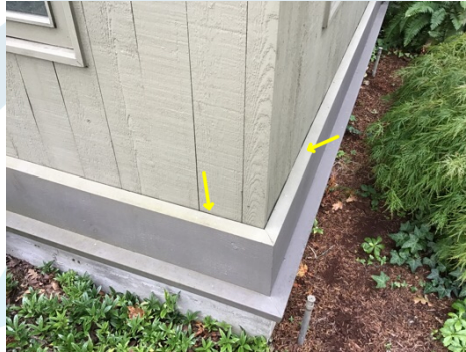
- Caulking around exposed penetrations (doors, windows, nail heads, etc.) is a normal and extremely important maintenance task which needs to be performed on a regular basis. It is also extremely important to maintain caulking along the top edge of horizontal trim boards or belly boards. Failure to maintain caulking may result in rapid deterioration of composite wood sidings; always use a high quality paintable caulk such as OSI Quad. Be aware that on used structures, particularly older structures where caulking has been allowed to fail hidden conditions may exist. Noted: Primary Structure.

- Z-type metal flashing is missing: Where siding materials such as wood panels or trim meet at a horizontal joint, Z-type metal flashing is used to prevent water penetration. Retrofit flashing installation is generally not reasonable to do, so it will be important to maintain caulking as a defense against water penetration on older structures. Be aware hidden conditions may exist. Noted: All sides.

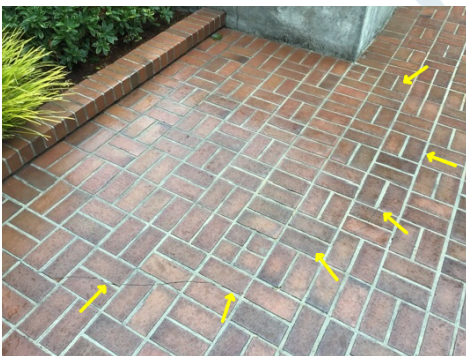
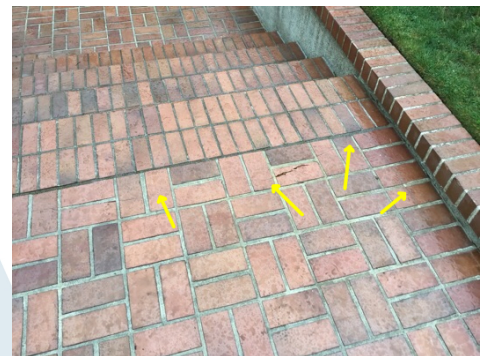
- Erosion or settling of concrete surface is present. If this is a concern, following up with a licensed contractor specializing in patio installation and repair is advised. This condition was noted on the following patio slab(s): Front.

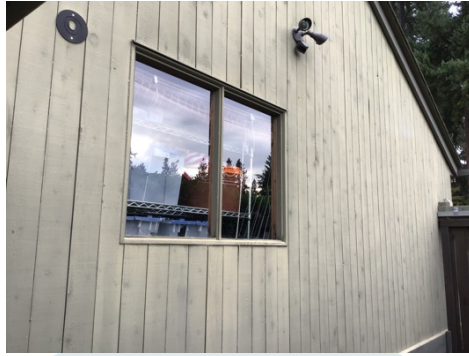
- The exterior paint or finish is weathered or deteriorated. Painting is a normal and ongoing maintenance issue and, as would be expected, weathered sides of the house are the first to show signs of failure. The frequency of repainting depends largely upon the quality of the preparation, the quality of the paint and the quality of the application. Back rolling and back brushing is always preferred to simply spraying on the product. In general, flat paints do not seem to hold up as well as semigloss types. A paint supplier or painting contractor can explain more. It is especially important to maintain good paint coverage on composite wood products to prevent failure, which can happen very quickly without proper paint coverage. At this time, the weathering and deterioration might best be described as: Minor.

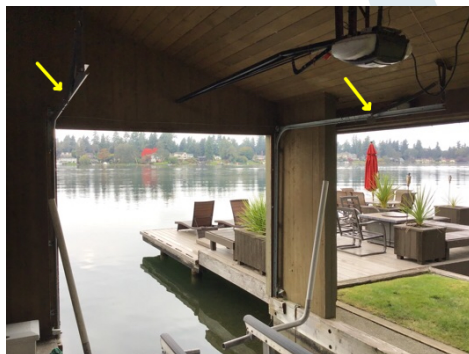
- Door to the boat garage is missing. The springs and cables are attached to the roller brackets for now. Recommend repair.

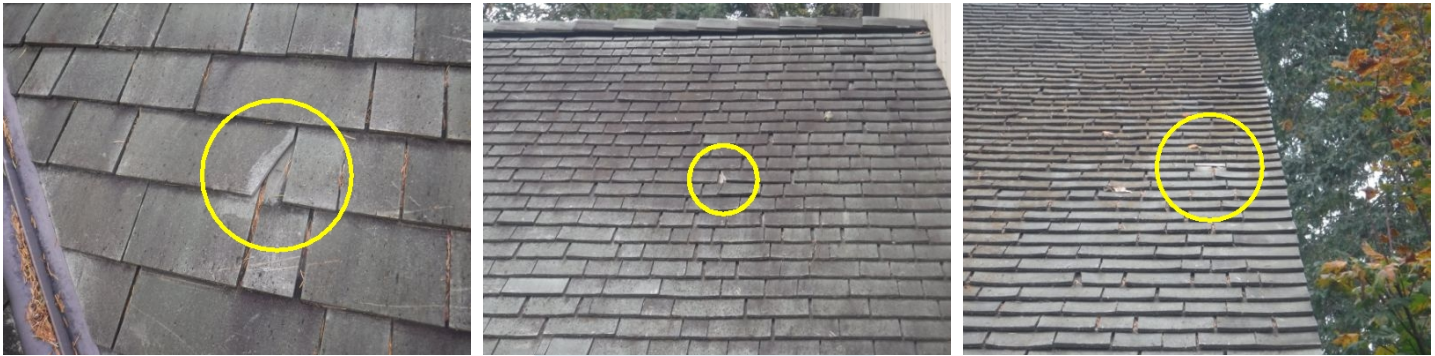
- Cedar shake/shingles showing some signs of wear. At this time, the signs of roofing wear include: Loose and/or missing shakes or shingles. Noted: Primary Structure.

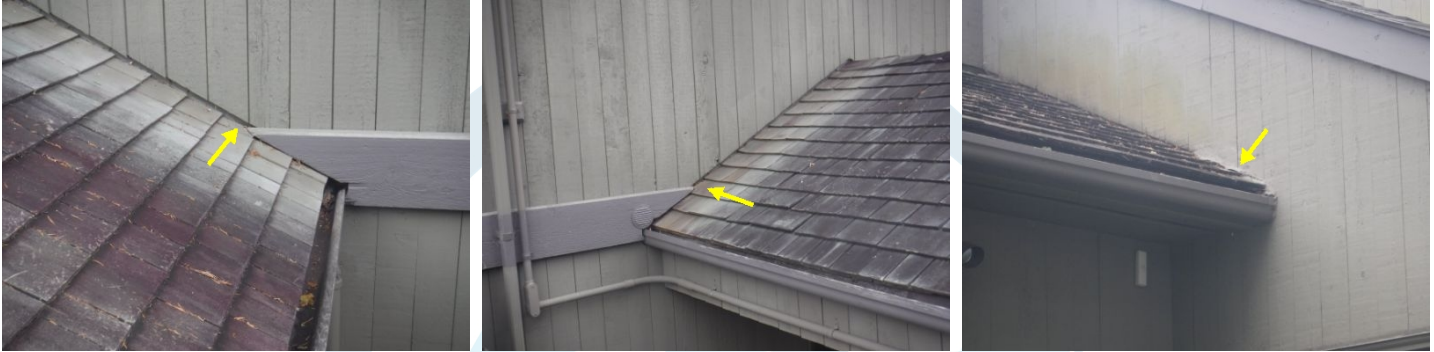
- Roof kick-out flashing is missing or inadequate. Where the gutter edge of a roof meets a wall, the last sidewall flashing above the gutter end should be installed so that water from the roof is directed into the gutter instead of behind the siding. This should be installed at the same height as the sidewall flashing (minimum of 4 inches). On older structures hidden conditions may exist. Caulking alone is not an acceptable substitute as it will fail overtime. Correction by a licensed professional roofer is recommended. Noted: Primary Structure.

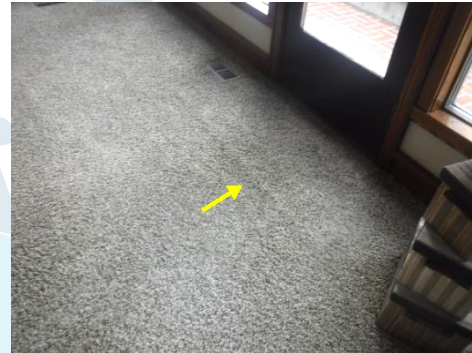
- Some floor squeaking is noted: This is a common occurrence often due to nails in the sub floor having missed the floor joist and are rubbing against it. A hardware supply or contractor can suggest remedies if this is of concern to you. Noted: Utility room.
- The carpet is loose and needs restretched. This was noted in the Living room.

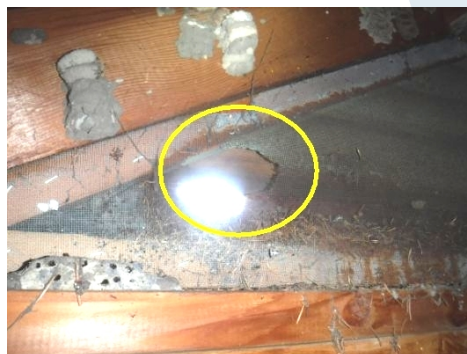
- There is an unsealed opening to the exterior observed in the attic. Recommend sealing to prevent possible entry by pests/vermin in the attic area. Noted: On the gable vent on the south side of the main structure.

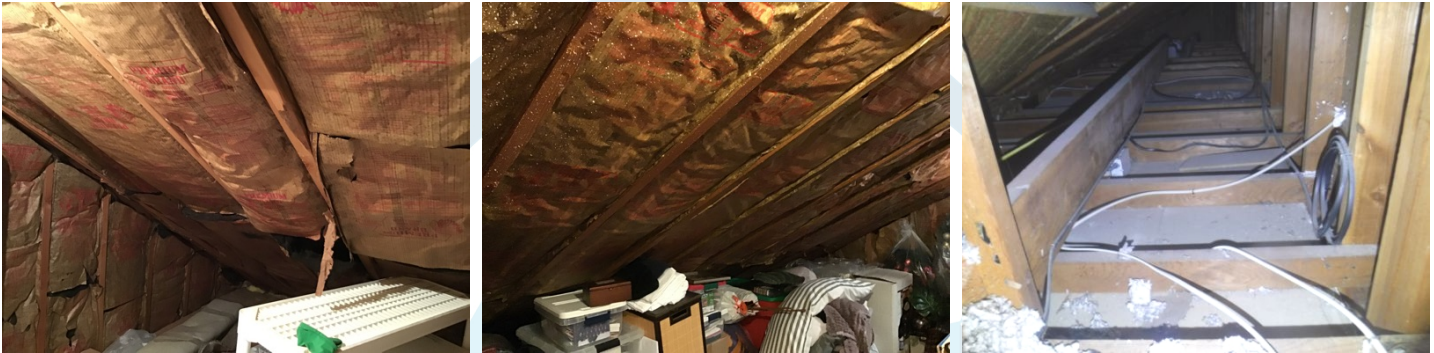
- Insulation has been installed directly on bottom of the roof sheathing. Recommend removal of insulation to allow proper air flow along the underside of roof. Note that all affected areas of the roof sheathing are specifically excluded from the report.
- Portions of the attic are not insulated: Recommend installing insulation to current standards as an energy saving upgrade. Noted: Above end of hallway and bathroom on second floor on north side of the structure.
- The attic is not insulated to current standards: Recommend improving for energy efficiency.

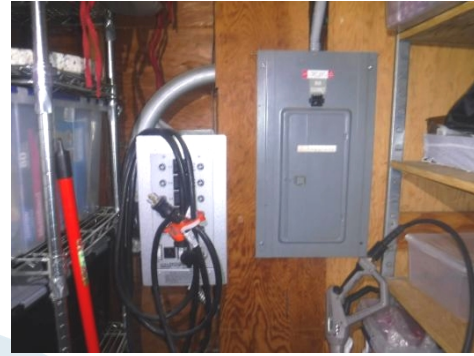
- The electrical panel(s) are a Federal Pacific Electric (FPE) brand: FPE panels have had conditions documented that include breaker failure and are considered by some to be a possible latent fire hazard. Considerable information is available on the internet by visiting https://inspectapedia.com/fpe/FPE_Stab_Lok_Hazards.php . It is recommended a licensed electrician evaluate the panel for safety and possible replacement. Noted: Garage.
- The electrical panel(s) have a mechanism in place to manage a generator. It is important for the buyer to understand how the system works. Therefore, having either the seller explain the proper operation or a licensed electrician explain the system will aide in the proper usage of the mechanism. Noted: Garage.
- The newer generator panel(s) lack a permit sticker. Recommend further review to see if a permit was pulled. Noted: Garage.

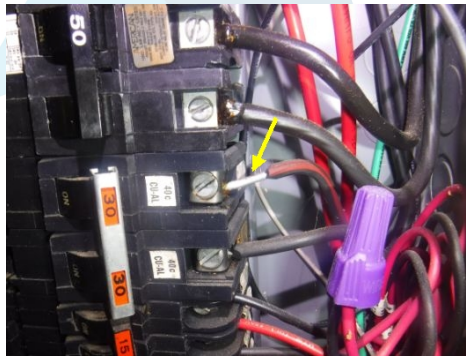
- Single stranded aluminum branch wiring is present: Older single stranded aluminum wiring is known for having issues with oxidation, overheating and the tendency to break due to fatigue. Recommend full evaluation by electrician. Also recommend following up with your homeowner's insurance company to verify coverage will be available with this type of wiring. Noted: Garage.

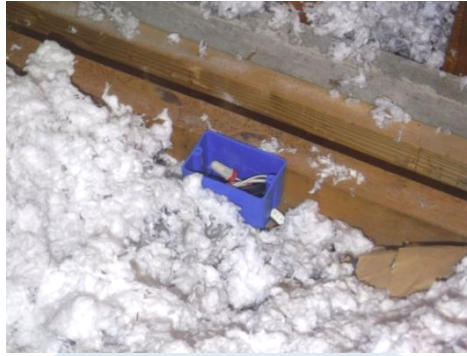
- Missing electric junction box covers are noted: Junction boxes should always have covers in place. Repair/replacement is recommended. Noted: Attic.

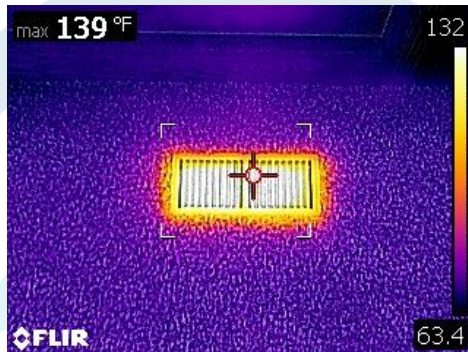
- At the time of inspection, when testing the unit in the heating mode, a sampling of the temperature was noted around: 140 F.
- The Gas, Oil or LPG heating unit appears older (>10 years): A full service evaluation is strongly recommended prior to closing the Real Estate Transaction. This should include Carbon Monoxide testing of flue gases to help determine the condition of the heat exchanger. Any damage to the heat exchanger could represent a health risk related to Carbon Monoxide. This evaluation should include any older A/C or heat pump systems which may be present and are integral to the central furnace.

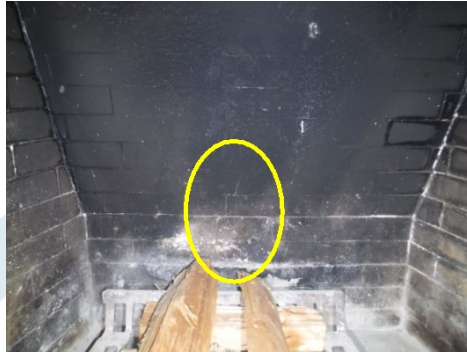
- There are cracked, loose and/or damaged firebricks in the fireplace: Recommend further evaluation and repair. This was observed on the unit in the following area(s): Master bedroom.

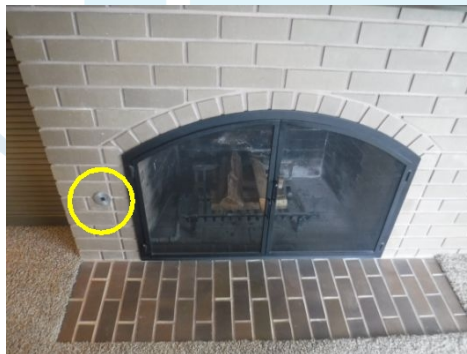
- The gas hookup is equipped with a shutoff valve that requires a wrench to operate. Modern building standards recommend the use of a hand shutoff type gas control valve. Recommend further review. This was observed on the unit(s) in the following area(s): Master bedroom.
- The gas shutoff valve cannot be located: Every gas appliance should have a readily accessible shutoff near the appliance. Followup with the seller to locate the gas shutoff. If none exists, recommend further professional evaluation. This was observed on the unit(s) in the following area(s): Living room.

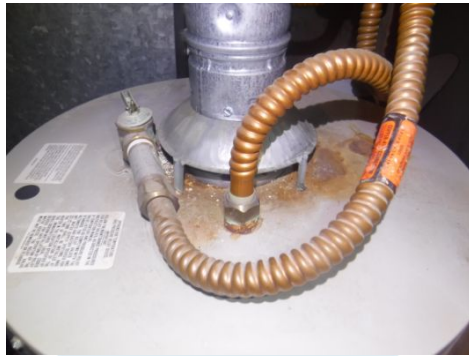
- Water heater appears older, (>10 years old): Be aware the unit may be nearing its end of useful life and may need to be replaced soon and may not be reliable. Determining the life expectancy of plumbing related equipment is outside the scope of inspection.

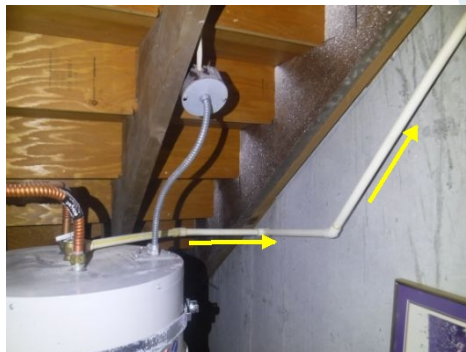
- The temperature pressure relief (TPR) line is improperly sloped. For safety, the manufacturer's installation requirements of the TPR line from the water heater are very specific: The inside diameter of the line should never be downsized; The line should always be sloped downhill; The line should terminate at an elbow pointing downward close to the ground; There should not be more than four elbows in the line. Any conditions noted should be corrected for safety.

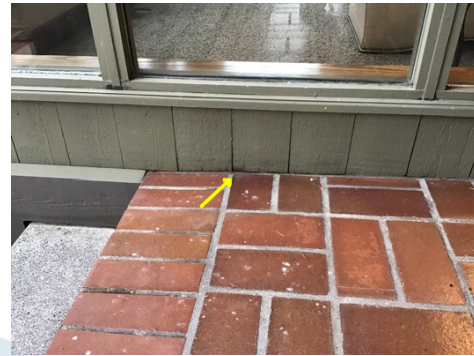
- Damage/decay present on the lower siding. Be aware hidden conditions may exist. This was seen in the following area(s):Rear.
