## BOGGS INSPECTION SERVICES

### PROPERTY CONDITION REPORT COPY

123 Main St  
Capital City WA 98513

Joe Smith  
JANUARY 26, 2021

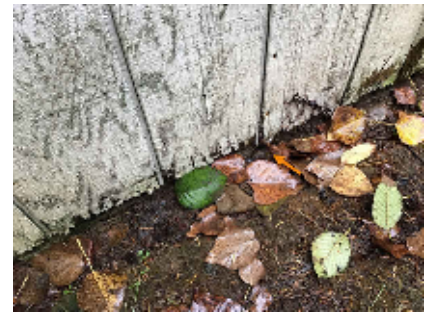
SHED

**WOOD DAMAGE OR DETERIORATION**

Wood cladding was damaged or deteriorated at the time of the inspection. The inspector recommends repair/replacement of damaged pieces and regular maintenance of the protective coating to prevent future deterioration.

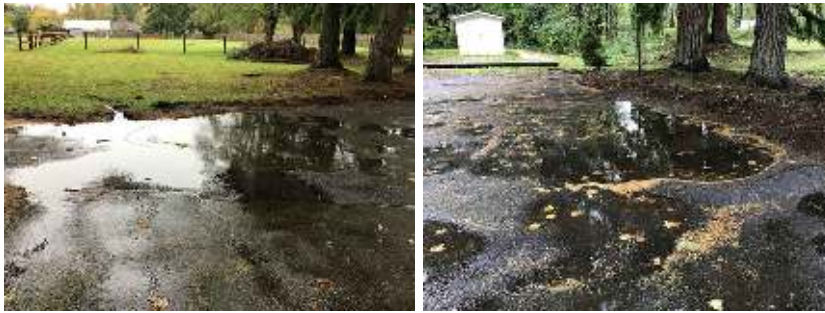
NW

**EVIDENCE OF PONDING**

Evidence of ponding was observed at the asphalt driving surface. Ponding is caused by water collecting in localized depressions that trap water and fail to properly route it to a storm drainage system where applicable. This condition will increase the rate of degradation of the asphalt at these areas. The inspector recommends correction by a qualified paving contractor.

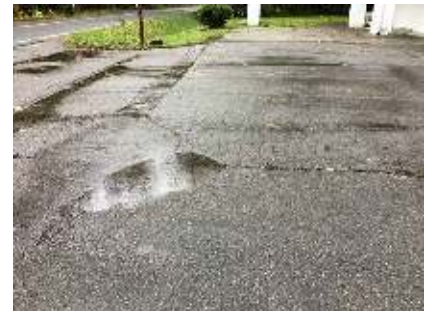
NE

#### **TRANSVERSE AND LONGITUDINAL CRACKING**

Asphalt drive and parking areas exhibited common transverse and longitudinal cracking. These cracks are caused by a number of conditions including the following:

- Poorly constructed paving joint crack
- Shrinkage of the asphalt layer
- Daily temperature cycling
- Cracks in an underlying layer that reflect up through the pavement
- Longitudinal segregation caused by the improper operation of the paver

Signs of correction were observed including the filling and sealing of cracks. These areas should be monitored for further deterioration and be maintained by a paving contractor as necessary.

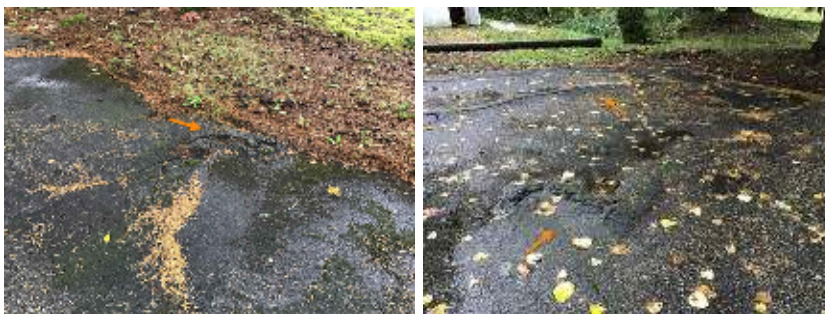
N, NW

#### **ASPHALT HEAVING/DAMAGE**

Heaving/damage of the asphalt was observed. Heaving/damage can result from a number of causes including the following: - Expansive soils - Tree root displacement. Recommend further evaluation by a licensed asphalt contractor.

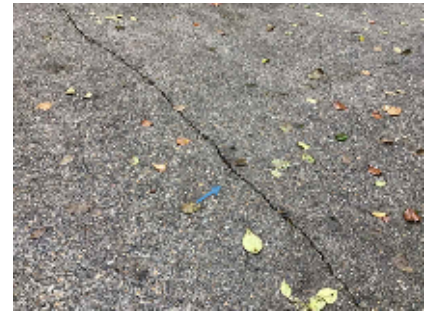
MAIN BUILDING: E

**TYPICAL CRACKS**

Typical cracking was observed in the walkways. Cracks over 1/4 inch should be filled with an appropriate sealant to prevent further damage from the expansion of freezing water.

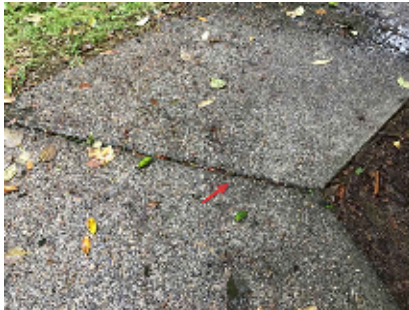
Main Building: SE

**SETTLED/UNEVEN**

Concrete walkways exhibited settling resulting in trip hazards. Trip hazards are defined as any change in elevation over 1/4 of an inch. Repairs should be made by a qualified paving contractor.

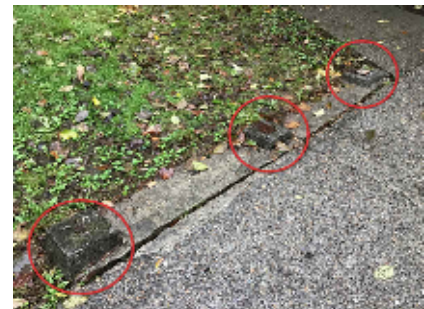
MAIN BUILDING: E

**OLD FOOTINGS - TRIP HAZARD**

There are old footings that are uneven with the walkway surface. Trip hazards are generally defined as any change in elevation over 1/4 of an inch. Repairs should be made by a qualified paving contractor.

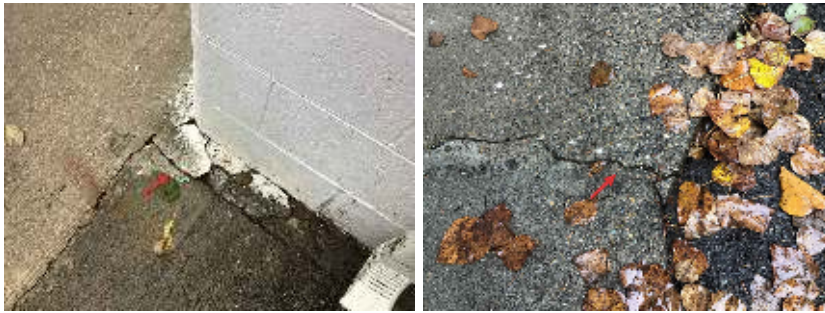
MAIN BUILDING: N

**LARGER CRACKS**

Trip Hazard: Concrete walkways exhibited damage or deterioration at the time of the inspection. In some areas deterioration resulted in vertical displacement greater than 1/4" in the walking surface. Changes greater than 1/4" constitute a trip hazard. Recommend correction by a qualified paving contractor to eliminate trip hazards and prolong service life.

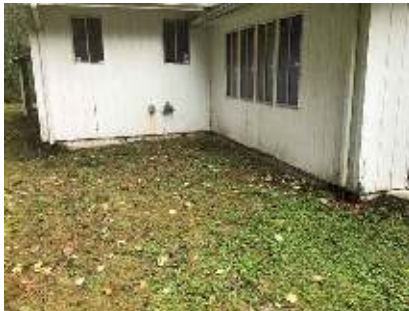
Main Building: S

#### AREAS OF NEGATIVE OR NEUTRAL GRADE

Localized areas of negative or neutral grade were observed that can direct runoff from precipitation toward the foundation. Erosion and/or excessive levels of moisture in the soil near the foundation can affect the ability of the soil to support the weight of the structure above. For ideal drainage, landscaping should slope away from the property at a rate of 1/4 inch per foot for at least six feet from the foundation. The inspector recommends regrading by a qualified landscaping or paving firm to direct water away from the foundation and building envelope.

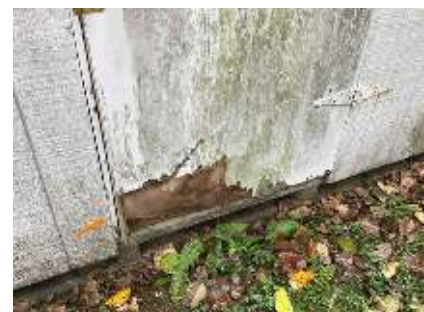
SHED

#### DETERIORATED DOORS

Wood doors exhibited general damage or deterioration commensurate with their age. The finish coating was poorly maintained which resulted in UV and moisture damage.

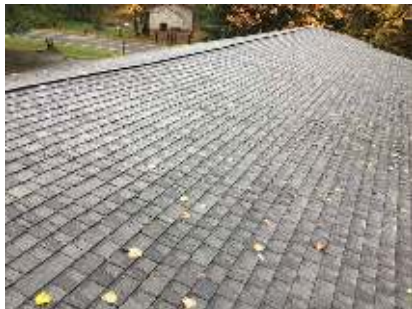
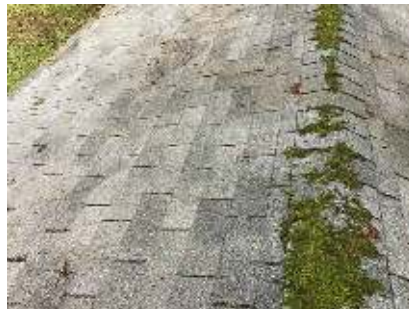
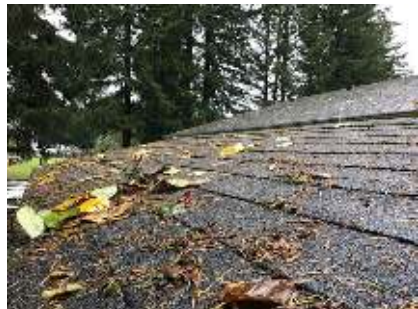
MAIN BUILDING, PUMP HOUSE, SHED

#### NORMAL AGING

Normal appearing aging is present. There are some signs of weathering and aging which would seem consistent with the age of the roofing material. Regular maintenance and inspections are advised.

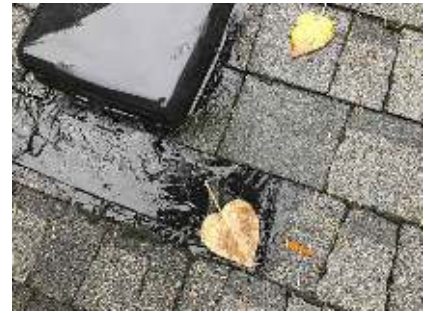
MAIN BUILDING

**MASTIC REPAIR**

Roof repairs are present which have been made with mastic/caulking. Where Mastic, tar or caulking has been used for repair, it may only provide temporary benefits and will likely need periodic reapplication. Be aware that hidden damages may exist which are outside the scope of inspection. It is recommended a roofer evaluate the repair for any hidden damages and provide a more permanent fix.

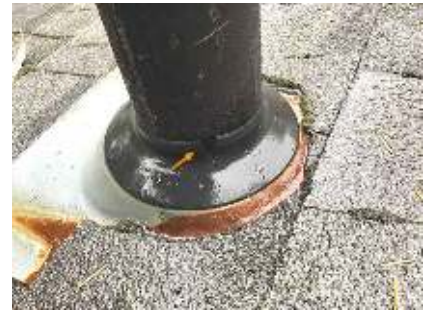
MAIN BUILDING

**PLUMBING BOOT DAMAGE**

Plumbing vent boot(s) damaged. Be aware that with used or older structures that hidden conditions may exist. Recommend further evaluation and repair.

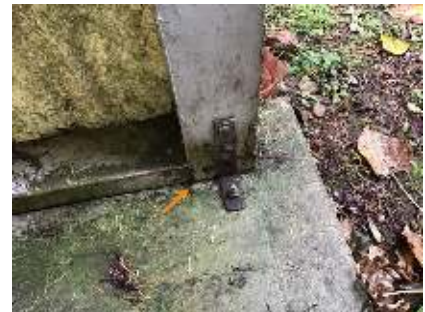
MAIN BUILDING: S

**DAMAGED POST**

Damage is present on the roof framing support post. Recommend evaluation by a licensed contractor.

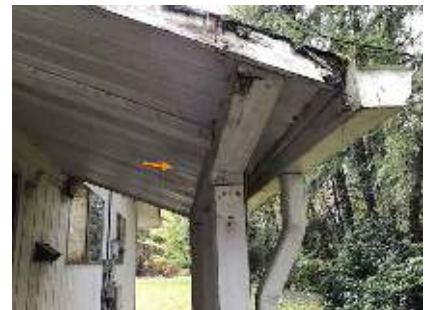
**BEAM DEFLECT**

The roof framing beam(s) appear deflected. Further evaluation and correction is recommended.

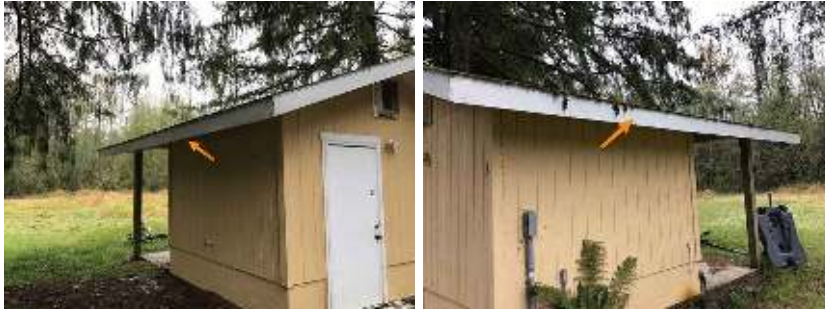
**MISSING GUTTER(S)**

One or more gutters was missing at the fascia where a pitched roof terminated. This condition will route excessive levels of moisture toward the foundation and/or building envelope. The inspector recommends the installation of gutters at all bottom roof edges.

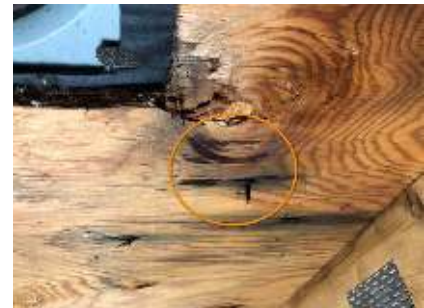
#### EVIDENCE OF ACTIVE ROOF LEAKS

Evidence of roof leakage was observed on the attic framing and/or underside of the roof sheathing. The conditions described may be the result of observations made in the roofing section of the report. Recommend further evaluation and repair.

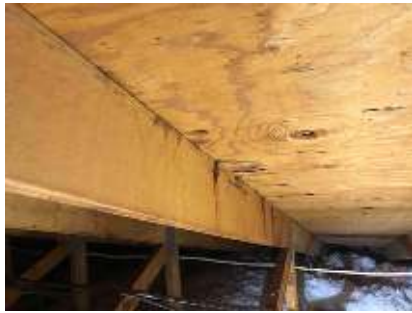
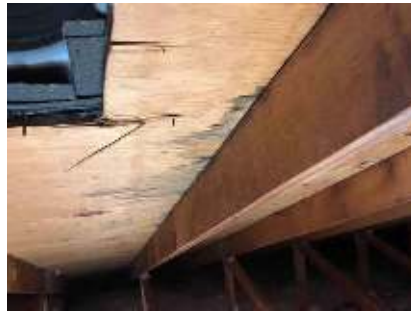
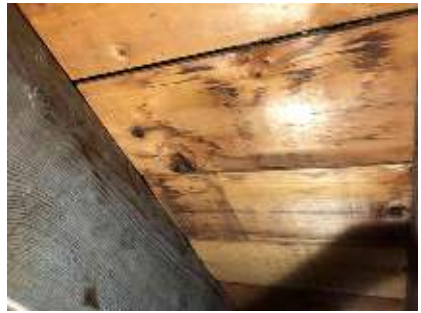
#### OLD LEAKS

Signs of old appearing leakage are present in attic. With older structures in particular, it is not uncommon to see evidence of past leaks in the attic. Sometimes, what appears to be an old leak could relate to intermittent leaking or possibly a one time event related to an unusual or extreme weather condition. The evidence could relate to a condition documented in the roofing section of this report. If not, the seller may be able to provide a history of any leaks in the attic, and what (if any) corrective actions were taken. If the seller cannot provide adequate explanation, you may wish to have further evaluation by a licensed roofer. Be aware hidden conditions may exist which are outside the scope of inspection.

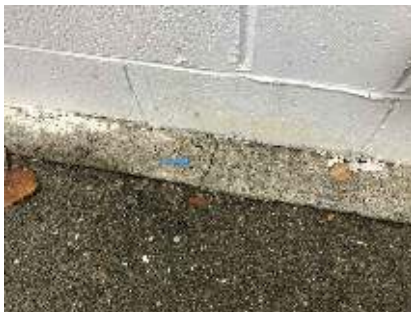
Main Building: N

#### CRACKS - MINOR

One or more minor cracks (1/8 inch or less) were found in the foundation. These don't appear to be a structural concern, but recommend sealing them to prevent water infiltration and monitoring them in the future. Numerous products exist to seal such cracks including:

- Hydraulic cement. Requires chiseling a channel in the crack to apply.
- Resilient caulks (easy to apply).
- Epoxy sealants (both a waterproof and structural repair).

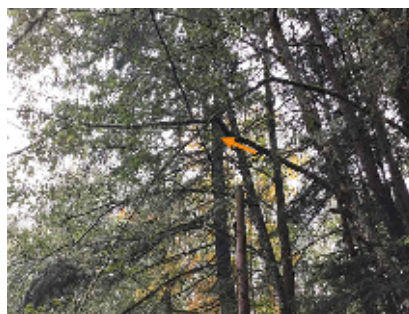
**VEGETATION**

Trees are obstructing the overhead service wires. This can be a potential safety issue. Correction is recommended.

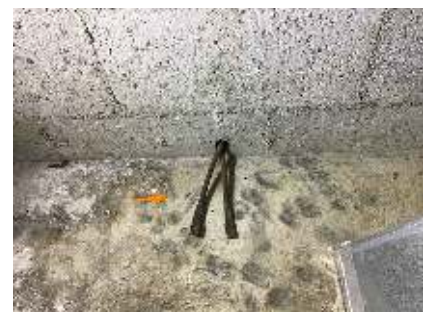
MAIN BUILDING N MECHANICAL ROOM

An abandoned oil tank may be present: Typical indicators include old, small diameter copper pipe, and/or vent pipes and filler pipes in the ground. If a tank is present, decommissioning may be required if it has not been done so already. Only an Environmental Auditor is qualified to conduct a Phase I Environmental Site Assessment which you may wish to have performed if this is of concern.

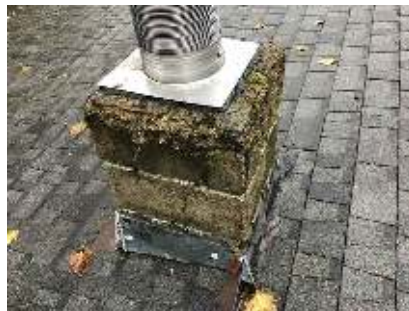
**DAMAGED**

The chimney brick/block is damaged, deteriorated and/or loose. A licensed mason should be called to make further evaluation and repairs as needed.

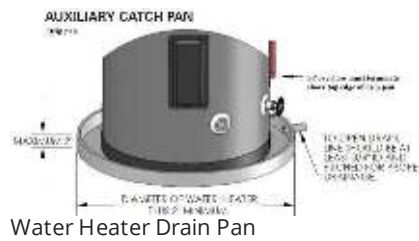
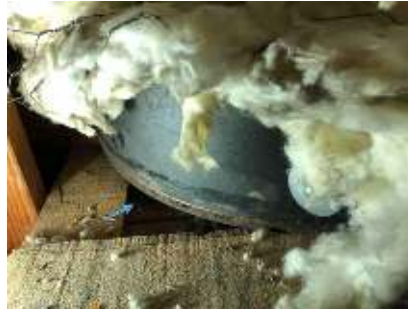
A water heater is installed over interior areas and has no catch/drip pan and drain installed or the catch/drip pan and drain is installed wrong. Recommend having a qualified contractor install a catch/drip pan and drain to prevent water damage to finished interior spaces below if/when the water heater develops a leak or is drained.

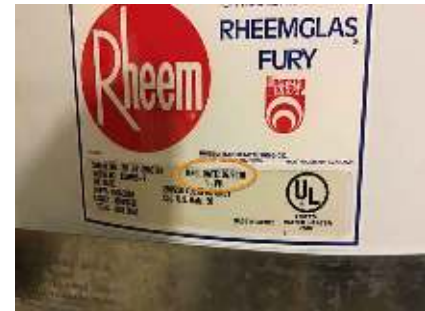
## 10 YEARS AND OLDER

The estimated useful life for most water heaters is 8-15 years. This water heater appears to be at this age or older and may need replacing at any time. Recommend budgeting for a replacement in the near future.

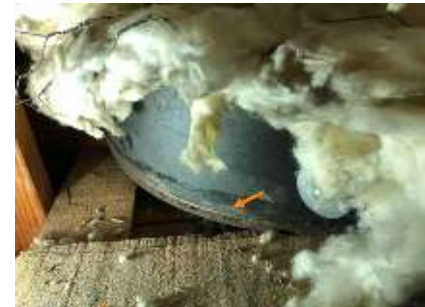
## CORROSION ON TANK

Corrosion was found in one or more areas on the water heater. The water heater may be failing. A qualified plumbing contractor should evaluate and replace or repair water heater if necessary.

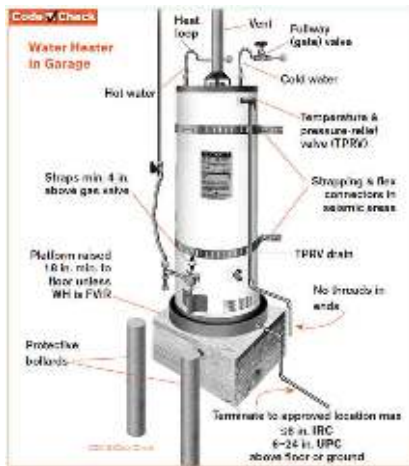
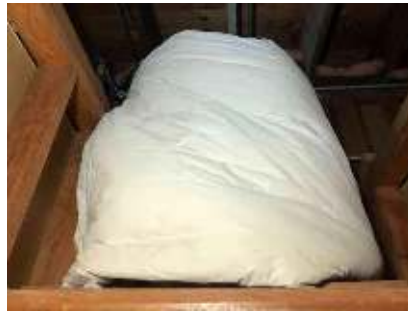
## STRAPS MISSING

The water heater does not have seismic straps or struts installed. This is a potential safety hazard since movement can cause leaks in the gas supply lines or damage wiring. Leaks may also occur in water supply pipes. A qualified contractor should install seismic straps or struts as necessary and as per standard building practices.

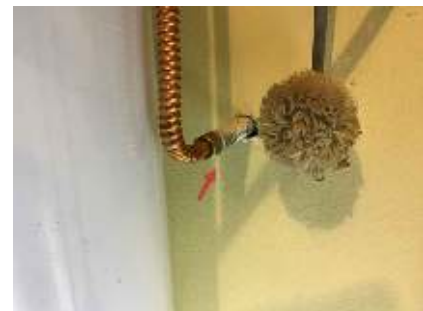
MAIN BUILDING W MECHANICAL ROOM

The temperature-pressure relief valve drain line is routed upwards. This drain line should be routed either down or horizontally. This is a safety hazard as water may not be able to flow through the drain line adequately when the valve releases due to accumulated water. Also, accumulated water may corrode the valve and prevent it from working. A qualified plumber should evaluate and repair so the drain line is routed down or horizontally, but not up.

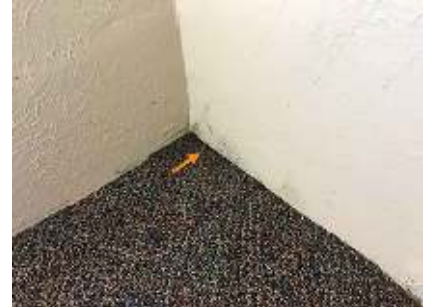
##### **EVIDENCE OF MOISTURE INTRUSION - PERIMETER WALL**

There are signs of moisture intrusion observed on the interior side of the perimeter wall. Recommend further evaluation by a contractor specializing in waterproofing. Be aware hidden conditions may exist.

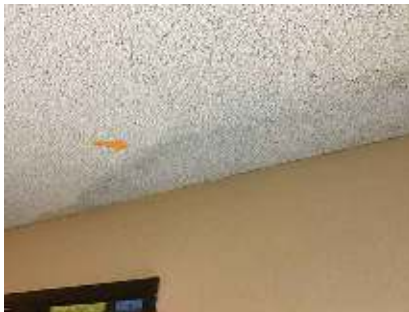
S Entry Hall

##### **MOISTURE RELATED STAINING - WALL/CEILING**

Dry appearing staining is observed on some areas of the wall(s) and/or ceiling(s) that were consistent with moisture intrusion. Staining was observed visually but full confirmation requires destructive testing that is outside the scope of the general PCA. Recommend further evaluation by a roofing and/or drywall contractor(s) to confirm or rule out active leaking.

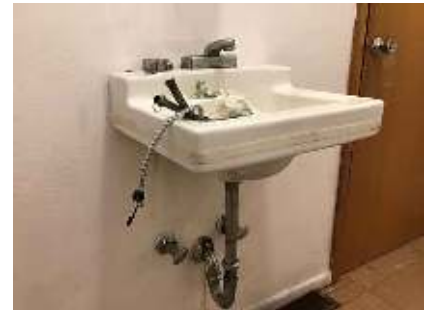
#### **DAMAGED/MISSING COMPONENTS**

The faucet fixture/components are missing/incomplete. Replacement indicated.
