HUD Engineering Certification Report

HUD Engineering Certification Report Summary

Permanent Foundation

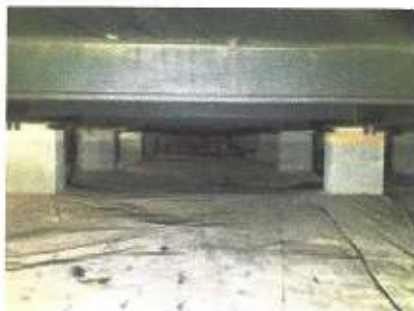
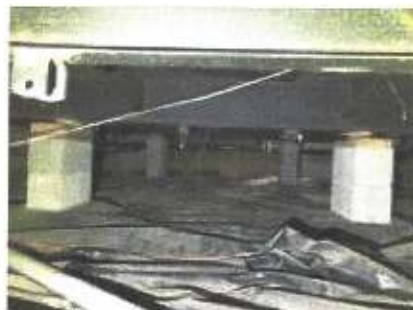
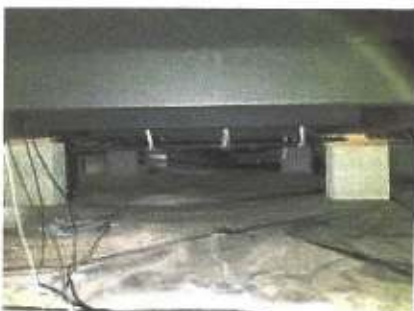
1.16 Foundation Type Images

Crawlspace

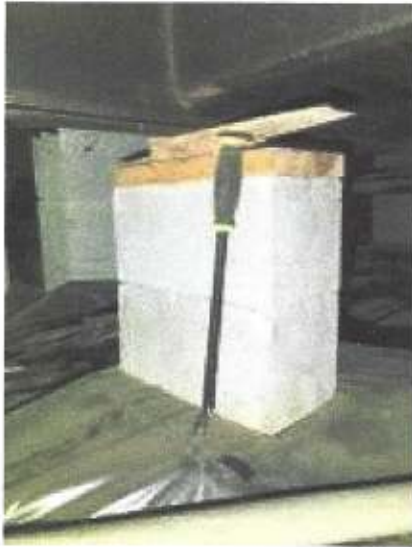
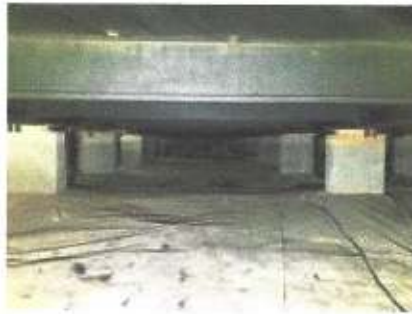
1.18 Piers Images

Dry-stacked Masonry Blocks

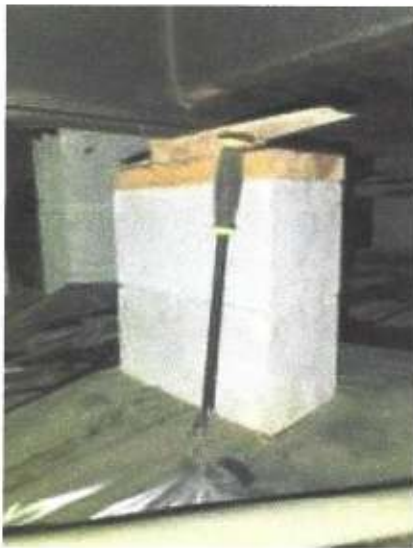
1.20 Piers Rest On Images

Concrete Footing

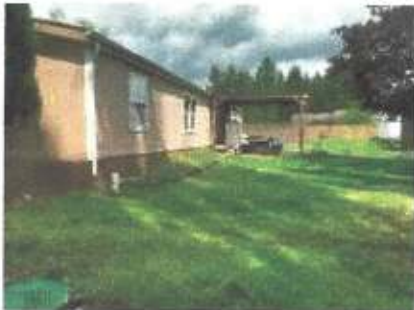
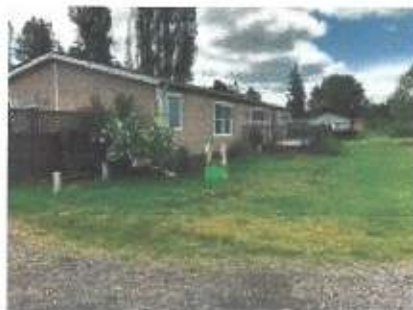
2.2 Exterior Grading Images

Reasonable grading around the home.

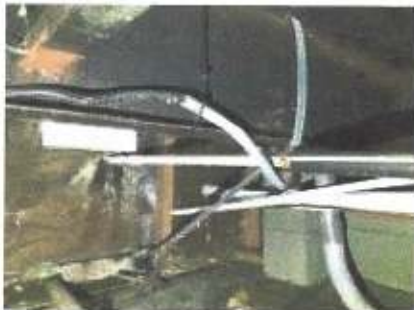
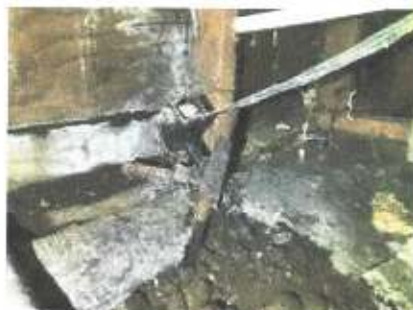
2.5 Anchor Method Images

Metal Straps connected to anchors augured into the soil

8'
