# *Bogg's Inspection Services*

## Property Inspection Report

Browns Point Blvd NE  
Inspection prepared for: Sample  
Date of Inspection: 11/14/2018 Time: 2:00 PM  
Age of Home: 1984 Size: 1566  
Order ID: 9399

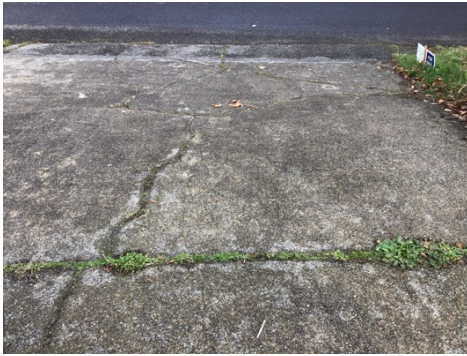
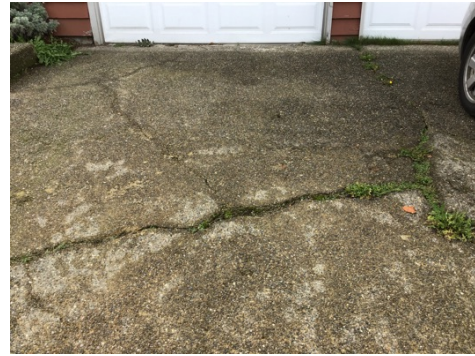
Page 21 Item: 3	Driveway	<ul style="list-style-type: none"> <li>Erosion and/or settling of driveway is present: Follow up with a licensed contractor specializing in driveway installation and repair is advised. Depending on severity further evaluation by an engineer may be needed at contractor's discretion.</li> </ul>
-----------------	----------	---

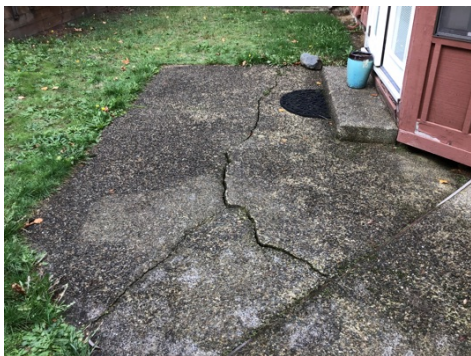
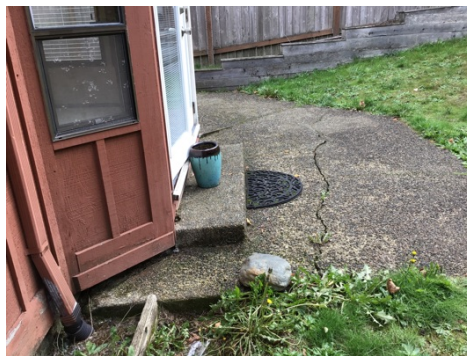
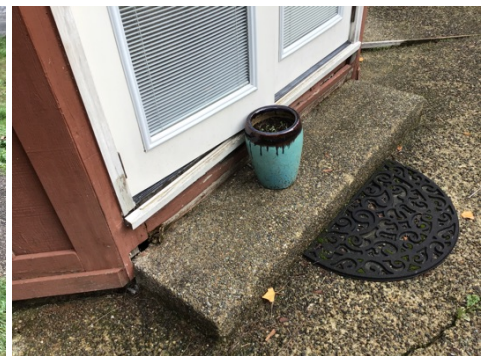
Page 22 Item: 5	Concrete, Masonry Patio	<ul style="list-style-type: none"> <li>Erosion or settling of concrete surface is present. Follow up with a licensed contractor specializing in patio installation and repair is advised. This condition was noted on the following patio slab: Rear</li> </ul>
-----------------	-------------------------	---

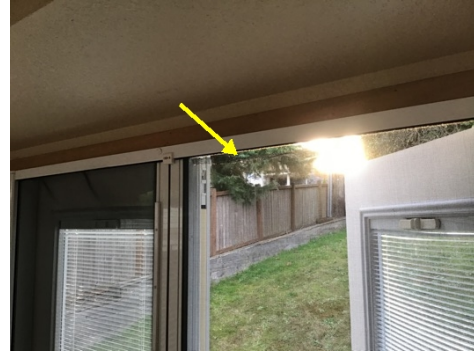
Page 22 Item: 6	Entry Doors	<ul style="list-style-type: none"><li>• Exterior door damaged or deteriorated: Repair or replacement suggested. These conditions were noted in the following areas: Front entry door.</li><li>• Screen/storm door damaged. This condition was noted on the following door: Rear screen slider.</li></ul>
-----------------	-------------	--

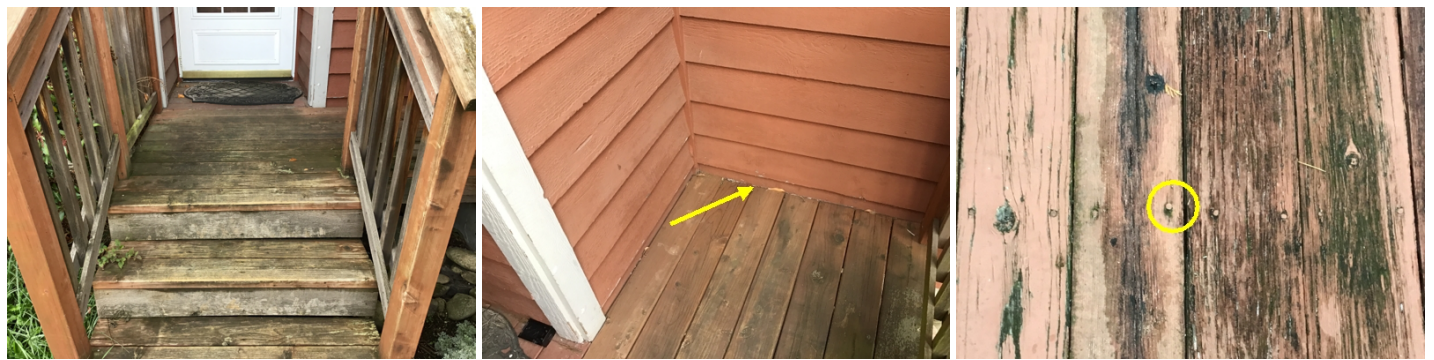
Page 23 Item: 1	General Condition	<ul style="list-style-type: none"><li>• There is deterioration of the finished deck surface(s): Exposed wood decks and landings require periodic cleaning and application of paints, stains or sealant as part of regular maintenance. A paint or hardware store can offer advice about the best methods to preserve your deck. These conditions were noted in the following areas: Front, Rear.</li><li>• The wood deck lacks a flashing detail where it attaches to the structure. A flashing detail should be installed to protect the deck ledger board and siding behind it from moisture. Be aware that on older structures hidden conditions may exist. Noted: Front, Rear.</li><li>• Exposed lifting nails seen. Recommend repair for added safety. Noted: Rear.</li></ul>
-----------------	-------------------	--

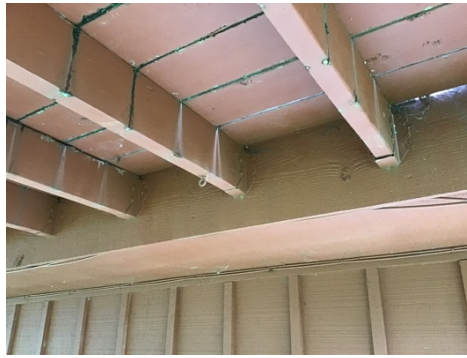
Page 24 Item: 4	Attachment	<ul style="list-style-type: none"> <li>The deck is not attached via a ledger board: The ledger board is critical to deck installation as it offers resistance against downward and lateral forces when installed properly with lag screws. Further, exterior sidings are not rated to have deck joists or hangers directly attached to them. Recommend evaluation by a licensed contractor. These conditions were noted in the following areas: Rear</li> </ul>
-----------------	------------	---

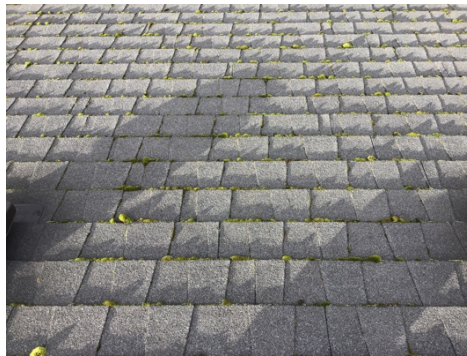
Page 26 Item: 7	General Defects	<ul style="list-style-type: none"><li>• Normal appearing aging is present: There are some signs of weathering and aging which would seem consistent with the age of the roofing material. Regular maintenance and inspections are advised. Noted: Primary structure.</li><li>• There is moss or debris present on roof: As normal structure maintenance moss and debris should be cleaned off of the roof as it can lead to damage and leaking. At this time the amount of moss or debris buildup would best be described as: Moderate. Noted: Primary structure</li></ul>
-----------------	-----------------	--

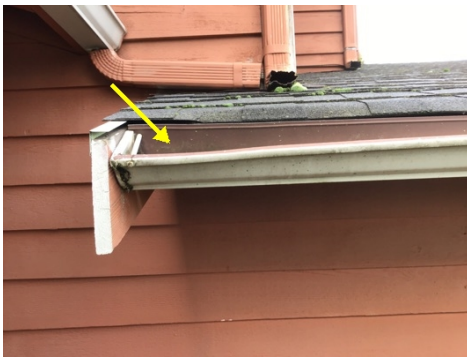
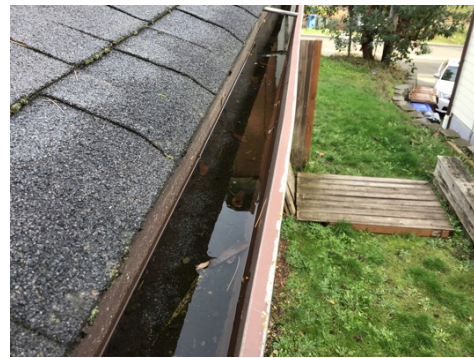
Page 27 Item: 11	Gutter	<ul style="list-style-type: none"><li>• Gutters sagging or pulling away from house. Recommend repair. Noted: Front</li><li>• Gutter is sloped improperly and holding water: Recommend correction. Noted: Left side</li></ul>
------------------	--------	--

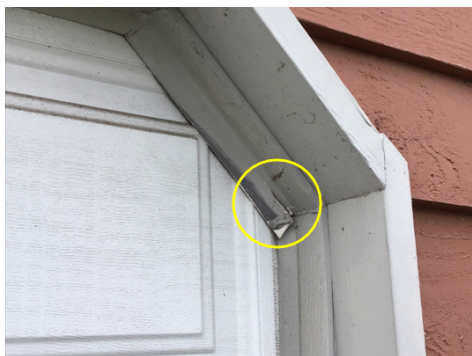
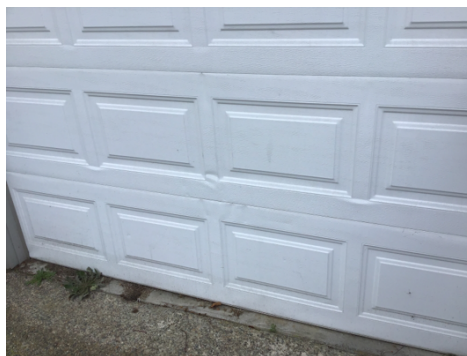
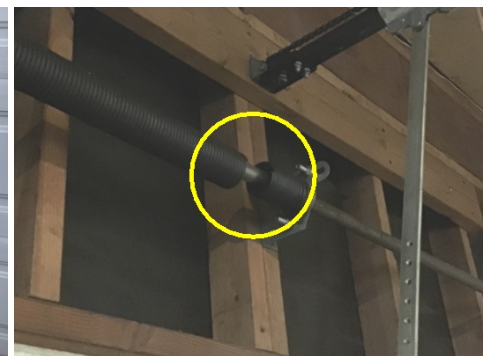
- Weather strip on the vehicle door(s) is damaged or missing: This should be repaired as part of normal maintenance. This observation was made on the following door(s): Right door
- The vehicle doors have minor cosmetic damage: This observation was made on the following door(s): Both doors.
- Vehicle door spring damaged: Recommend follow up with door installer for service and repair. This observation was made on the following door(s): Left door
- Automatic vehicle door opener(s) not operational: Repair/replacement indicated. Noted: Right door

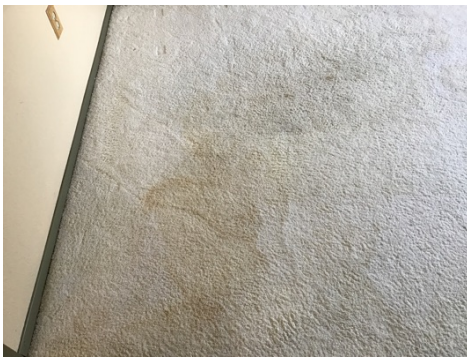
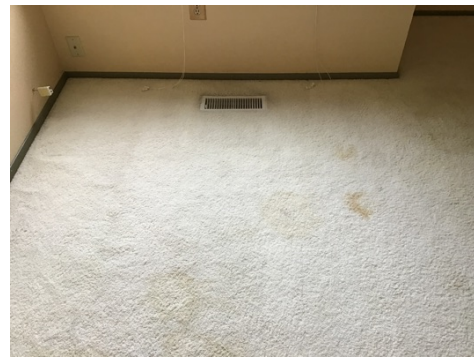
- There is staining of the carpet. A professional carpet cleaner should be called to evaluate. This was noted in the front right bedroom
- Use related floor wear was noted: The existing floor wear may best be described as: "Normal" and minor appearing wear and deterioration.

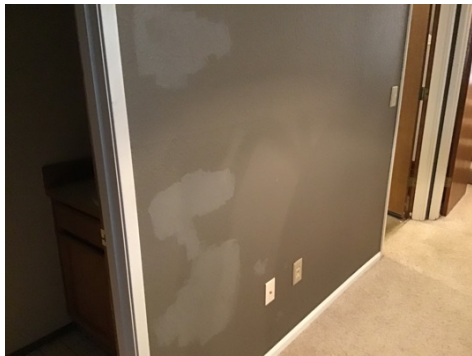
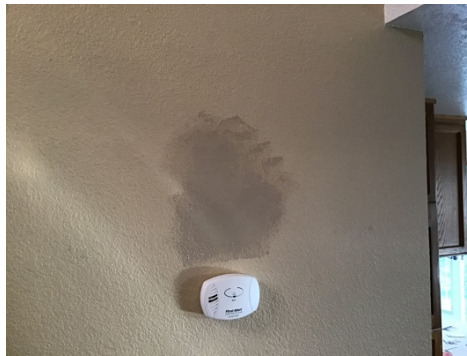
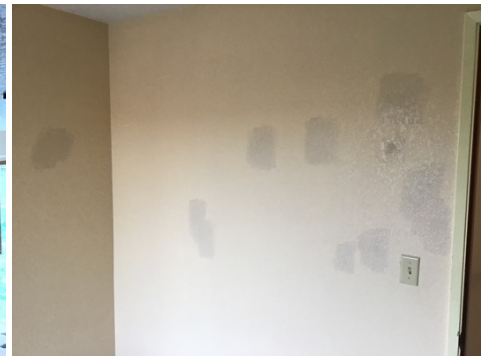
Page 30 Item: 3	Walls & ceiling	<ul style="list-style-type: none"> <li>Use related wall/ceiling wear was noted: This would include such things as scrapes, small holes, dents, scratches, holes from hanging items, scuffs, indentations from furniture and areas of damaged texture to name a few. This typically includes trim, such as baseshoe molding and/or corner molding. The existing wear may best be described as "Normal" and minor appearing wear and deterioration.</li> </ul>
Page 30 Item: 4	Finish & Trim	<ul style="list-style-type: none"> <li>Conditions exist regarding the interior paint: The interior paint coverage appears very thin with noticeable brush/roller marks and nonuniform color.</li> </ul>

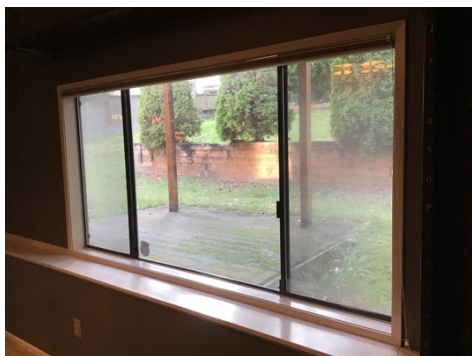
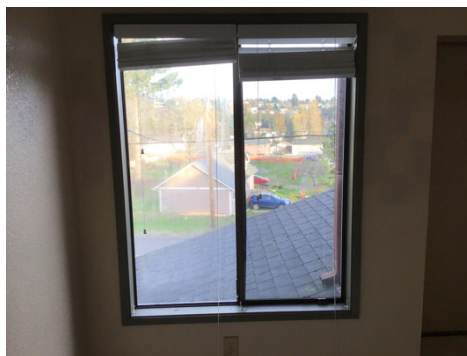
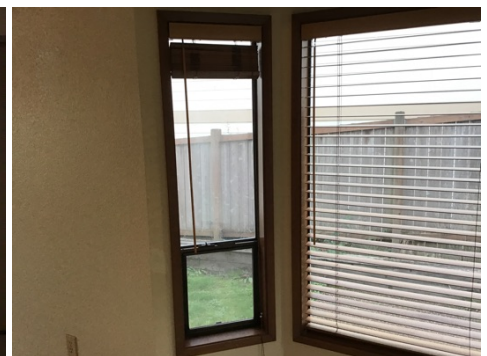
Page 30 Item: 5	Windows	<ul style="list-style-type: none"> <li>Fogged or failed double pane window(s) observed: Double pane glass sometimes loses its seal causing steaming or fogging in between the panes, as well as some loss of insulating ability. Replacement is indicated (Be aware that cooler weather makes this condition very difficult to identify, and under such conditions it is possible other windows may be failed, but not identified during the inspection). This was noted in the Family room, Front right bedroom, Dining room</li> <li>Some window screens are missing: Replacement indicated.</li> </ul>
-----------------	---------	---

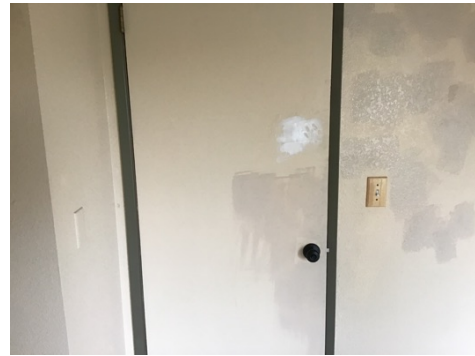
Page 31 Item: 6	Interior Doors	<ul style="list-style-type: none"> <li>Interior door damage viewed: Maintenance repair/replacement is indicated. Damage was seen on the following door(s): Bath off Family room, Front right bedroom</li> <li>Some minor rubbing and/or binding of interior door(s) noted: No recommendations.</li> </ul>
-----------------	----------------	---

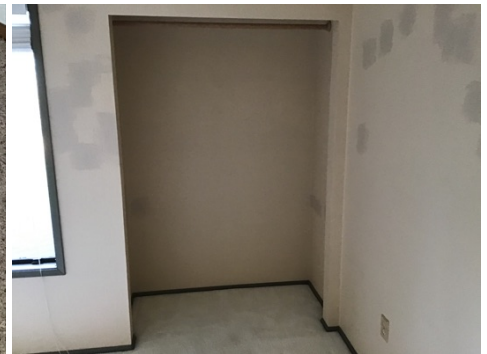
- The closets are missing floor guides. Recommend installation for added safety. Noted: Front left bedroom
- Missing closet doors noted. Recommend replacement. Noted: Utility closet, Front left bedroom.

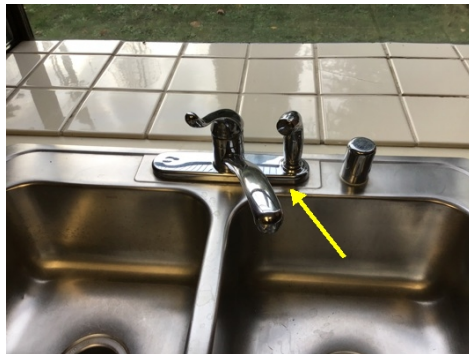
Page 34 Item: 4	Faucets	<ul style="list-style-type: none"> <li>Kitchen faucet is loose: Maintenance attention to resecure the faucet to the sink is indicated.</li> </ul>

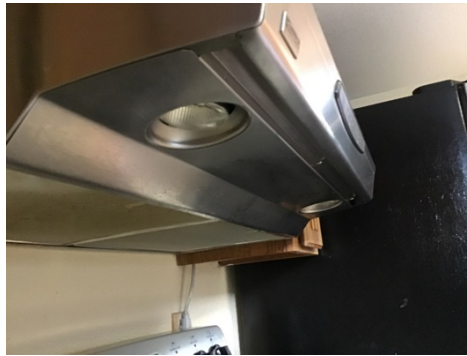
Page 34 Item: 6	Garbage Disposal	<ul style="list-style-type: none"> <li>The garbage disposal appears older: Be aware the disposal appears older and could be prone to failure or malfunction at any time.</li> </ul>
Page 34 Item: 7	Cooktop and Oven	<ul style="list-style-type: none"> <li>The cooktop/oven appear older: Be aware the cooktop and oven appear older and could be prone to failure or malfunction at any time.</li> </ul>
Page 34 Item: 8	Ventilation	<ul style="list-style-type: none"> <li>Kitchen fan recirculates only: This is a common finding on older homes which predate current requirements. Recommend installing a kitchen fan which exhausts to the exterior as a future upgrade if possible or reasonable to do so.</li> <li>Kitchen exhaust fan light did not operate: If replacing the bulb does not correct the condition a professional evaluation may be needed.</li> </ul>

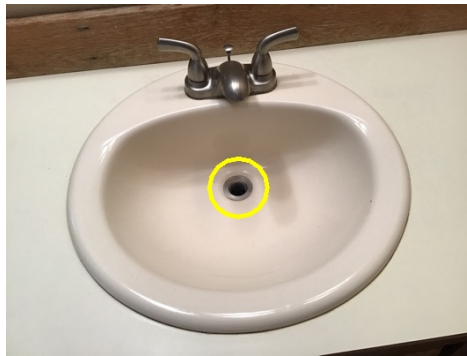
- Sink stopper is missing or did not operate properly: Maintenance repair/replacement is indicated. Noted: Second floor hall bath

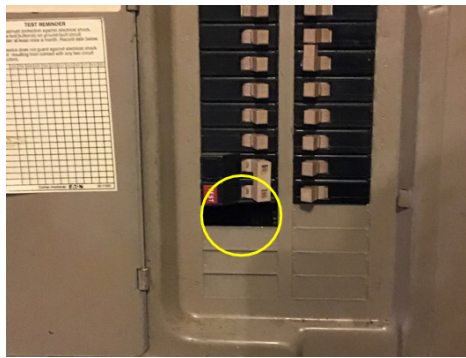
Electrical		
Page 38 Item: 2	Panel	<ul style="list-style-type: none"><li>• Unprotected Openings: The electric panel has unprotected openings. For safety, any unused breaker openings or other gaps in the panel should be properly closed. Noted: Garage.</li></ul>

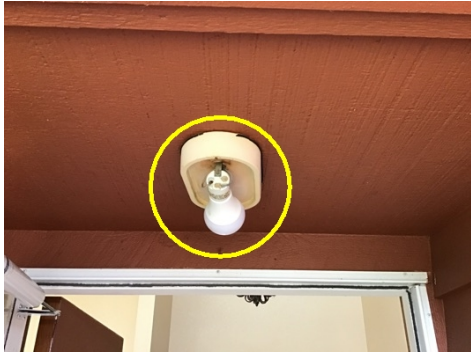
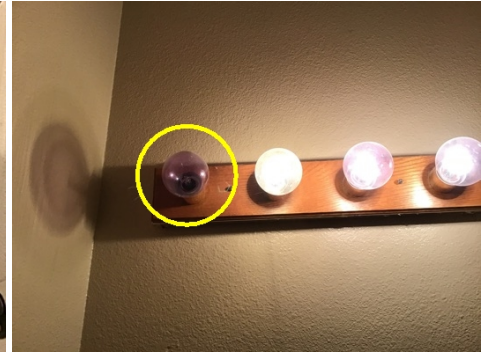
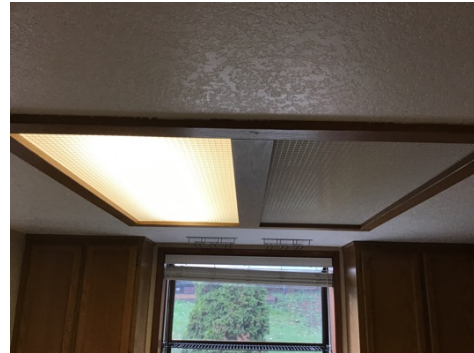
Page 40 Item: 5	Lights	<ul style="list-style-type: none"> <li>Lights are missing a cover or globe: Replacement indicated. Noted: Exterior front, Second floor hallway.</li> <li>Some missing or damaged switch cover plates noted: Recommend correction. Noted: Garage</li> <li>Lights are not operational in some areas: This may occur simply due to a bad bulb. Recommend having the seller check and install a new bulb for any light which does not work. If this does not correct the condition, an electrician should be consulted. Noted: Family room bath, Second floor hallway, Kitchen</li> </ul>
-----------------	--------	---

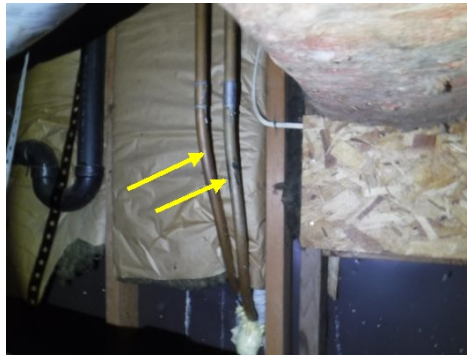
Page 43 Item: 5	Plumbing Supply Lines :	<ul style="list-style-type: none"> <li>Some plumbing supply line insulation is damaged or missing: Maintenance repair is indicated. Crawlspace</li> <li>A note about old pipes: Galvanized and copper pipes have been standards in the industry for years and usually last for decades. However, their life span largely depends upon the acidity and mineral content of the water, both of which are outside the scope of inspection to determine. Either type may develop buildup inside the pipe, especially if high levels of calcium are present. Galvanized pipe may also rust from the inside out as it ages. Copper is particularly susceptible to acid and in areas where water is acidic, and it may corrode or develop pinhole leaks within just a few years. A water treatment specialist can perform further testing and determine if there is any need for remediation. Also be aware that any older pipe may need replacement at some point in time.</li> </ul>

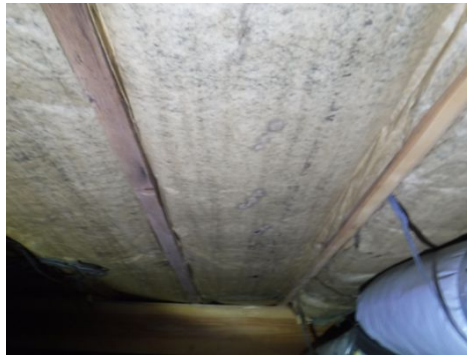
Page 45 Item: 3	Structure Insulation :	<ul style="list-style-type: none"><li>• The sub floor insulation has been installed incorrectly: Installing sub floor insulation with the vapor barrier facing the wrong way, (not toward the heated side). may lead to condensation within the joist spaces. An insulation contractor will be able to suggest a proper remedy.</li></ul>
-----------------	------------------------	---

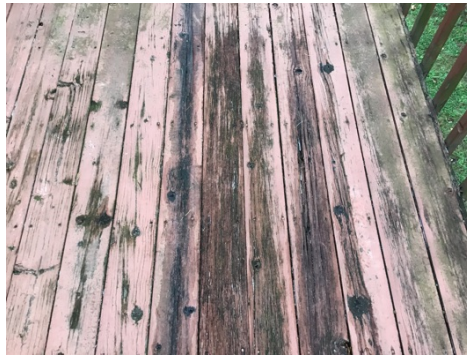
Page 51 Item: 3	Deck	<ul style="list-style-type: none"><li>• There is decay seen on the decking material. This was noted in the following area: Rear</li></ul>
-----------------	------	---

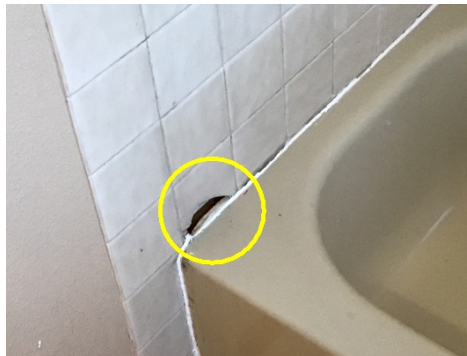
Page 51 Item: 1	Tub or Shower Surround	<ul style="list-style-type: none"><li>• The tub/shower surround is damaged. Hidden conditions may exist. This was noted in the following area: Second floor hall bath</li></ul>
-----------------	------------------------	---

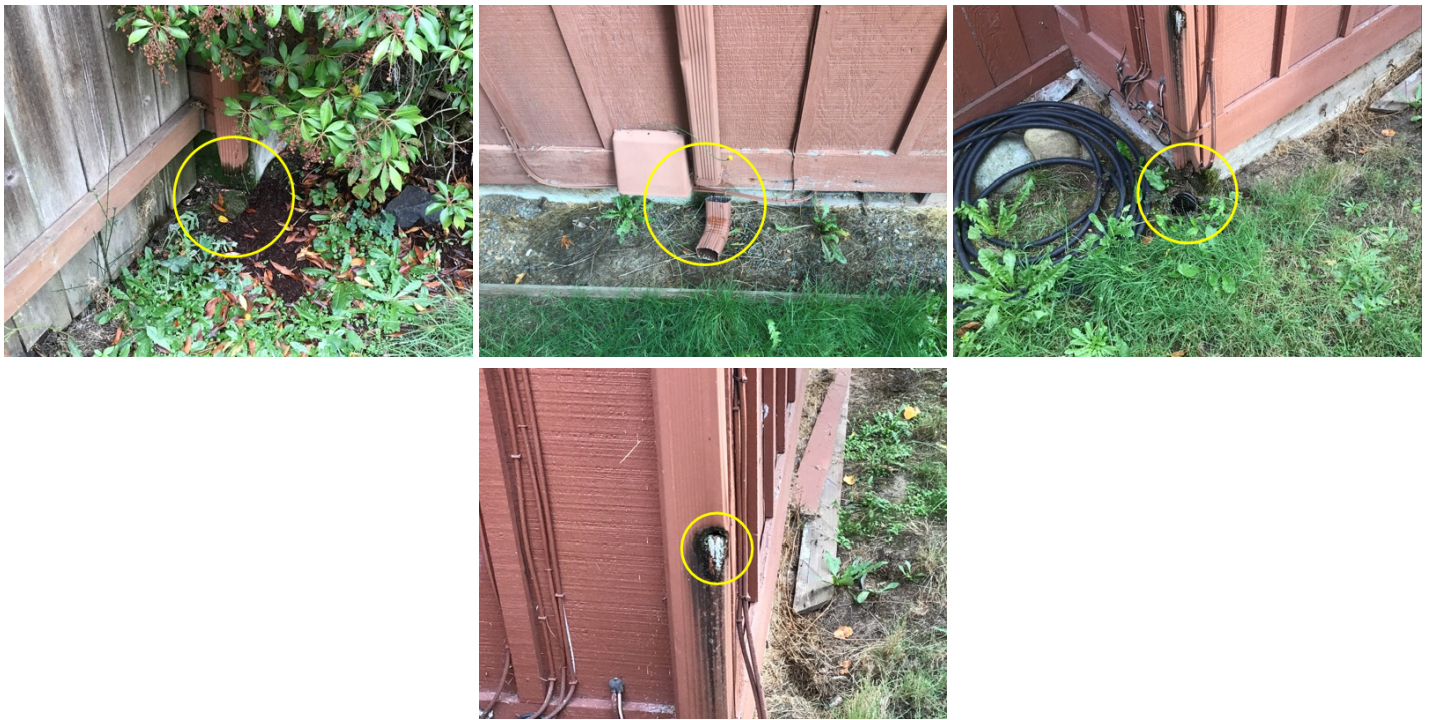
Page 52 Item: 1	Downspouts	<ul style="list-style-type: none"><li>• Downspouts lack adequate diversion away from house. Downspouts should have elbows and splash blocks to direct water away from the house. Any poor or damaged connections to existing drain lines should be repaired. Unique conditions where a splash block may not be viable and no drain line exists may need to be referred to a licensed drainage contractor for evaluation. This was noted in the following area: Front, Rear</li><li>• Downspout is damaged. Repair is recommended to ensure proper function. This was noted in the following area: Rear.</li></ul>
-----------------	------------	---

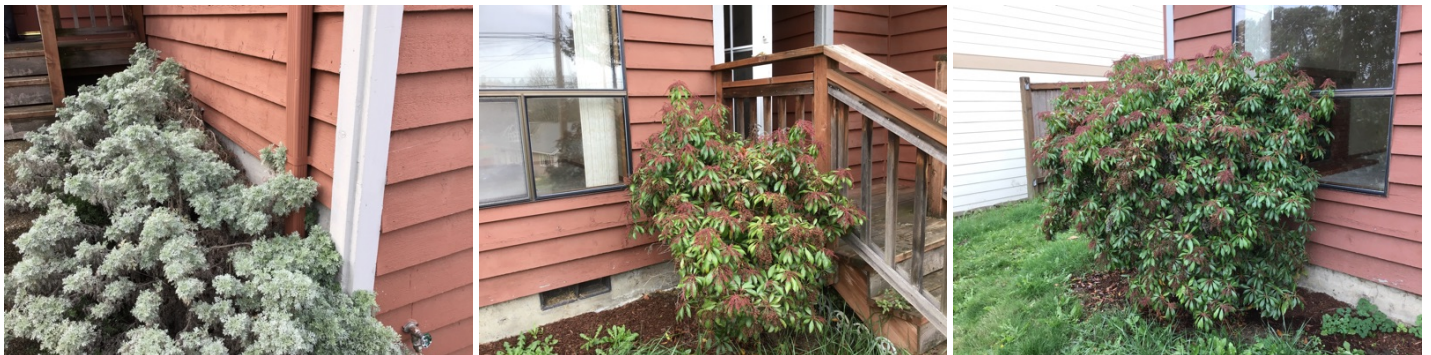
- Foliage should be maintained so it is at least 10 to 12 inches away from house as it may cause mechanical damage to the siding and promote high moisture conditions and/or infestation. Where foliage is dense and access limited, hidden conditions may exist which should be reported to the inspecting firm if discovered. Where there is decorative, established foliage against the structure such as climbing vines, cutting the foliage back may be detrimental to the aesthetic appearance of the home. If the foliage is left in place, be aware that infestation and high moisture conditions may occur. Regular and periodic inspections are suggested.

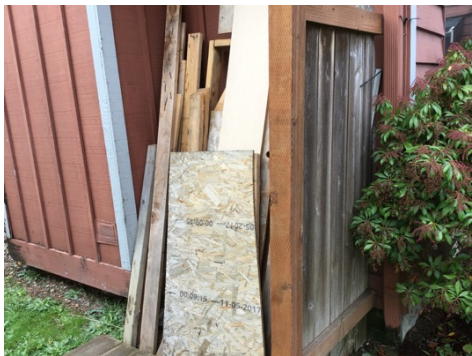
- Other exterior conducive conditions are seen: There is wood or debris against the structure. Removal of all wood away from the structure by at least ten feet is recommended to prevent access to the structure by wood destroying pest. Noted: Left side

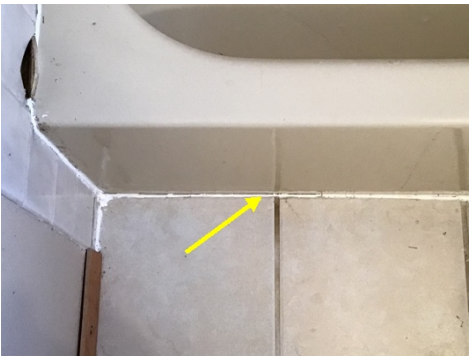
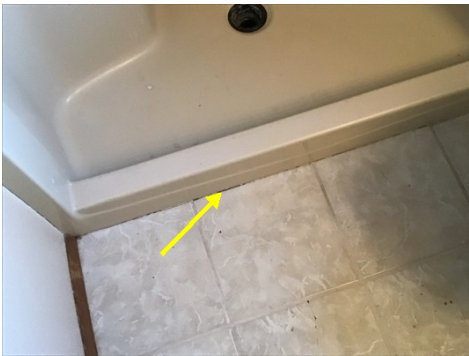
Page 53 Item: 1	Flooring by Tub/Shower	<ul style="list-style-type: none"><li>The caulking on the floor in front of tub/shower has failed. Failed caulking may allow moisture to penetrate into and decay the underlayment and should be repaired. This was noted in the following area: Second floor hall bath, Master bath</li></ul>
-----------------	---------------------------	--

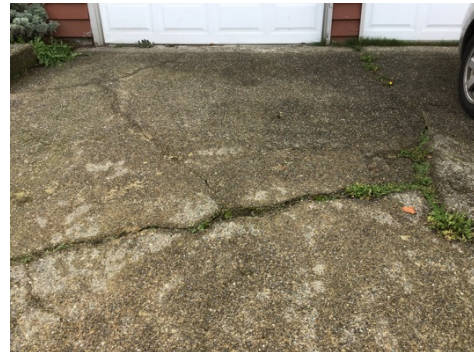
- Erosion and/or settling of driveway is present: Follow up with a licensed contractor specializing in driveway installation and repair is advised. Depending on severity further evaluation by an engineer may be needed at contractor's discretion.

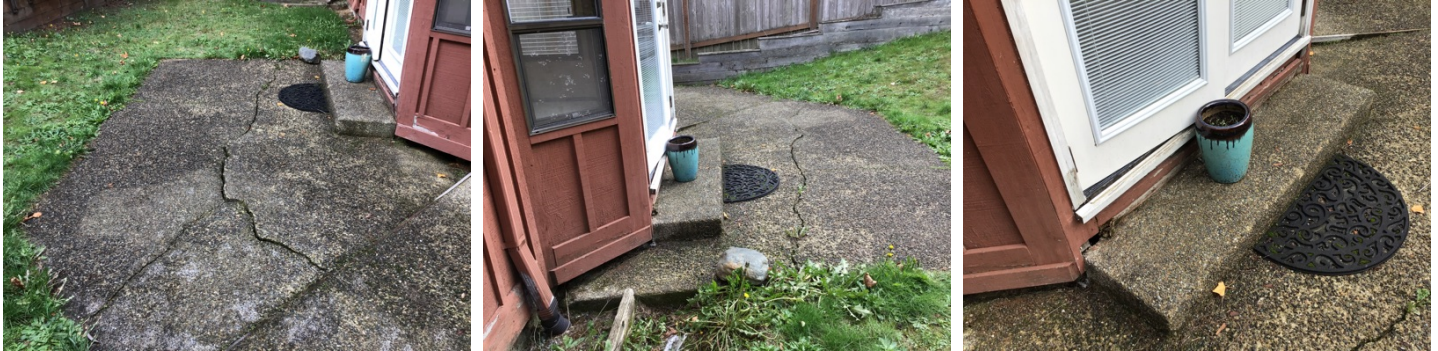
- Erosion or settling of concrete surface is present. Follow up with a licensed contractor specializing in patio installation and repair is advised. This condition was noted on the following patio slab: Rear

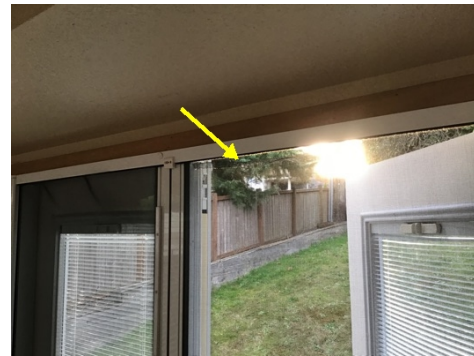
- Exterior door damaged or deteriorated: Repair or replacement suggested. These conditions were noted in the following areas: Front entry door.
- Screen/storm door damaged. This condition was noted on the following door: Rear screen slider.

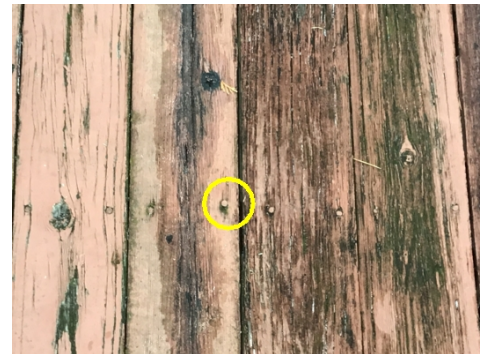
- There is deterioration of the finished deck surface(s): Exposed wood decks and landings require periodic cleaning and application of paints, stains or sealant as part of regular maintenance. A paint or hardware store can offer advice about the best methods to preserve your deck. These conditions were noted in the following areas: Front, Rear.

- The wood deck lacks a flashing detail where it attaches to the structure. A flashing detail should be installed to protect the deck ledger board and siding behind it from moisture. Be aware that on older structures hidden conditions may exist. Noted: Front, Rear.

- Exposed lifting nails seen. Recommend repair for added safety. Noted: Rear.

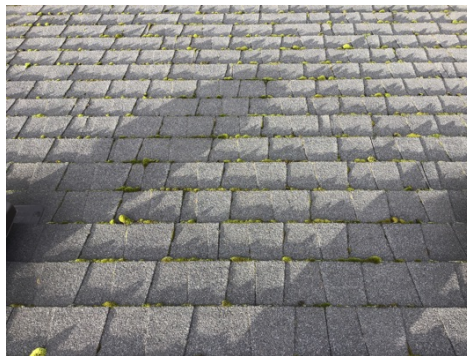
- Normal appearing aging is present: There are some signs of weathering and aging which would seem consistent with the age of the roofing material. Regular maintenance and inspections are advised. Noted: Primary structure.
- There is moss or debris present on roof: As normal structure maintenance moss and debris should be cleaned off of the roof as it can lead to damage and leaking. At this time the amount of moss or debris buildup would best be described as: Moderate. Noted: Primary structure

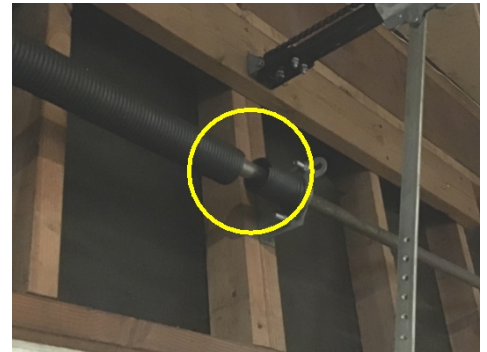
- Weather strip on the vehicle door(s) is damaged or missing: This should be repaired as part of normal maintenance. This observation was made on the following door(s): Right door
- The vehicle doors have minor cosmetic damage: This observation was made on the following door(s): Both doors.
- Vehicle door spring damaged: Recommend follow up with door installer for service and repair. This observation was made on the following door(s): Left door
- Automatic vehicle door opener(s) not operational: Repair/replacement indicated. Noted: Right door

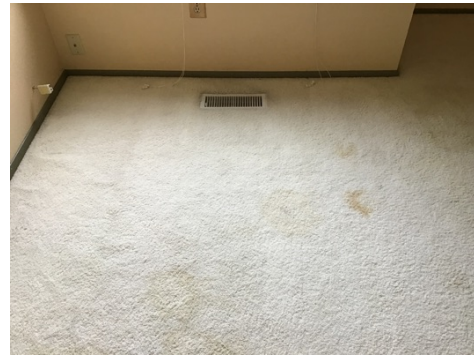
- There is staining of the carpet. A professional carpet cleaner should be called to evaluate. This was noted in the front right bedroom
- Use related floor wear was noted: The existing floor wear may best be described as: "Normal" and minor appearing wear and deterioration.

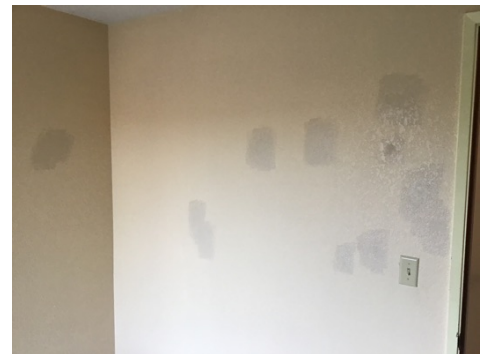
- Interior painted surfaces showing signs of wear: Painting is part of normal maintenance. Paint wear may include thinning, nicks, gouges, cracking, peeling and loss of luster to name a few. At this time, the amount of wear might best be described as: Minor.
- Conditions exist regarding the interior paint: The interior paint coverage appears very thin with noticeable brush/roller marks and nonuniform color.

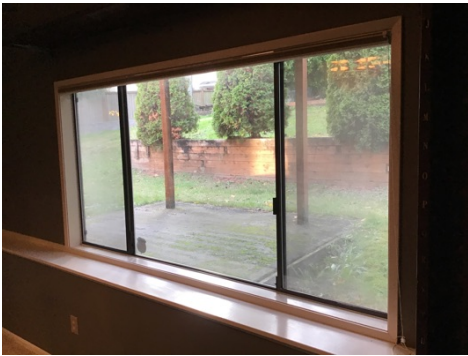
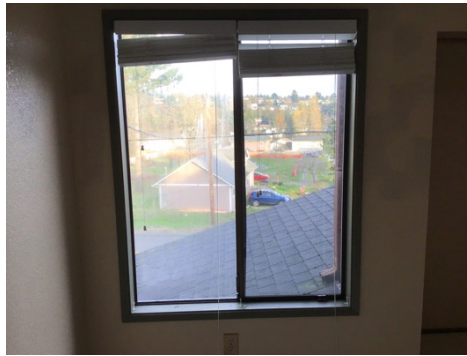
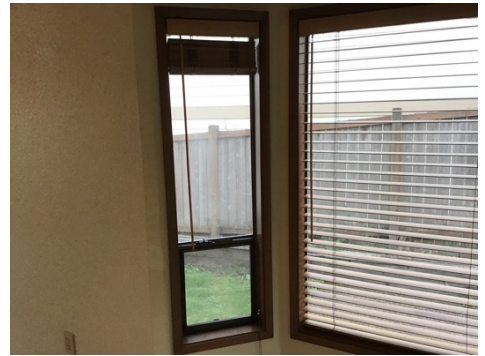
- Fogged or failed double pane window(s) observed: Double pane glass sometimes loses its seal causing steaming or fogging in between the panes, as well as some loss of insulating ability. Replacement is indicated (Be aware that cooler weather makes this condition very difficult to identify, and under such conditions it is possible other windows may be failed, but not identified during the inspection). This was noted in the Family room, Front right bedroom, Dining room
- Some window screens are missing: Replacement indicated.

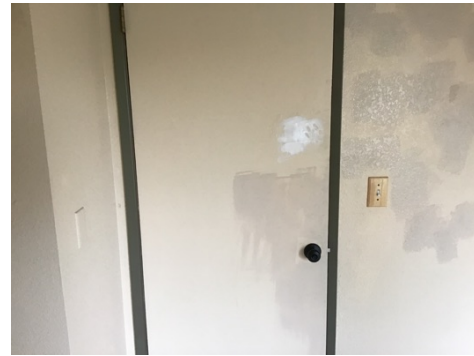
- Interior door damage viewed: Maintenance repair/replacement is indicated. Damage was seen on the following door(s): Bath off Family room, Front right bedroom
- Some minor rubbing and/or binding of interior door(s) noted: No recommendations.

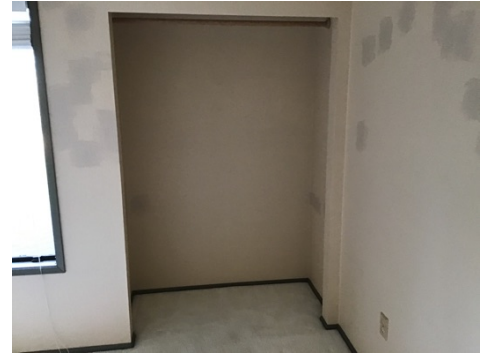
- The closets are missing floor guides. Recommend installation for added safety. Noted: Front left bedroom
- Missing closet doors noted. Recommend replacement. Noted: Utility closet, Front left bedroom.

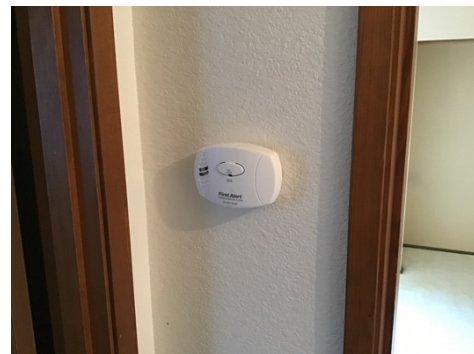
- Where a fuel burning appliance is installed and there is no Carbon Monoxide (CO) detector present, it is strongly recommended you purchase a CO Detector and install it according to manufacturer's recommendations. For safety, your home may require more than one device normally one on each level outside the bedroom area. It is outside the scope of inspection to test CO detectors. Missing family room.

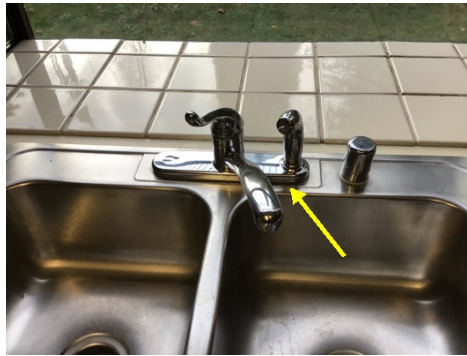
- Kitchen faucet is loose: Maintenance attention to resecure the faucet to the sink is indicated.

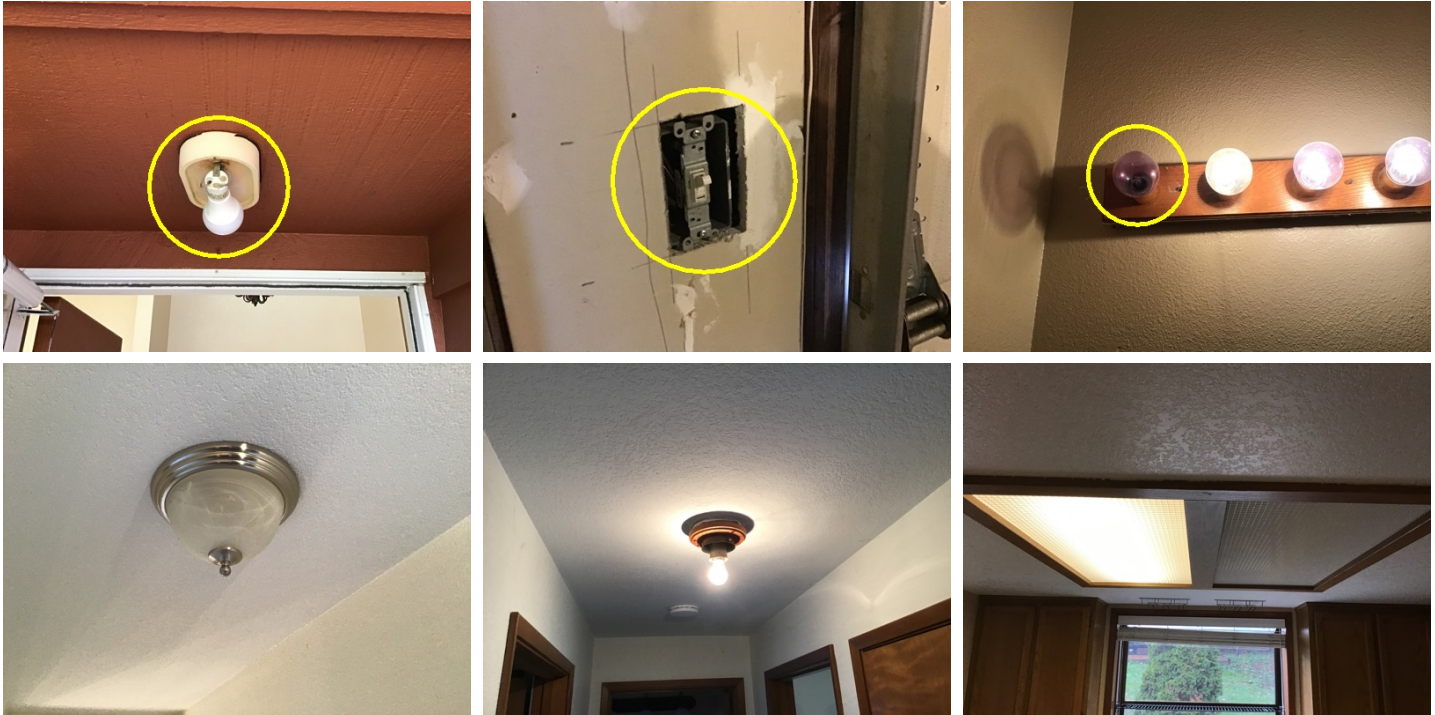
- Lights are missing a cover or globe: Replacement indicated. Noted: Exterior front, Second floor hallway.
- Some missing or damaged switch cover plates noted: Recommend correction. Noted: Garage
- Lights are not operational in some areas: This may occur simply due to a bad bulb. Recommend having the seller check and install a new bulb for any light which does not work. If this does not correct the condition, an electrician should be consulted. Noted: Family room bath, Second floor hallway, Kitchen

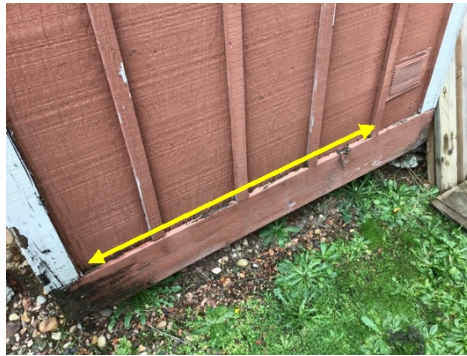
- There is damage noted to lower siding. Be aware hidden conditions may exist. This was seen in the following area: Left side

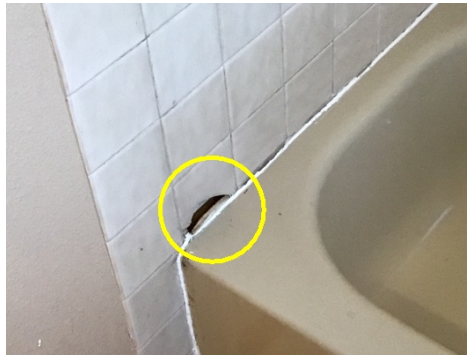
- The tub/shower surround is damaged. Hidden conditions may exist. This was noted in the following area: Second floor hall bath
