PROPERTY CONDITION REPORT COPY

123 Main St Olympia WA 98513

> Joe Smith JANUARY 26, 2021

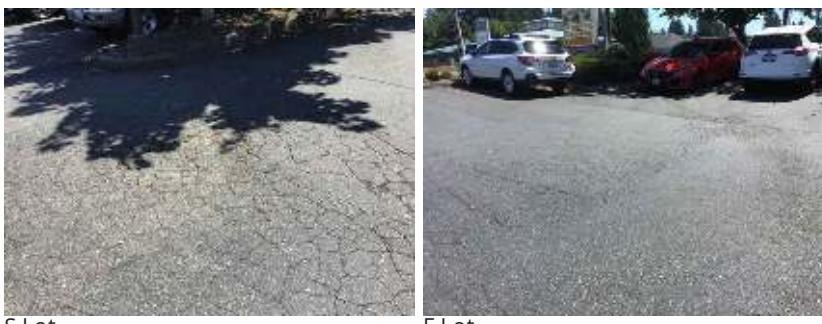
S Lot

3.2.1 Paving/Parking Areas ASPHALT - ADVANCED DETERIORATION

Advanced deterioration observed. Unsealed cracks were further damaged by vegetation and sealing in these areas will be difficult. Recommend evaluation by an asphalt and paving contractor to determine the cost of recovering or repair.

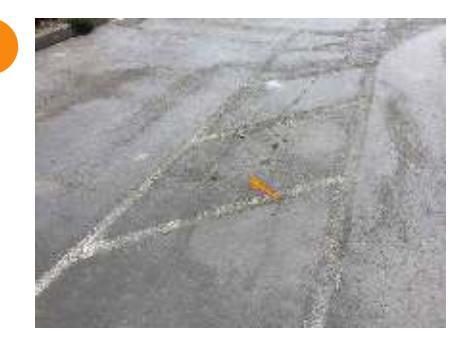
ASPHALT - FATIGUE CRACKING

The asphalt drive exhibited fatigue cracking in the driving surface. Fatigue cracking is caused by the following conditions:

- Excessive loading
- Weak surface, base, or subgrade
- Thin surface or base
- Poor drainage

Fatigue cracking will eventually worsen over time. Sealing fatigue cracks will protect against degradation from thermal expansion and contraction, however it does not address the underlying causes. Fatigue cracks will eventually require a full depth patch. The inspector recommends correction by a qualified paving contractor.

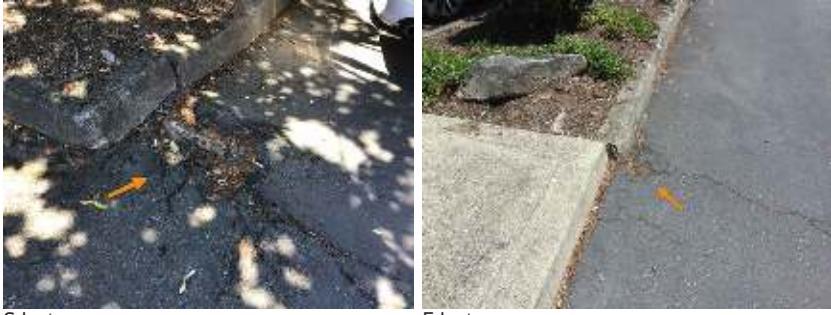
S Lot

3.2.3 Paving/Parking Areas ASPHALT - HEAVING/DAMAGE

Heaving/damage of the asphalt was observed. Heaving/damage can result from a number of causes including the following: - Expansive soils - Tree root displacement. Recommend further evaluation by a licensed asphalt contractor.

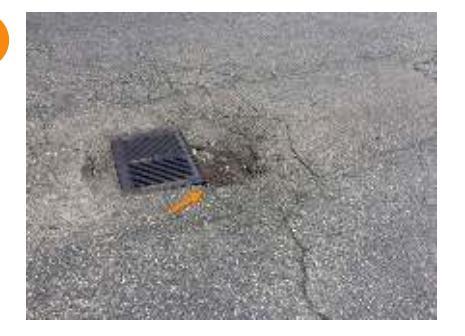
E LOT

3.2.4 Paving/Parking Areas ASPHALT - SEVERE DAMAGE OR DETERIORATION

Areas were observed on the fatigue cracked surfaces with severe damage or deterioration requiring a full depth patch.

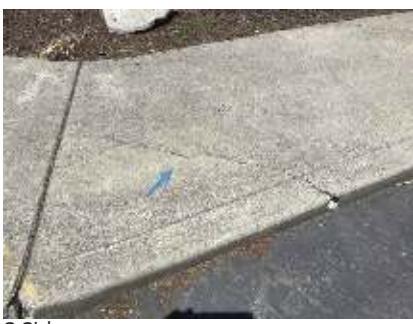
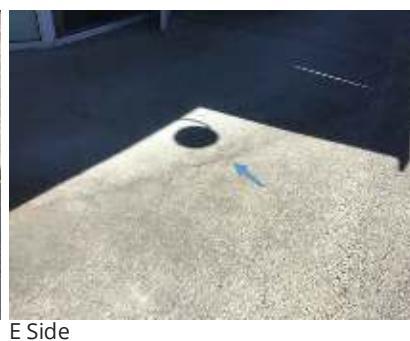
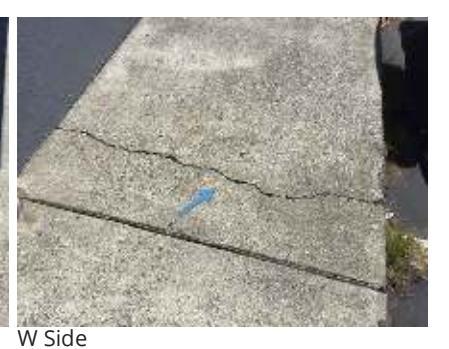
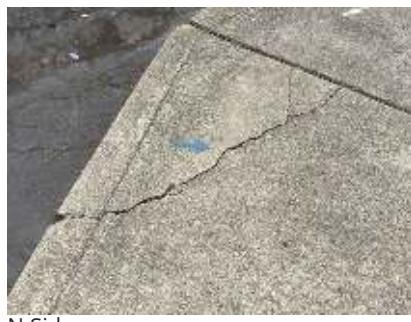
3.3.1 Walkways TYPICAL CRACKS

Typical cracking was observed in the walkways. Cracks over 1/4 inch should be filled with an appropriate sealant to prevent further damage from the expansion of freezing water.

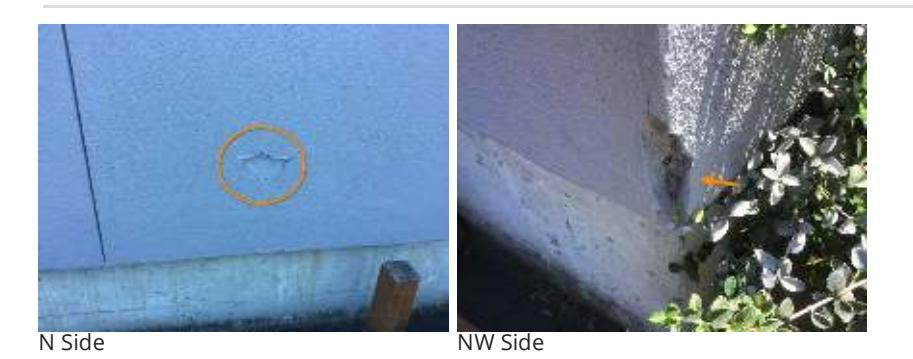
3.4.1 Exterior Cladding & Siding EIFS - SIGNIFICANT DAMAGE/DETERIORATION

Damage and/or deterioration was observed in EIFS panels. Exterior insulated finish systems vary by manufacturer, but typically consist of expanded polystyrene insulation (EPS aka styrofoam), covered by a fiberglass embedded base coat, and a finish coat. The majority of the panel thickness consists of the EPS insulation, and as such is susceptible to damage from impact and thermal expansion and contraction of the building substrate. Control joints allow for thermal movement if properly installed (usually ever 144 sq feet), but are also a point of weakness in the exterior cladding. Deteriorated control joints were observed at the time of the inspection. Control joints should be regularly maintained to avoid moisture intrusion.

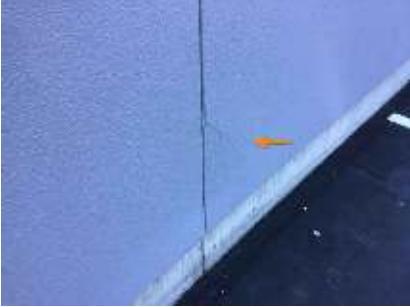
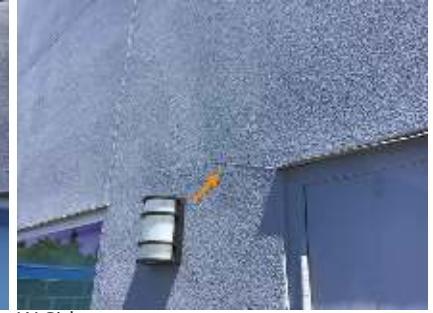
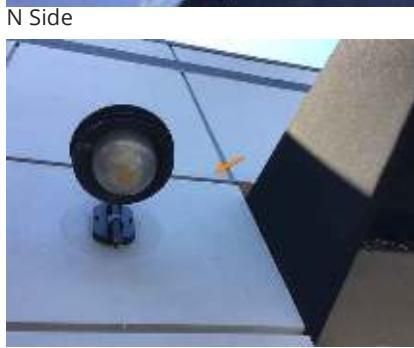
EIFS - MINOR DAMAGE/DETERIORATION

Light damage or deterioration was observed in EIFS panels. The inspector recommends correction by a qualified EIFS specialist to prevent further deterioration.

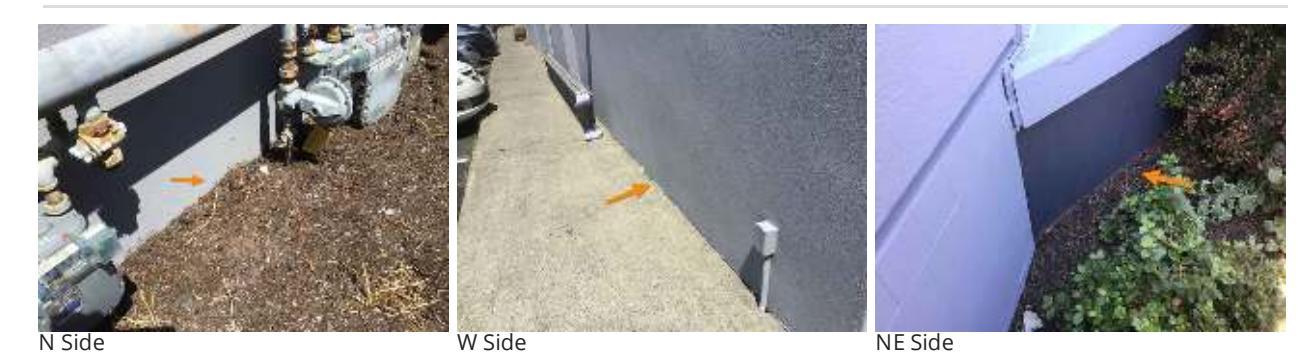
3.4.3 Exterior Cladding & Siding **EIFS - INADEQUATE CLEARANCE FROM GRADE**

The exterior insulating finish system (EIFS) cladding was in contact with or too close to dirt/paving in one or more areas. This condition is conducive for moisture and pest intrusion. The Inspector recommends a qualified contractor repair or grade as necessary and per best building practices.

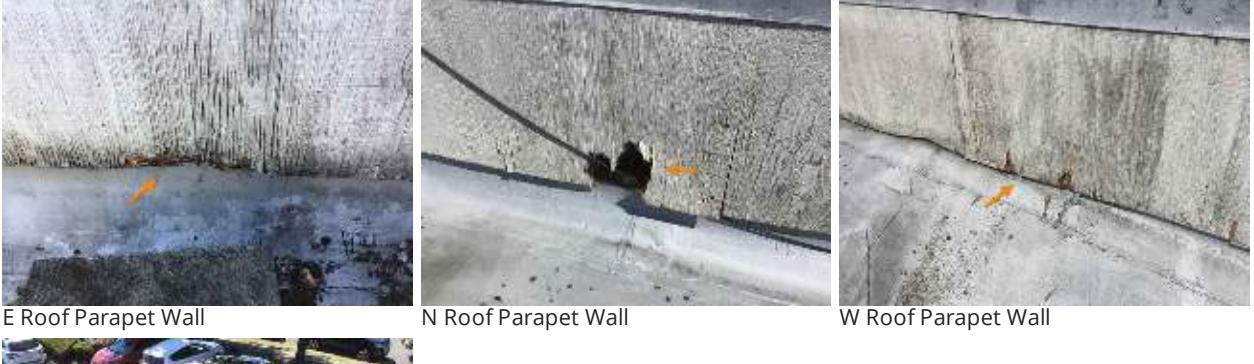
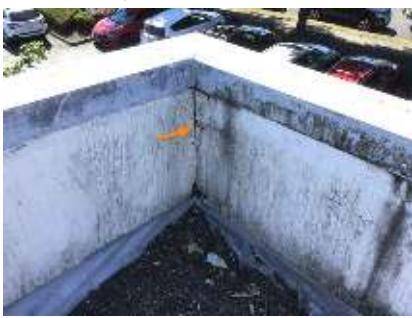
S Roof Parapet Wall

WOOD CLADDING - DAMAGE/DETERIORATION

Wood cladding was damaged and/or deteriorated at the time of the inspection. The Inspector recommends repair/replacement of damaged pieces and regular maintenance of the protective coating to prevent future deterioration.

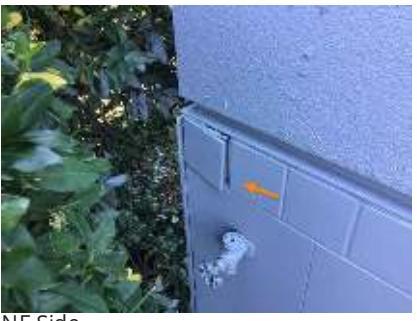
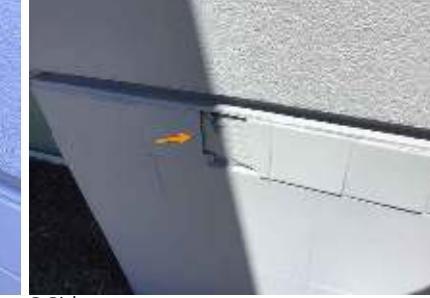
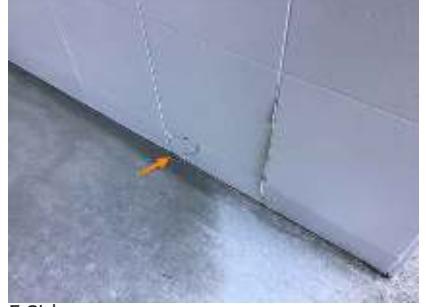
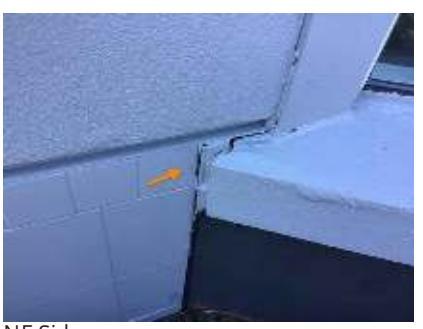
3.4.5 Exterior Cladding & Siding **TILE - DAMAGED/LOOSE** SEE PHOTO CAPTIONS

The exterior tile cladding is damaged/loose. The Inspector recommends further evaluation and repair by a qualified contractor.

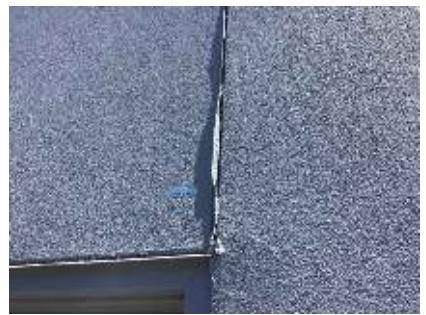
W Side

3.4.6 Exterior Cladding & Siding **EXPANSION JOINT - SEALANT DETERIORATION** SEE PHOTO CAPTIONS

Deterioration of the expansion joint sealant is observed. The Inspector recommends maintenance repair by a qualified contractor.

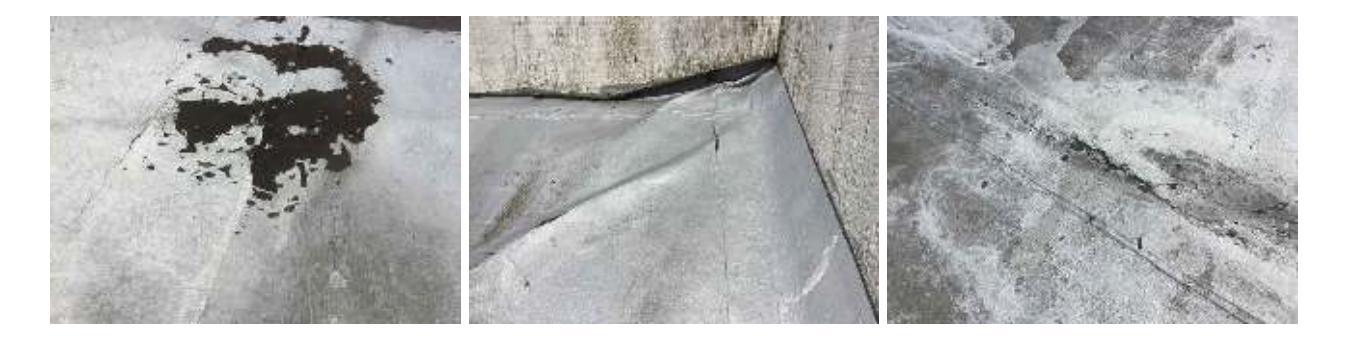
FLAT - WEAR

The flat roofing material is showing signs of increasing wear and age. A licensed roofer should be called to evaluate the roof and offer their opinion with regard to the estimated remaining life span, and the possible need for any immediate repairs. Recommendations for replacement versus repairs of any conditions documented below are at the roofer's discretion. At this time, the signs of roofing wear may include: Alligatoring, Bubbling, Lifting, Surface Deterioration and/or Open Seams.

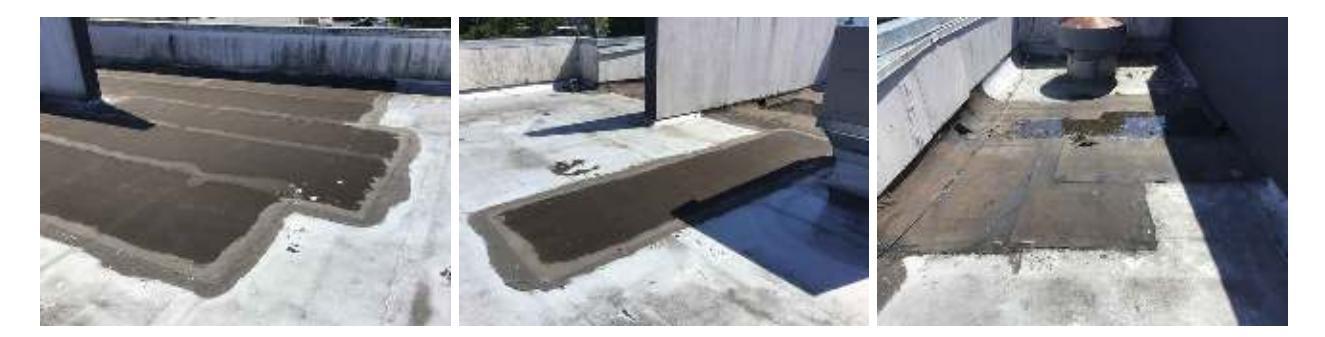
NE

FLAT - PREVIOUS REPAIRS

Patches were observed in the roof covering membrane at the time of the inspection. These patches indicated some level of roof maintenance and seams at patches were intact. Repairs like those observed are necessary to ensure the roof lasts for the entirety of its life expectancy, however they also are a weak point in the membrane and their condition should be regularly assessed.

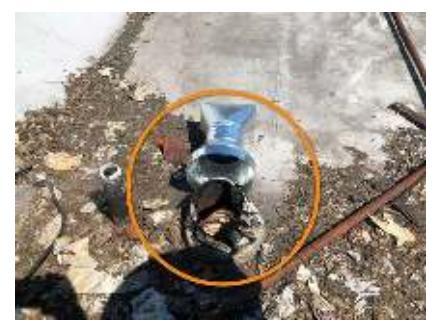
S SIDE

MISSING/DAMAGED FLASHING

Roof flashing is missing/damaged. Missing/damaged flashing may lead to leaks/damage and repair by a licensed professional roofer is recommended. On older structures be aware hidden conditions may exist.

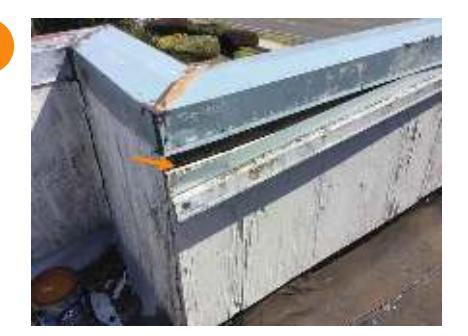
NE SIDE

DAMAGED/LOOSE FLASHING

Roof flashing is damaged/loose and leaking maybe occurring. The Inspector recommends further evaluation and repair by a licensed roofing contractor.

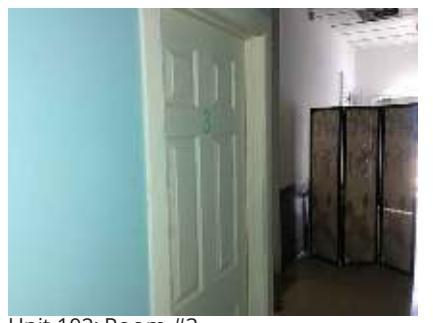
The room was occupied/in-use and was unable to be inspected.

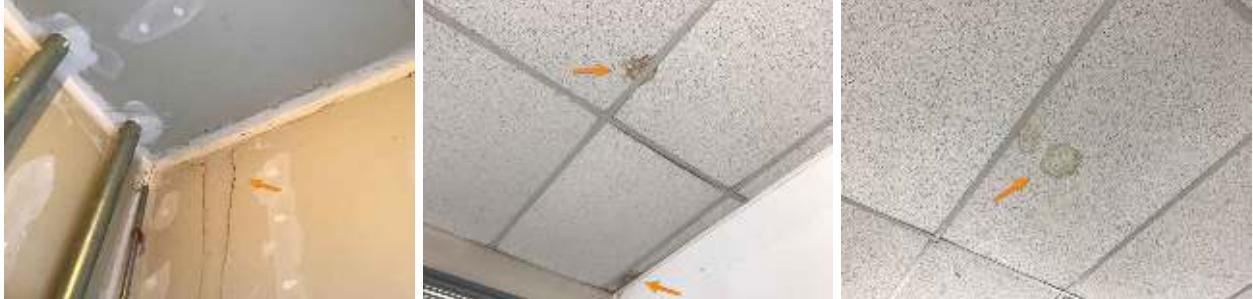
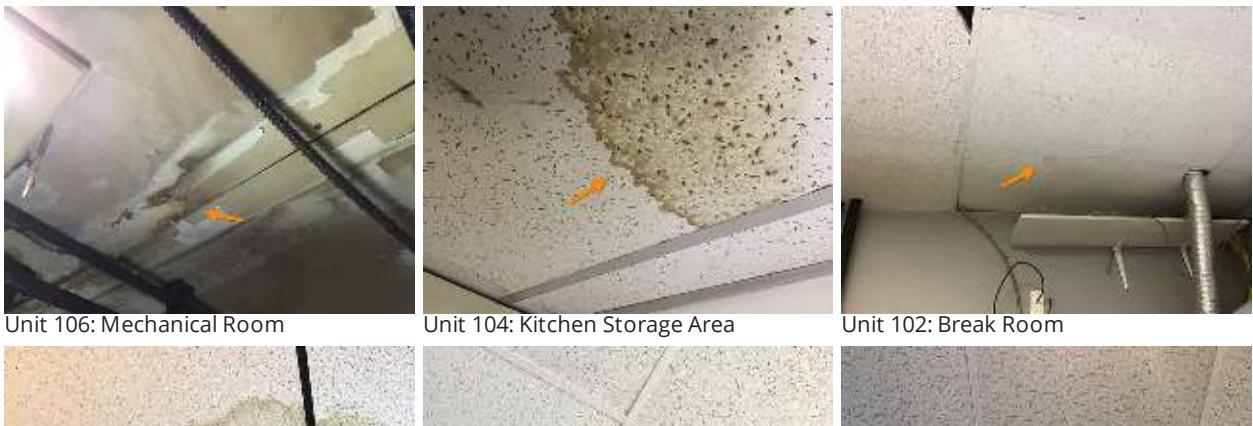
5.2.1 Ceilings, Walls, & Floors MOISTURE RELATED STAINS

Stains were observed on ceilings/walls that were consistent with moisture intrusion. Stains were observed visually. Confirmation requires destructive testing that is outside the scope of the general PCA. The inspector recommends further evaluation by roofing and/or drywall contractors to confirm or rule out leaking and to determine the cost of correction.

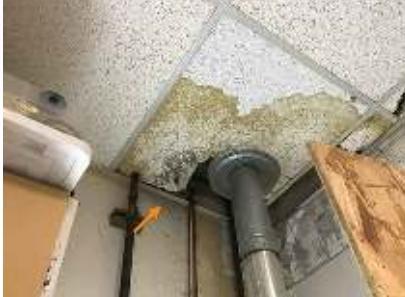
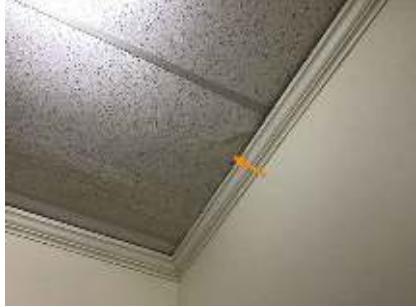
5.2.2 Ceilings, Walls, & Floors CEILING/WALL CRACK - MOISTURE SEE PHOTO CAPTIONS

A ceiling/wall crack was observed that is consistent with damage caused by moisture intrusion. The inspector recommends further evaluation.

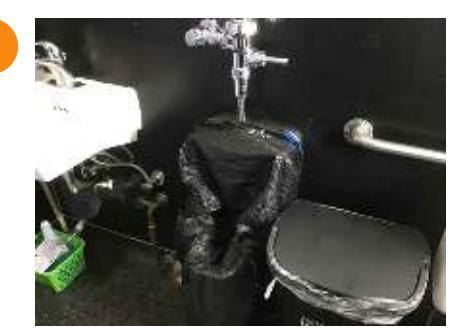
UNIT 102

6.3.1 Urinals **OUT OF ORDER**

The urinal appeared to be out of order at the time of the inspection. This urinal was not operated because of the apparent risk of potential problems.

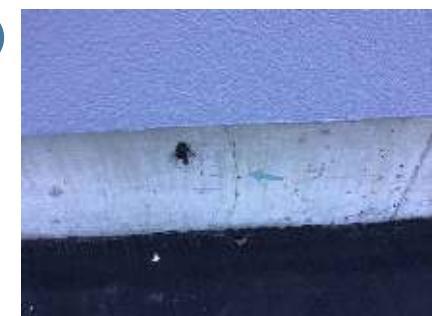
N Side

CRACKS - MINOR

One or more minor cracks (1/8 inch or less) were found in the foundation. These don't appear to be a structural concern, but recommend sealing them to prevent water infiltration and monitoring them in the future. Numerous products exist to seal such cracks including:

• Hydraulic cement. Requires chiseling a channel in the crack to apply.

- Resilient caulks (easy to apply).
- Epoxy sealants (both a waterproof and structural repair).

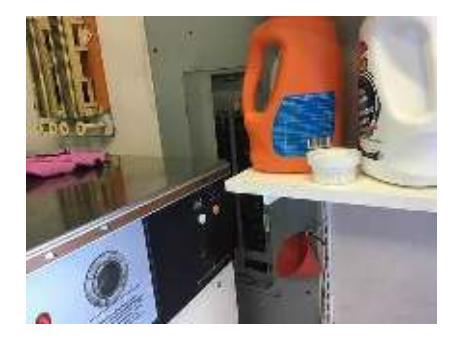
INTERIOR OF UNIT 106

Stored items prevented a full view/access to the panel. Hidden conditions may exist.

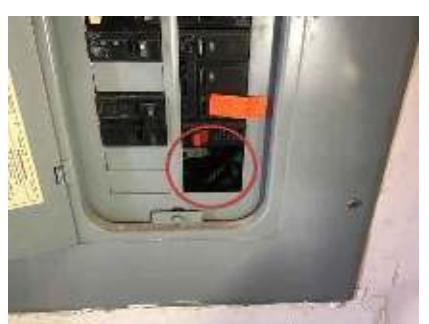
Sub Panel for Unit 101 Labeled "Village Manor Storage Room" located on the N Wall of the Utility Room

The electric panel(s) have unprotected openings. For safety, any unused breaker openings or other gaps in the panel should be properly closed.

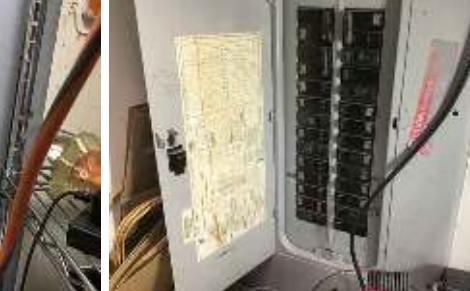
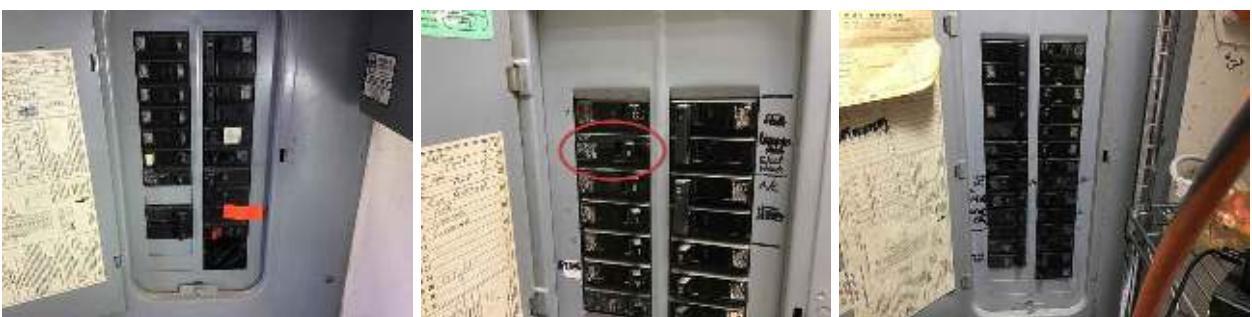
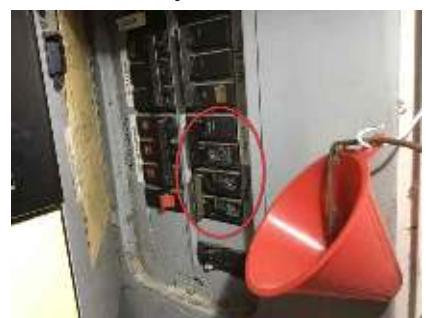
Circuit breakers are mismatched. Breakers do not appear to be compatible with panel brand and model. The Inspector recommends an electrician evaluate the panel.

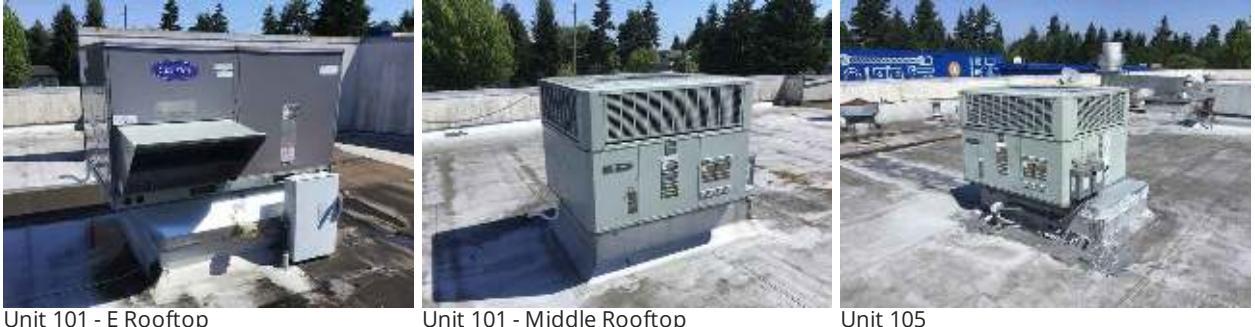
Unit 101 - E Rooftop

The unit lacks evidence of recent service. Forced air units should be checked and serviced yearly, especially those which burn gas, oil or LPG. Units which have not been serviced on a regular basis may have subtle, hidden conditions which may only be detected during detailed, technical servicing. Lack of servicing may also cause some components to be prone to early failure, which cannot be detected during the inspection. It is possible the seller has receipts from recent servicing, but if not, it is recommended a full service and technical evaluation be performed. The average lifespan for this type of unit is 15-20 years with annual maintenance performed. This unit was <15 years old.

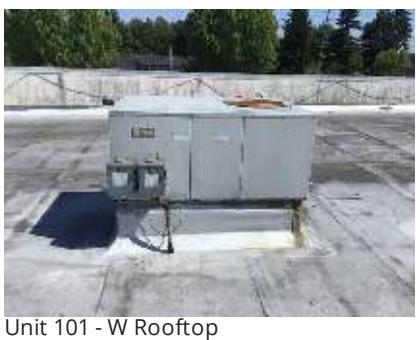
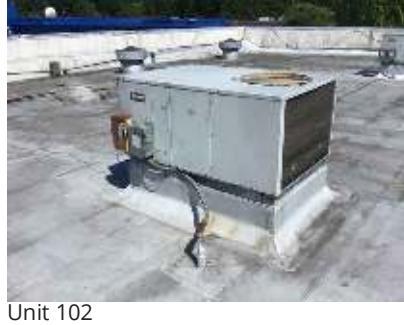
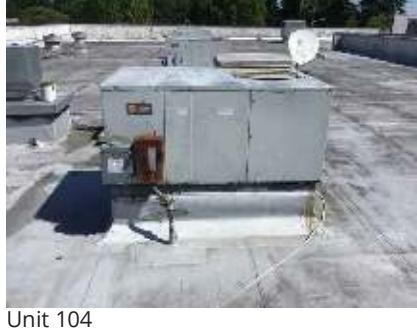
10.2.2 General Condition - Forced Air/High Efficiency LACK OF SERVICE/MAINTENANCE - OLDER

The unit lacks evidence of recent service. Forced air units should be checked and serviced yearly, especially those which burn gas, oil or LPG. Units which have not been serviced on a regular basis may have subtle, hidden conditions which may only be detected during detailed, technical servicing. Lack of servicing may also cause some components to be prone to early failure, which cannot be detected during the inspection. It is possible the seller has receipts from recent servicing, but if not, it is recommended a full service and technical evaluation be performed. The average lifespan for this type of unit is 15-20 years with annual maintenance performed. This unit was >15 years old. Repair/replacement may be needed in the near future.

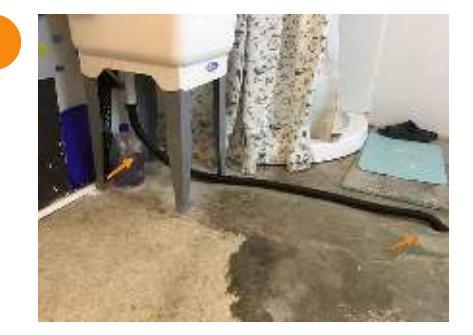
UNIT 102: WASHROOM

POOR REPAIR

A temporary or unprofessional drain line repair is present. Such repairs may function for a time, but may not be reliable. The Inspector recommends further professional evaluation.

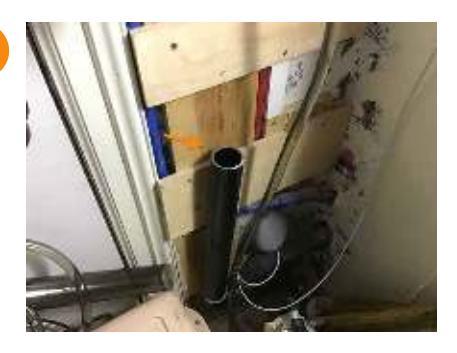
UNIT 103: WATER HEATER AREA

11.2.2 Drain and Waste OPEN WASTE LINE - INTERIOR

There is an open waste line observed. The Inspector recommends that a cap be installed to prevent any sewer line gases from entering the interior.

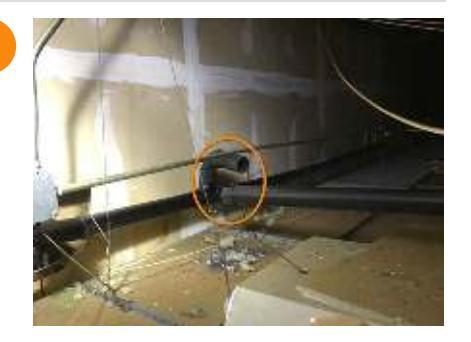
UNIT 104: NW ATTIC ABOVE KITCHEN AREA

11.3.1 Venting **DISCONNECTED**

The plumbing vent has come disconnected. The Inspector recommends further evaluation and repair by a licensed plumbing contractor.

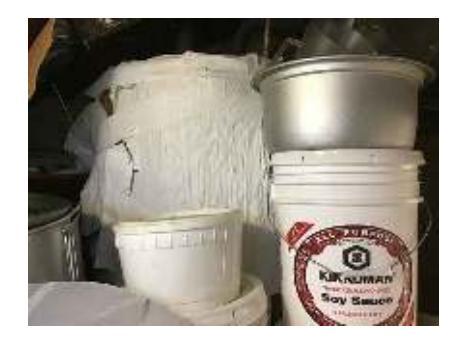
UNIT 104 N ATTIC ABOVE KITCHEN STORAGE AREA

A permanently installed insulated jacket is installed on the water heater. It obscures the manufacturer's information label and most of the water heater. The inspector was unable to fully evaluate the water heater.

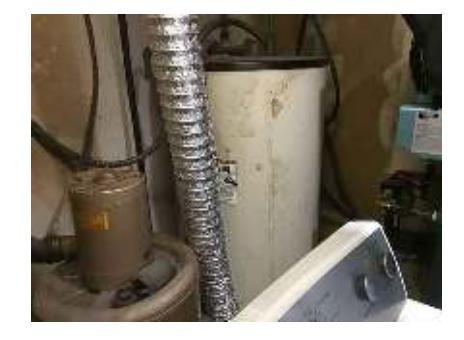
UNIT 106

STORED ITEMS

Stored items, furnishings and/or debris blocked access to the water heater. The inspector was unable to fully evaluate the water heater.

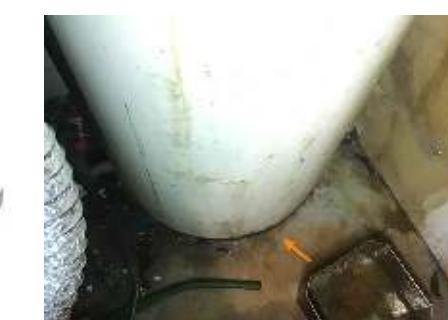
Interior of Unit 106

12.1.1 Water Heater **2 INCH PAD** SEE PHOTO CAPTIONS

Recommend installation of a 2 inch platform to prevent moisture from wicking into the water heater from the concrete and causing corrosion.

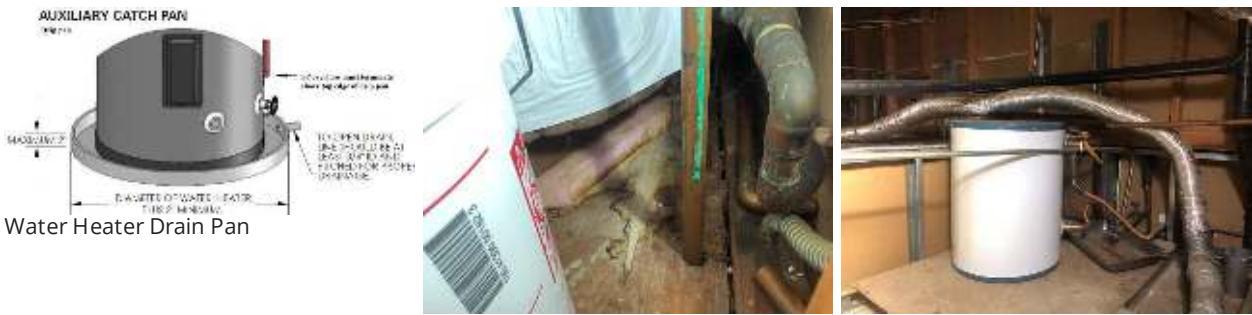
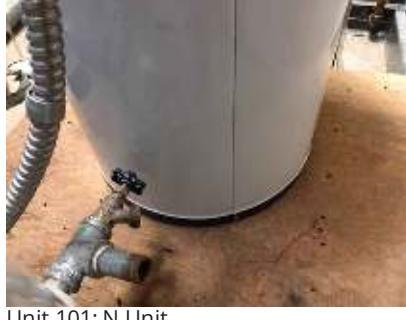
12.1.2 Water Heater **NO CATCH PAN OR DRAIN**

A water heater is installed over interior areas and has no catch/drip pan and drain installed or the catch/drip pan and drain is installed wrong. The Inspector recommends having a qualified contractor install a catch/drip pan and drain to prevent water damage to finished interior spaces below if/when the water heater develops a leak or is drained.

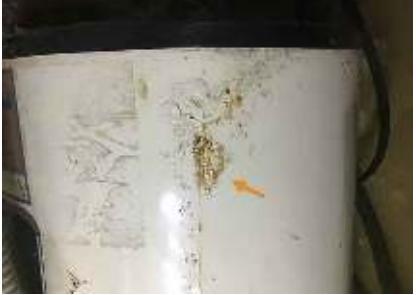
Interior of Unit 106

12.2.1 Tank Casing CORROSION

Corrosion was found in one or more areas of the water heater. The water heater may be failing. A qualified plumbing contractor should evaluate and replace or repair water heater if necessary.

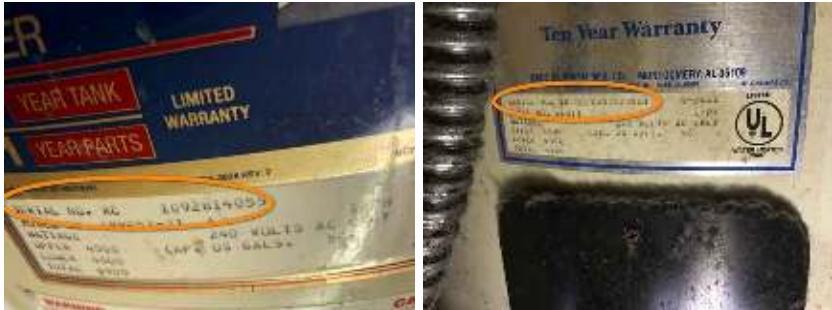
The estimated useful life for most water heaters is 8-15 years. This water heater appears to be at this age or older and may need replacing at any time.

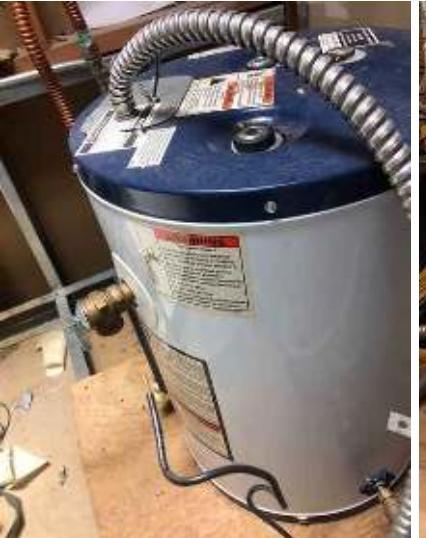
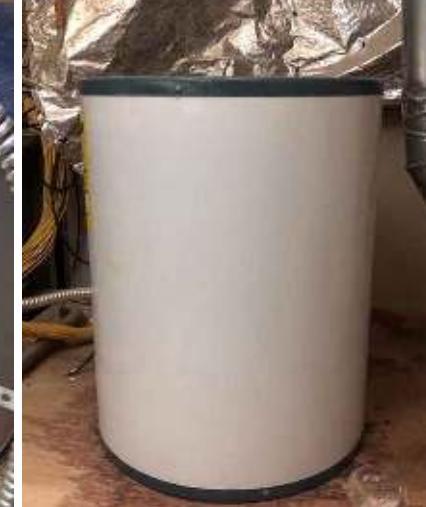
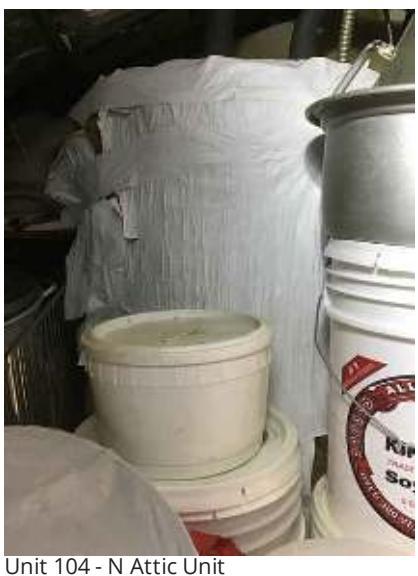
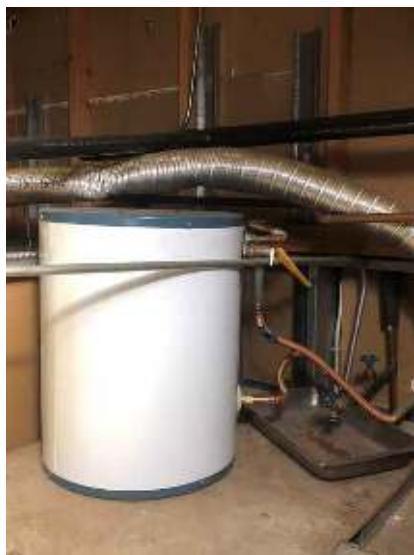
The estimated useful life for most water heaters is 8 to 15 years. The inspector was unable to determine the age of the water heater due to the manufacturer's label being obscured, no serial number being visible, or the serial number not clearly indicating the age. The client(s) should be aware that this water heater may be near, at, or beyond its useful life and may need replacing at any time. The Inspector recommends further evaluation to determine the age of the appliance.

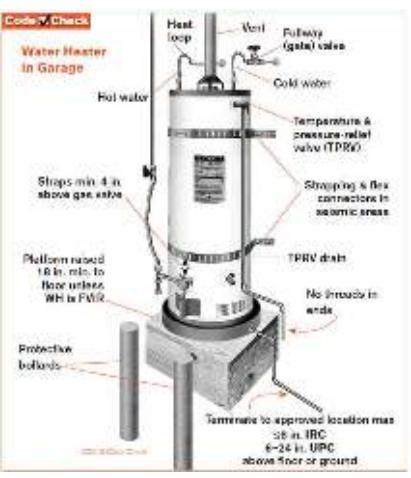
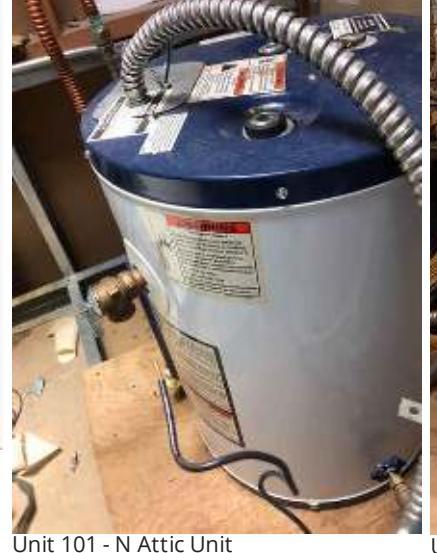
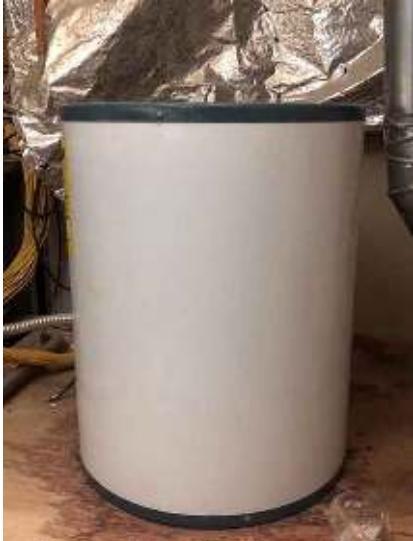
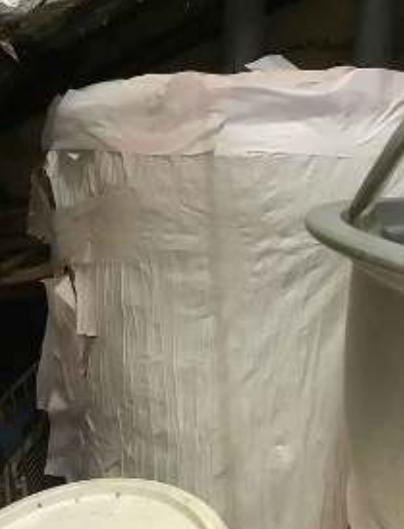
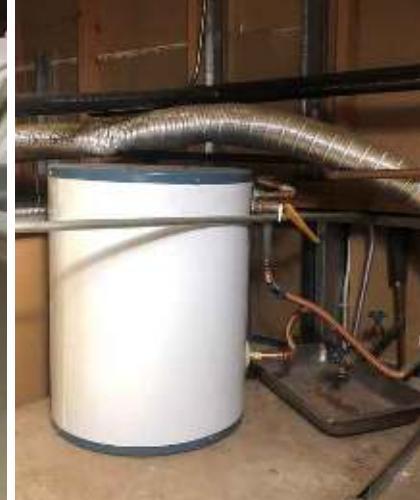
STRAPS MISSING

The water heater does not have seismic straps or struts installed. This is a potential safety hazard since movement can cause leaks in the gas supply lines or damage wiring. Leaks may also occur in water supply pipes. A qualified contractor should install seismic straps or struts as necessary and as per standard building practices.

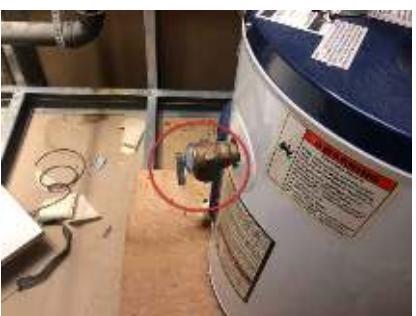
Unit 101: N Unit

DRAIN LINE MISSING

No drain line is installed for the temperature-pressure relief valve. This is a potential safety hazard due to the risk of scalding if someone is standing next to the water heater when the valve opens. A qualified plumber should install a drain line as per standard building practices. For example, extending to 6 inches from the floor, or routed so as to drain outside.

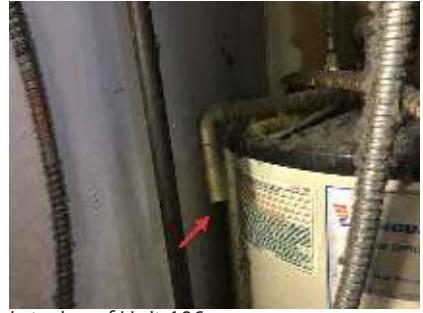
Interior of Unit 106

12.6.2 TPR Drain Line TERMINATES IN THE INTERIOR

The Temperature pressure relief (TPR) line from the water heater is not terminated to the exterior. Wherever it is possible to do so, the TPR line should be terminated outside and be pointed downward to within 6 inches from the ground. If this is not possible, for instance in a basement or garage, the line should terminate close to the floor. A plumber may be able to recommend other corrective actions.
