# PROPERTY INSPECTION REPORT

**Property Address:** Sample Dr SW ,

**Date:** 10/13/2019

**Inspector:** Dwayne Boggs

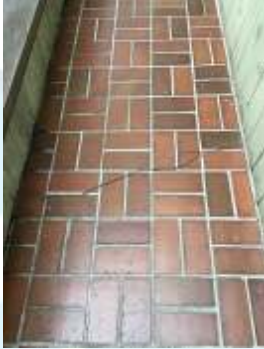
Page 22 Item: 2	Walkways	<ul style="list-style-type: none"> <li>Spalling or deterioration of walkway is present: Repair/replacement may be necessary. Follow up with a licensed concrete contractor is advised. These conditions were noted in the following areas: Left side.</li> </ul>

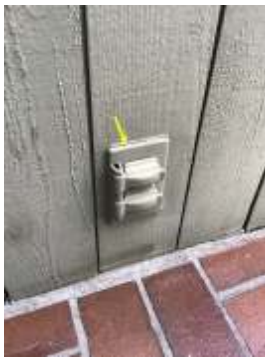
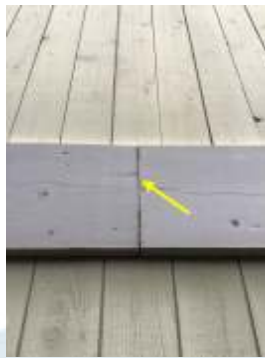
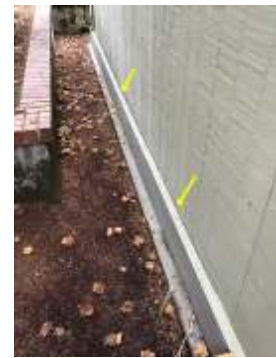
Page 22 Item: 3	Siding And Trim	<ul style="list-style-type: none"> <li>Caulking around exposed penetrations (doors, windows, nail heads, etc.) is a normal and extremely important maintenance task which needs to be performed on a regular basis. It is also extremely important to maintain caulking along the top edge of horizontal trim boards or belly boards. Failure to maintain caulking may result in rapid deterioration of composite wood sidings; always use a high quality paintable caulk such as OSI Quad. Be aware that on used structures, particularly older structures where caulking has been allowed to fail hidden conditions may exist. Noted: Primary Structure.</li> <li>Z-type metal flashing is missing: Where siding materials such as wood panels or trim meet at a horizontal joint, Z-type metal flashing is used to prevent water penetration. Retrofit flashing installation is generally not reasonable to do, so it will be important to maintain caulking as a defense against water penetration on older structures. Be aware hidden conditions may exist. Noted: All sides.</li> </ul>

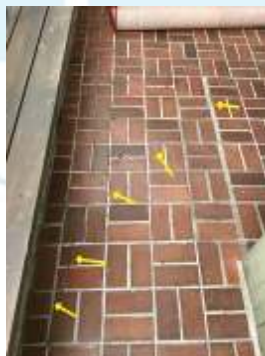
Page 23 Item: 4

• Erosion or settling of concrete surface is present. If this is a concern, following up with a licensed contractor specializing in patio installation and repair is advised. This condition was noted on the following patio slab(s): Front.

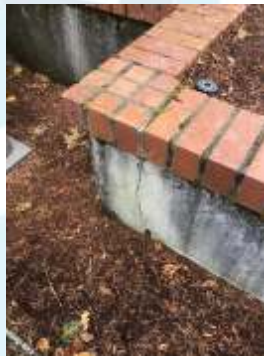
Page 24 Item: 7	Retaining Wall	<ul style="list-style-type: none"> <li>Retaining wall(s) damaged and/or displaced: A licensed contractor experienced with retaining walls should be called to make further evaluation and recommendations for repair. This condition was noted on the following retaining wall(s): Front.</li> </ul>
-----------------	----------------	--

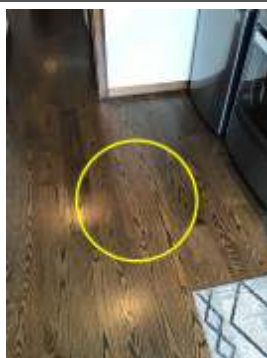
Page 29 Item: 2	Flooring Defects	<ul style="list-style-type: none"> <li>Some floor squeaking is noted: This is a common occurrence often due to nails in the sub floor having missed the floor joist and are rubbing against it. A hardware supply or contractor can suggest remedies if this is of concern to you. Noted: Utility room.</li> <li>The carpet is loose and needs restretched. This was noted in the Living room.</li> </ul>
-----------------	------------------	---

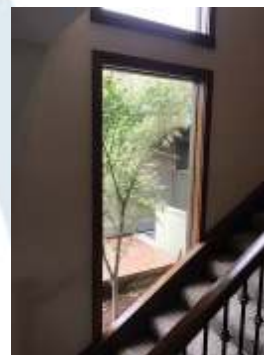
Page 29 Item: 4

- Damage or deterioration of the interior window framing/sill exists: Be aware hidden conditions may exist. Repair is recommended. Noted in the following area(s): Garage.

- The following window conditions are present: Some older windows are not safety glass. Older structures rarely meet the current standards. Exercise caution and consider changing to safety glass as a future upgrade or if windows should ever need replacing.. This was noted in the following area(s): Stairwell. Safety glass is currently required in the following circumstances: (1) If the window pane is > 9 sq. ft, < 18 inches above the floor, the top edge of the window is > 36 inches above the ground, and the window is within 36 inches of a walking surface. (2) The window is within 2 ft of a door and its bottom edge is < 60 inches over a walking surface. (3) The windows is in a wall enclosing a tub, shower or spa and the bottom edge is < 60 inches over a walking surface. (4) Windows within 60 inches of the bottom tread of a stairway if the exposed glass is < 60 inches from the nose of the tread. (5) All windows in railings. This requirement is often not met on older structures (which predate the code). Extreme caution is advised, particularly if small children are present. If these windows should ever be replaced, they should be changed to safety glass.

- Some or all window screens are missing: Repair is recommended. Noted in the following area(s): Several areas.

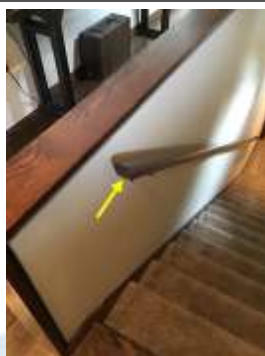
Page 30 Item: 5

- Stair hand rail ends are exposed: This is a common finding in older homes which predates the requirements to have the rail ends return to the wall. Be aware rail ends can snag clothes and cause falls.

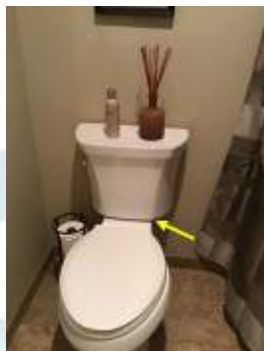
Page 32 Item: 2	Toilets/ Bidets	<ul style="list-style-type: none"> <li>The toilet tank(s) are loose: The tank(s) should be tightened as needed, as part of normal maintenance and to also prevent possible leaking. Noted: Second floor hall bath at top of stairs.</li> </ul>
-----------------	-----------------	--

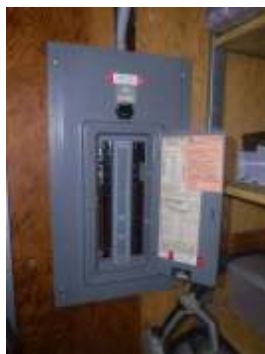
Page 34 Item: 2	Panel	<ul style="list-style-type: none"> <li>The electrical panel(s) are a Federal Pacific Electric (FPE) brand: FPE panels have had conditions documented that include breaker failure and are considered by some to be a possible latent fire hazard. Considerable information is available on the internet by visiting <a href="https://inspectapedia.com/fpe/FPE_Stab_Lok_Hazards.php">https://inspectapedia.com/fpe/FPE_Stab_Lok_Hazards.php</a>. It is recommended a licensed electrician evaluate the panel for safety and possible replacement. Noted: Garage.</li> <li>The electrical panel(s) have a mechanism in place to manage a generator. It is important for the buyer to understand how the system works. Therefore, having either the seller explain the proper operation or a licensed electrician explain the system will aide in the proper usage of the mechanism. Noted: Garage.</li> <li>The newer generator panel(s) lack a permit sticker. Recommend further review to see if a permit was pulled. Noted: Garage.</li> </ul>

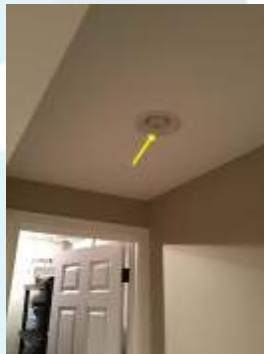
- Light(s) are not operational in some areas: This may occur simply due to a bad bulb. Exterior lights may be on a sensor and won't turn on unless it's dusk. Recommend having the seller check and install a new bulb for any light which does not work. If this does not correct the condition, an electrician should be consulted. Noted: Basement.

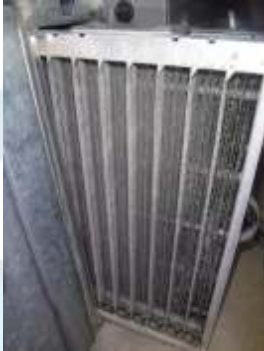
Page 37 Item: 3	Filters:	<ul style="list-style-type: none"> <li>The furnace air filter is dirty: Recommend cleaning/changing filter as part of normal maintenance. Be aware that where filters have remained dirty over extended lengths of time, excess wear on the furnace may have occurred, which in turn may cause premature failure of some components such as blowers and fans. It is outside the scope of inspection to predict when or if such failures may occur.</li> </ul>

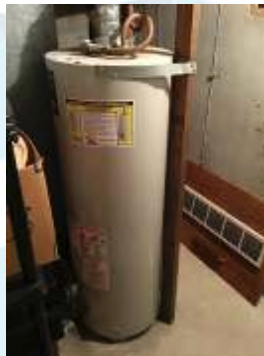
- The existing earthquake strapping for the water heater is marginal: Current safety standards require two rated straps to secure the appliance. Recommend upgrading this for safety.

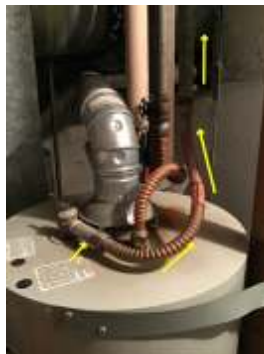
Page 41 Item: 5

- The temperature pressure relief (TPR) line is improperly sloped. For safety, the manufacturer's installation requirements of the TPR line from the water heater are very specific: The inside diameter of the line should never be downsized; The line should always be sloped downhill; The line should terminate at an elbow pointing downward close to the ground; There should not be more than four elbows in the line. Any conditions noted should be corrected for safety.

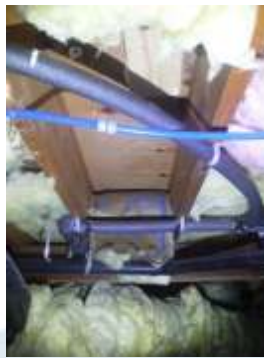
Page 44 Item: 3	Structure Insulation :	<ul style="list-style-type: none"> <li>Some sub structure insulation is damaged: Recommend repair.</li> </ul>
-----------------	------------------------	---

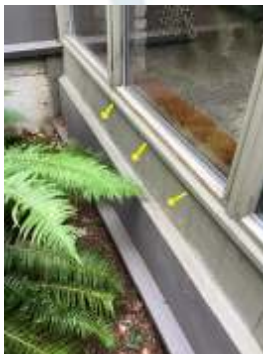
- Damage/decay present on the lower siding. Be aware hidden conditions may exist. This was seen in the following area(s):Rear.

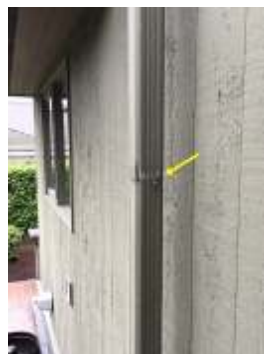
Page 51 Item: 1

- A downspout is becoming disconnected from itself. Downspouts should be properly reconnected and secured. This was noted in the following area(s):Front.

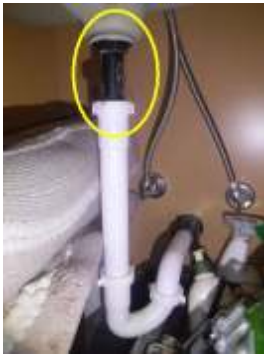
<b>Conductive/Interior</b>		
Page 52 Item: 1	Bath Sink	<ul style="list-style-type: none"> <li>The bath sink drain line is leaking. A licensed tradesperson should be called to make repairs. This was noted in the following area(s): Master bath.</li> </ul>

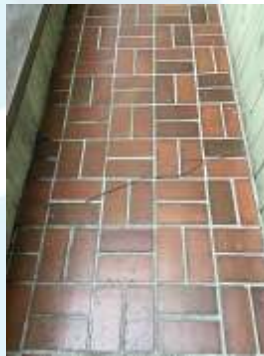
- Spalling or deterioration of walkway is present: Repair/replacement may be necessary. Follow up with a licensed concrete contractor is advised. These conditions were noted in the following areas: Left side.

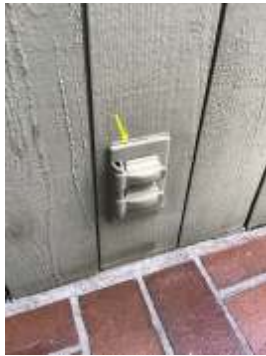
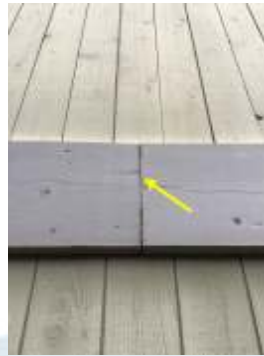
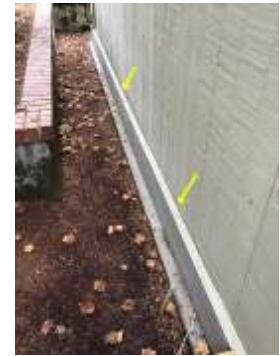
## 3. Siding And Trim

- Caulking around exposed penetrations (doors, windows, nail heads, etc.) is a normal and extremely important maintenance task which needs to be performed on a regular basis. It is also extremely important to maintain caulking along the top edge of horizontal trim boards or belly boards. Failure to maintain caulking may result in rapid deterioration of composite wood sidings; always use a high quality paintable caulk such as OSI Quad. Be aware that on used structures, particularly older structures where caulking has been allowed to fail hidden conditions may exist. Noted: Primary Structure.

- Z-type metal flashing is missing: Where siding materials such as wood panels or trim meet at a horizontal joint, Z-type metal flashing is used to prevent water penetration. Retrofit flashing installation is generally not reasonable to do, so it will be important to maintain caulking as a defense against water penetration on older structures. Be aware hidden conditions may exist. Noted: All sides.

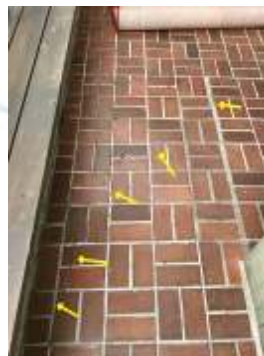
#### 4. Concrete, Masonry Patio

- Erosion or settling of concrete surface is present. If this is a concern, following up with a licensed contractor specializing in patio installation and repair is advised. This condition was noted on the following patio slab(s): Front.

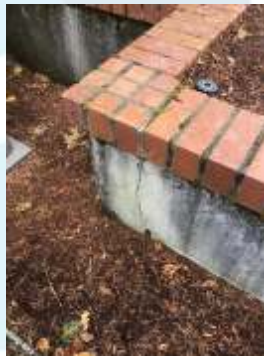
- Retaining wall(s) damaged and/or displaced: A licensed contractor experienced with retaining walls should be called to make further evaluation and recommendations for repair. This condition was noted on the following retaining wall(s): Front.

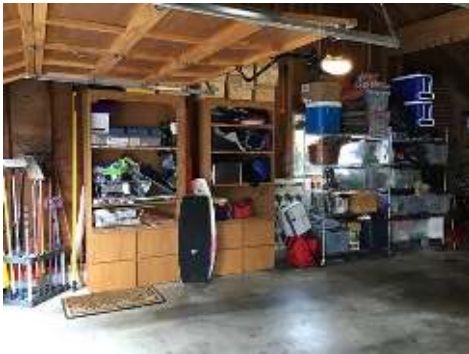
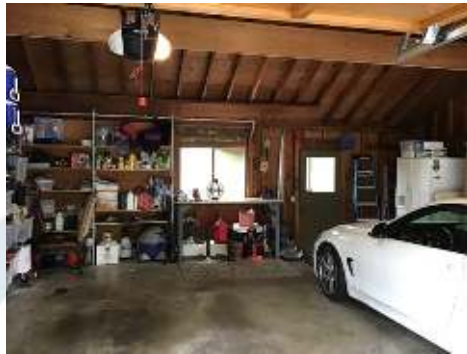
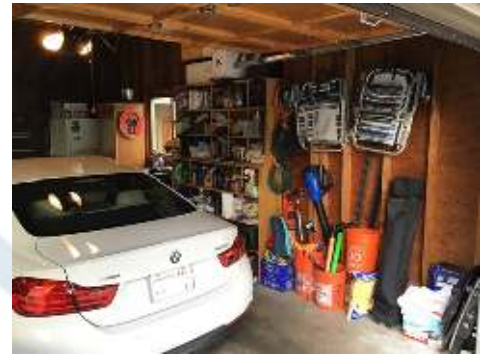
- Stored personal items present: Access and visibility limited. Determining the condition of the concrete slab beneath stored items is outside the scope of inspection.

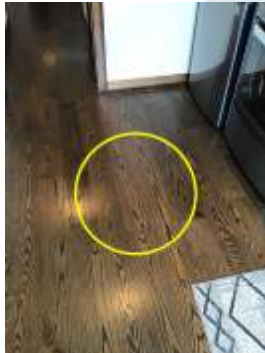
## 2. Flooring Defects

- Some floor squeaking is noted: This is a common occurrence often due to nails in the sub floor having missed the floor joist and are rubbing against it. A hardware supply or contractor can suggest remedies if this is of concern to you. Noted: Utility room.
- The carpet is loose and needs restretched. This was noted in the Living room.

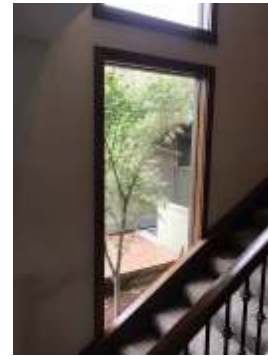
- Some or all window screens are missing: Repair is recommended. Noted in the following area(s): Several areas.

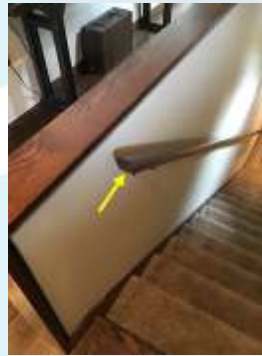
- Stair hand rail ends are exposed: This is a common finding in older homes which predates the requirements to have the rail ends return to the wall. Be aware rail ends can snag clothes and cause falls.

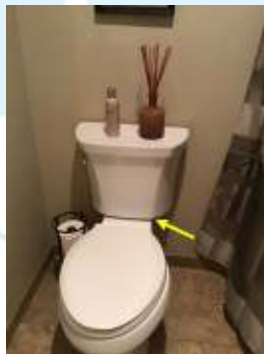
- The toilet tank(s) are loose: The tank(s) should be tightened as needed, as part of normal maintenance and to also prevent possible leaking. Noted: Second floor hall bath at top of stairs.

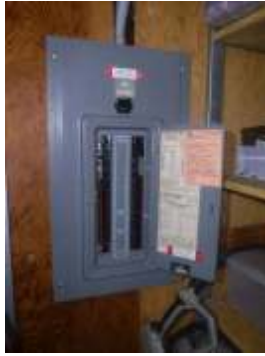
- The electrical panel(s) are a Federal Pacific Electric (FPE) brand: FPE panels have had conditions documented that include breaker failure and are considered by some to be a possible latent fire hazard. Considerable information is available on the internet by visiting [https://inspectapedia.com/fpe/FPE\\_Stab\\_Lok\\_Hazards.php](https://inspectapedia.com/fpe/FPE_Stab_Lok_Hazards.php) . It is recommended a licensed electrician evaluate the panel for safety and possible replacement. Noted: Garage.

- The electrical panel(s) have a mechanism in place to manage a generator. It is important for the buyer to understand how the system works. Therefore, having either the seller explain the proper operation or a licensed electrician explain the system will aide in the proper usage of the mechanism. Noted: Garage.

- The newer generator panel(s) lack a permit sticker. Recommend further review to see if a permit was pulled. Noted: Garage.

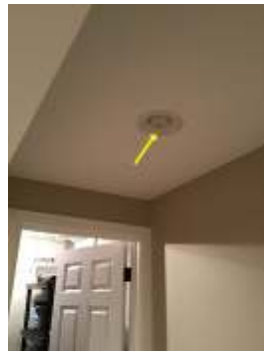
- Light(s) are not operational in some areas: This may occur simply due to a bad bulb. Exterior lights may be on a sensor and won't turn on unless it's dusk. Recommend having the seller check and install a new bulb for any light which does not work. If this does not correct the condition, an electrician should be consulted. Noted: Basement.

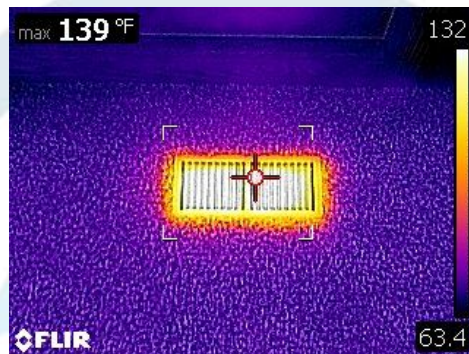
- At the time of inspection, when testing the unit in the heating mode, a sampling of the temperature was noted around: 140 F.
- The Gas, Oil or LPG heating unit appears older (>10 years): A full service evaluation is strongly recommended prior to closing the Real Estate Transaction. This should include Carbon Monoxide testing of flue gases to help determine the condition of the heat exchanger. Any damage to the heat exchanger could represent a health risk related to Carbon Monoxide. This evaluation should include any older A/C or heat pump systems which may be present and are integral to the central furnace.

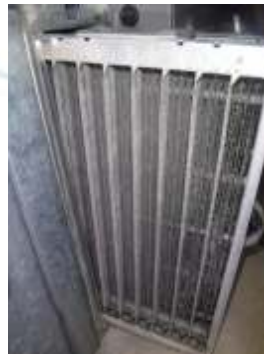
- The furnace air filter is dirty: Recommend cleaning/changing filter as part of normal maintenance. Be aware that where filters have remained dirty over extended lengths of time, excess wear on the furnace may have occurred, which in turn may cause premature failure of some components such as blowers and fans. It is outside the scope of inspection to predict when or if such failures may occur.

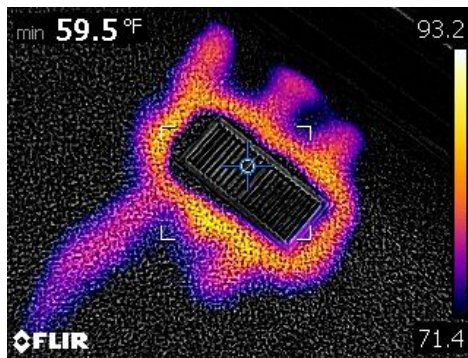
- At the time of inspection, when testing the unit in the cooling mode, the temperature was noted around: 60 F.

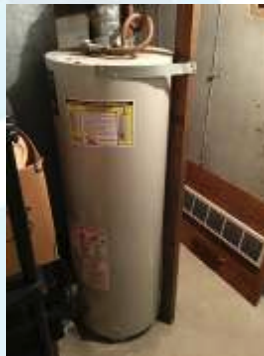
- The existing earthquake strapping for the water heater is marginal: Current safety standards require two rated straps to secure the appliance. Recommend upgrading this for safety.

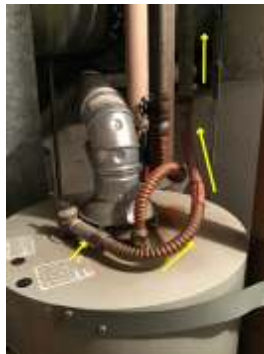
- The temperature pressure relief (TPR) line is improperly sloped. For safety, the manufacturer's installation requirements of the TPR line from the water heater are very specific: The inside diameter of the line should never be downsized; The line should always be sloped downhill; The line should terminate at an elbow pointing downward close to the ground; There should not be more than four elbows in the line. Any conditions noted should be corrected for safety.

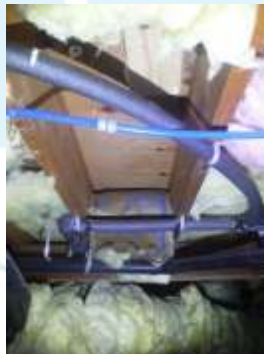
- Some sub structure insulation is damaged: Recommend repair.

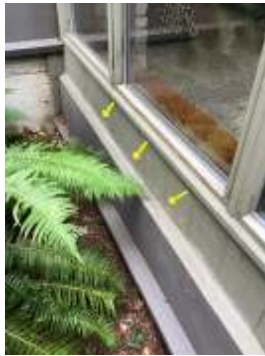
- Damage/decay present on the lower siding. Be aware hidden conditions may exist. This was seen in the following area(s):Rear.

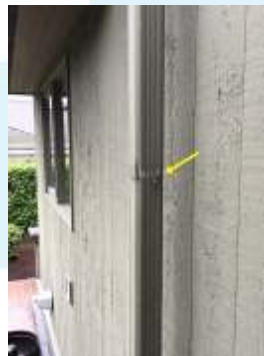
- A downspout is becoming disconnected from itself. Downspouts should be properly reconnected and secured. This was noted in the following area(s): Front.

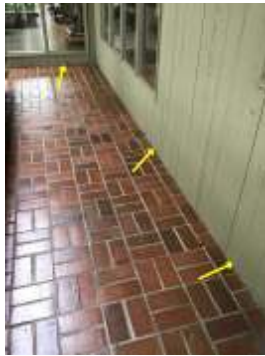
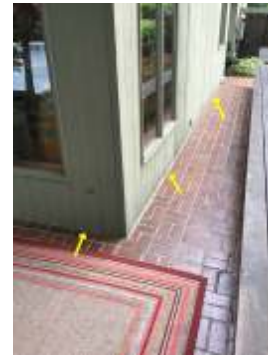
- The exterior siding is in contact with a concrete, masonry or asphalt surface. This may allow decay to occur to the siding as well as to the wood members behind it. Even if the area in question is covered by a roof structure, placing potted plants nearby and watering them may cause decay to occur. A contractor may be able to suggest some measures, such as caulking, to prevent water penetration. Be aware that on used structures, particularly older ones, hidden damages may exist and are outside the scope of inspection. This condition was noted in the following area(s): Rear and left side.

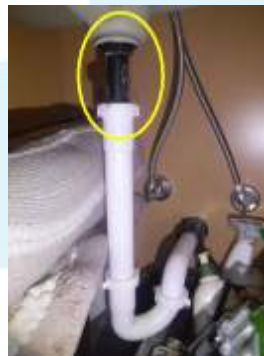
- The bath sink drain line is leaking. A licensed tradesperson should be called to make repairs. This was noted in the following area(s): Master bath.

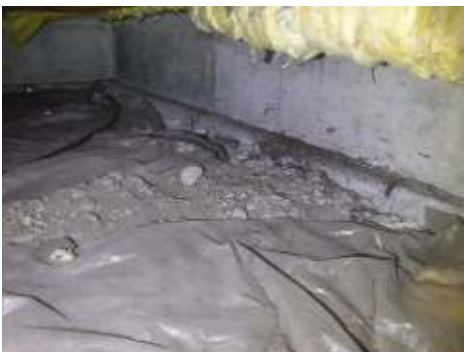
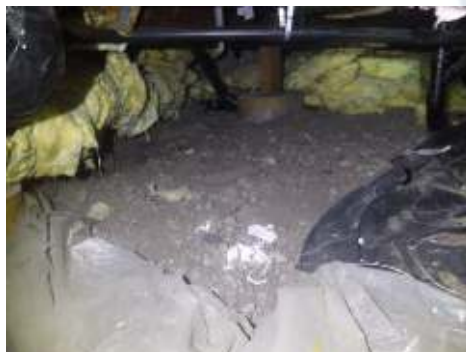
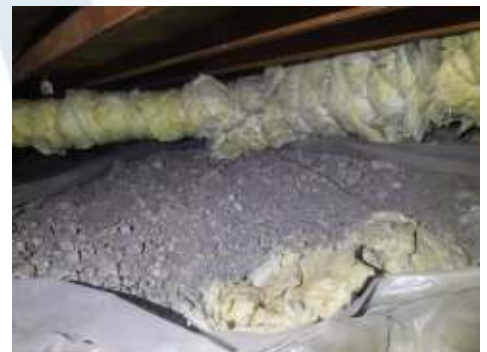
- The crawl space has inadequate and/or damaged vapor barrier coverage. Spread existing crawl space vapor barrier as able and install additional 6 mm black plastic vapor barriers as needed to meet current building requirements with provision for appropriate overlap at seams, (12 inches). This was noted in the following area(s): Scattered.

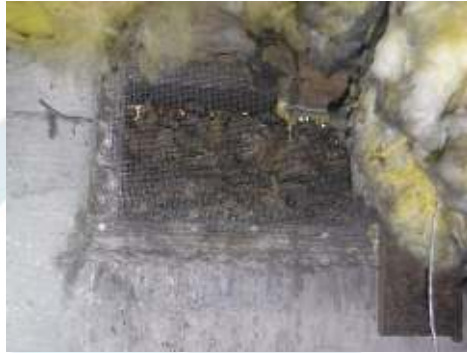
- Foundation vents are blocked. Unblock any and all foundation vents which have been either purposefully blocked and/or are blocked by landscaping material or dirt. Repair any damaged screen with 1/4 inch, non-louvered, galvanized hardware cloth. If vent is below grade, a foundation vent well should be installed to keep dirt and landscaping material clear of the vent. This was noted in the following area(s) : Front.
