PROPERTY INSPECTION REPORT

Property Address: Sample Dr SW ,

Date: 10/13/2019

Inspector: Dwayne Boggs

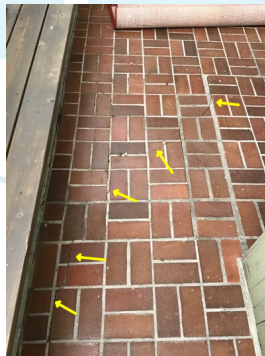
• Erosion or settling of concrete surface is present. If this is a concern, following up with a licensed contractor specializing in patio installation and repair is advised. This condition was noted on the following patio slab(s): Front.

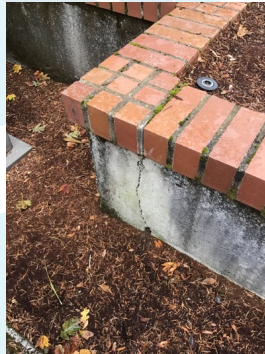
Page 24 Item: 7	Retaining Wall	<ul style="list-style-type: none"> Retaining wall(s) damaged and/or displaced: A licensed contractor experienced with retaining walls should be called to make further evaluation and recommendations for repair. This condition was noted on the following retaining wall(s): Front.
-----------------	----------------	--

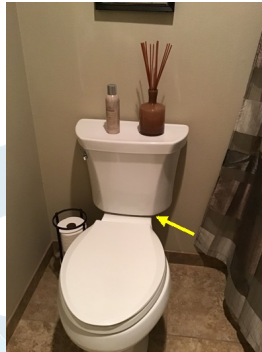
- The toilet tank(s) are loose: The tank(s) should be tightened as needed, as part of normal maintenance and to also prevent possible leaking. Noted: Second floor hall bath at top of stairs.

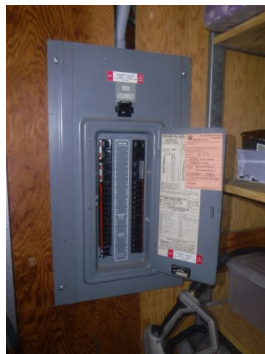
Page 34 Item: 2

- The electrical panel(s) are a Federal Pacific Electric (FPE) brand: FPE panels have had conditions documented that include breaker failure and are considered by some to be a possible latent fire hazard. Considerable information is available on the internet by visiting https://inspectapedia.com/fpe/FPE_Stab_Lok_Hazards.php . It is recommended a licensed electrician evaluate the panel for safety and possible replacement. Noted: Garage.
- The electrical panel(s) have a mechanism in place to manage a generator. It is important for the buyer to understand how the system works. Therefore, having either the seller explain the proper operation or a licensed electrician explain the system will aid in the proper usage of the mechanism. Noted: Garage.
- The newer generator panel(s) lack a permit sticker. Recommend further review to see if a permit was pulled. Noted: Garage.

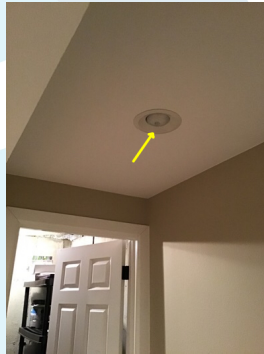
- Light(s) are not operational in some areas: This may occur simply due to a bad bulb. Exterior lights may be on a sensor and won't turn on unless it's dusk. Recommend having the seller check and install a new bulb for any light which does not work. If this does not correct the condition, an electrician should be consulted. Noted: Basement.

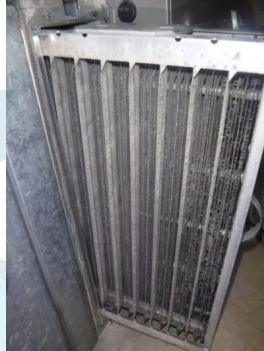
Page 37 Item: 3	Filters:	<ul style="list-style-type: none"> The furnace air filter is dirty: Recommend cleaning/changing filter as part of normal maintenance. Be aware that where filters have remained dirty over extended lengths of time, excess wear on the furnace may have occurred, which in turn may cause premature failure of some components such as blowers and fans. It is outside the scope of inspection to predict when or if such failures may occur.
-----------------	----------	---

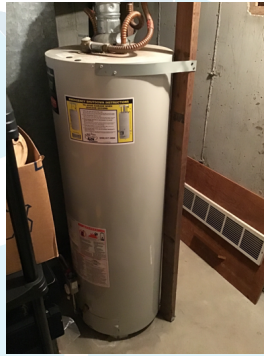
- The existing earthquake strapping for the water heater is marginal: Current safety standards require two rated straps to secure the appliance. Recommend upgrading this for safety.

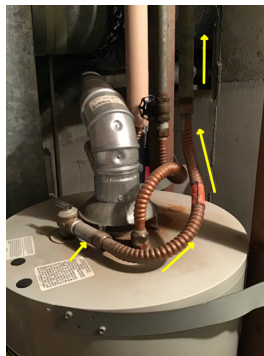
Page 41 Item: 5

- The temperature pressure relief (TPR) line is improperly sloped. For safety, the manufacturer's installation requirements of the TPR line from the water heater are very specific: The inside diameter of the line should never be downsized; The line should always be sloped downhill; The line should terminate at an elbow pointing downward close to the ground; There should not be more than four elbows in the line. Any conditions noted should be corrected for safety.

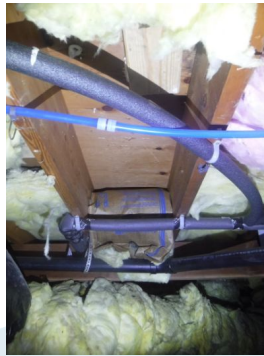
Page 44 Item: 3	Structure Insulation :	<ul style="list-style-type: none"> Some sub structure insulation is damaged: Recommend repair.
-----------------	------------------------	---

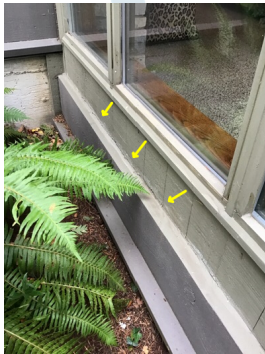
Page 50 Item: 1	Exterior Siding	<ul style="list-style-type: none"> Damage/decay present on the lower siding. Be aware hidden conditions may exist. This was seen in the following area(s):Rear.
-----------------	-----------------	--

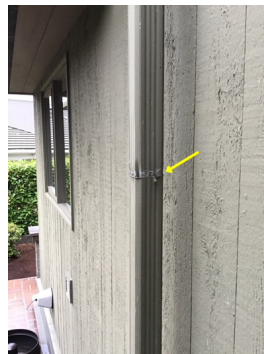
Page 51 Item: 1	Downspouts	<ul style="list-style-type: none"> A downspout is becoming disconnected from itself. Downspouts should be properly reconnected and secured. This was noted in the following area(s):Front.
-----------------	------------	---

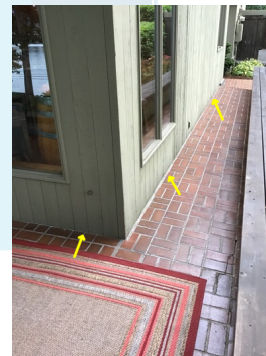
Page 51 Item: 2	Foliage	<ul style="list-style-type: none"> Foliage should be maintained so it is at least 10 to 12 inches away from house as it may cause mechanical damage to the siding and promote high moisture conditions and/or infestation. Where foliage is dense and access limited, hidden conditions may exist which should be reported to the inspecting firm if discovered. Where there is decorative, established foliage against the structure such as climbing vines, cutting the foliage back may be detrimental to the aesthetic appearance of the home. If the foliage is left in place, be aware that infestation and high moisture conditions may occur. Regular and periodic inspections are suggested.
Page 51 Item: 3	Hard Surface Contact	<ul style="list-style-type: none"> The exterior siding is in contact with a concrete, masonry or asphalt surface. This may allow decay to occur to the siding as well as to the wood members behind it. Even if the area in question is covered by a roof structure, placing potted plants nearby and watering them may cause decay to occur. A contractor may be able to suggest some measures, such as caulking, to prevent water penetration. Be aware that on used structures, particularly older ones, hidden damages may exist and are outside the scope of inspection. This condition was noted in the following area(s): Rear and left side.

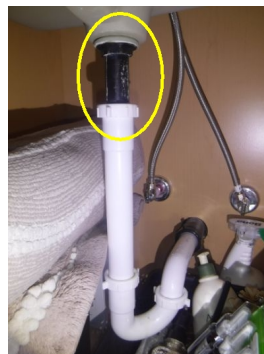
Page 52 Item: 1	Bath Sink	<ul style="list-style-type: none"> The bath sink drain line is leaking. A licensed tradesperson should be called to make repairs. This was noted in the following area(s): Master bath.
-----------------	-----------	--

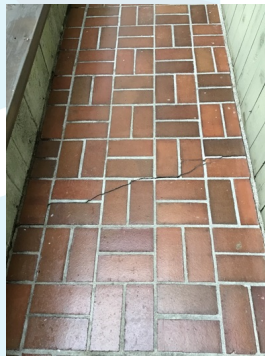
- Spalling or deterioration of walkway is present: Repair/replacement may be necessary. Follow up with a licensed concrete contractor is advised. These conditions were noted in the following areas: Left side.

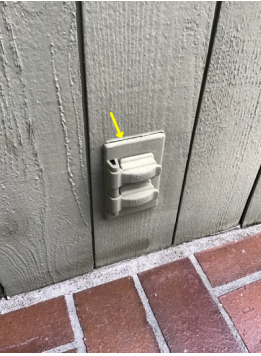
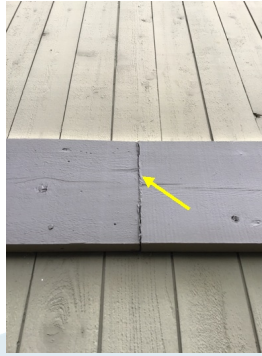
- Caulking around exposed penetrations (doors, windows, nail heads, etc.) is a normal and extremely important maintenance task which needs to be performed on a regular basis. It is also extremely important to maintain caulking along the top edge of horizontal trim boards or belly boards. Failure to maintain caulking may result in rapid deterioration of composite wood sidings; always use a high quality paintable caulk such as OSI Quad. Be aware that on used structures, particularly older structures where caulking has been allowed to fail hidden conditions may exist. Noted: Primary Structure.

- Z-type metal flashing is missing: Where siding materials such as wood panels or trim meet at a horizontal joint, Z-type metal flashing is used to prevent water penetration. Retrofit flashing installation is generally not reasonable to do, so it will be important to maintain caulking as a defense against water penetration on older structures. Be aware hidden conditions may exist. Noted: All sides.

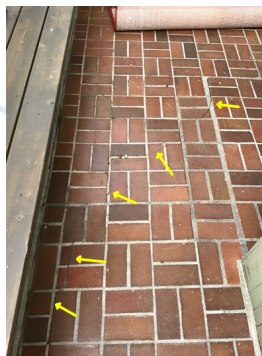
- Erosion or settling of concrete surface is present. If this is a concern, following up with a licensed contractor specializing in patio installation and repair is advised. This condition was noted on the following patio slab(s): Front.

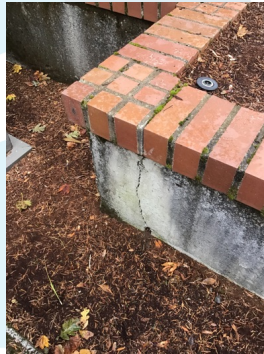
- Retaining wall(s) damaged and/or displaced: A licensed contractor experienced with retaining walls should be called to make further evaluation and recommendations for repair. This condition was noted on the following retaining wall(s): Front.

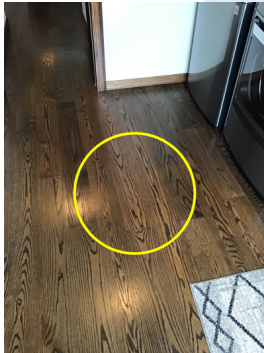
- Some floor squeaking is noted: This is a common occurrence often due to nails in the sub floor having missed the floor joist and are rubbing against it. A hardware supply or contractor can suggest remedies if this is of concern to you. Noted: Utility room.
- The carpet is loose and needs restretched. This was noted in the Living room.

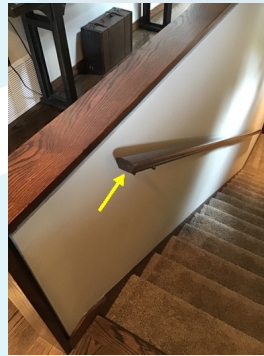
- Stair hand rail ends are exposed: This is a common finding in older homes which predates the requirements to have the rail ends return to the wall. Be aware rail ends can snag clothes and cause falls.

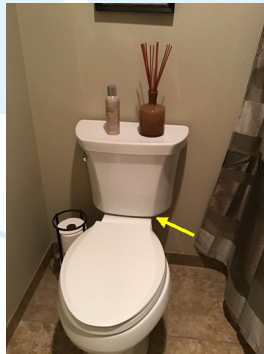
- The toilet tank(s) are loose: The tank(s) should be tightened as needed, as part of normal maintenance and to also prevent possible leaking. Noted: Second floor hall bath at top of stairs.

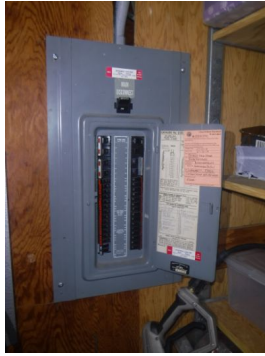
- The electrical panel(s) are a Federal Pacific Electric (FPE) brand: FPE panels have had conditions documented that include breaker failure and are considered by some to be a possible latent fire hazard. Considerable information is available on the internet by visiting https://inspectapedia.com/fpe/FPE_Stab_Lok_Hazards.php . It is recommended a licensed electrician evaluate the panel for safety and possible replacement. Noted: Garage.
- The electrical panel(s) have a mechanism in place to manage a generator. It is important for the buyer to understand how the system works. Therefore, having either the seller explain the proper operation or a licensed electrician explain the system will aide in the proper usage of the mechanism. Noted: Garage.
- The newer generator panel(s) lack a permit sticker. Recommend further review to see if a permit was pulled. Noted: Garage.

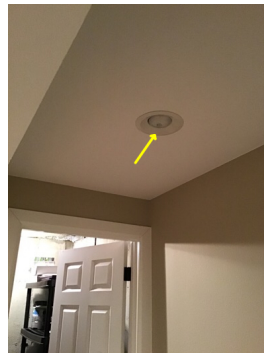
- Light(s) are not operational in some areas: This may occur simply due to a bad bulb. Exterior lights may be on a sensor and won't turn on unless it's dusk. Recommend having the seller check and install a new bulb for any light which does not work. If this does not correct the condition, an electrician should be consulted. Noted: Basement.

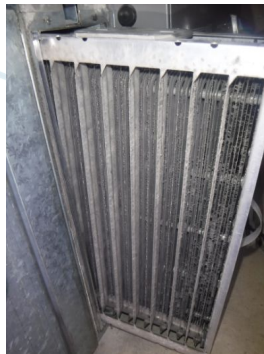
- The furnace air filter is dirty: Recommend cleaning/changing filter as part of normal maintenance. Be aware that where filters have remained dirty over extended lengths of time, excess wear on the furnace may have occurred, which in turn may cause premature failure of some components such as blowers and fans. It is outside the scope of inspection to predict when or if such failures may occur.

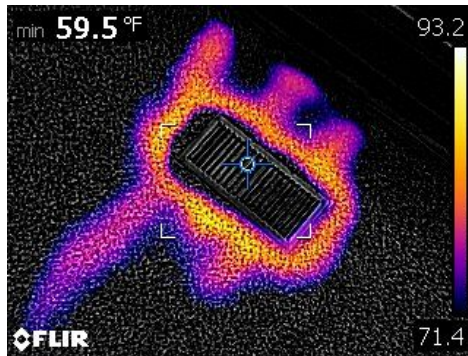
- At the time of inspection, when testing the unit in the cooling mode, the temperature was noted around: 60 F.

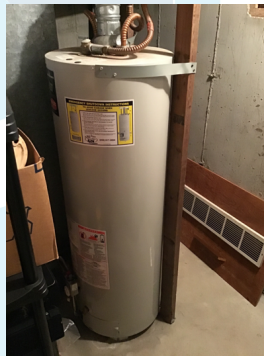
- The existing earthquake strapping for the water heater is marginal: Current safety standards require two rated straps to secure the appliance. Recommend upgrading this for safety.

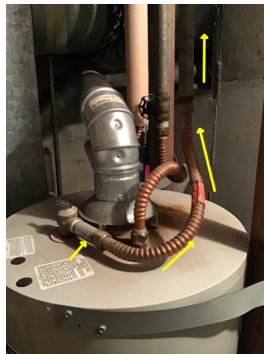
5. Water heater TPR :

- The temperature pressure relief (TPR) line is improperly sloped. For safety, the manufacturer's installation requirements of the TPR line from the water heater are very specific: The inside diameter of the line should never be downsized; The line should always be sloped downhill; The line should terminate at an elbow pointing downward close to the ground; There should not be more than four elbows in the line. Any conditions noted should be corrected for safety.

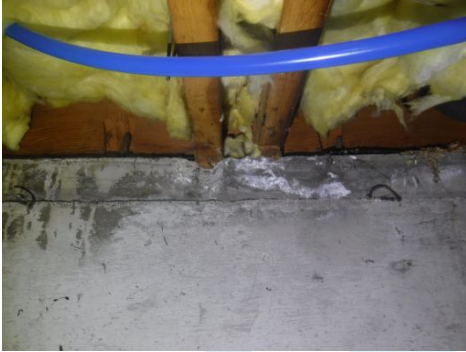
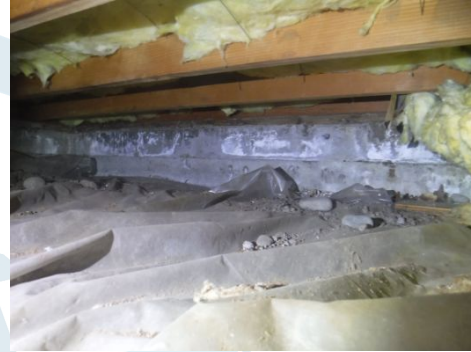
- There is efflorescence in the crawlspace: Efflorescence is a white powdery residue left behind when moisture migrates through concrete, brick, or mortar and evaporates leaving mineral deposits behind. Typically, this is seen on concrete stem walls where there may be inadequate management of exterior drainage or roof runoff. There is no specific mitigation other than correcting issues related to drainage, roof runoff or other water related issues contained in this report. Regular pest inspections are advised. Noted: Right side and rear.

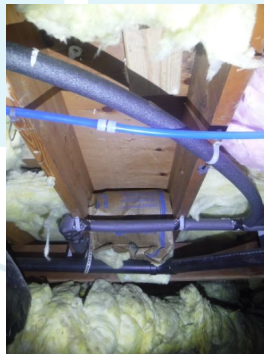
3. Structure Insulation :

- Some sub structure insulation is damaged: Recommend repair.

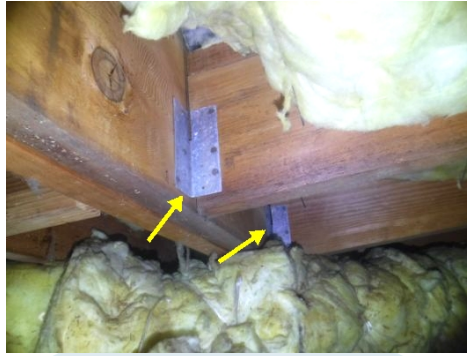
- The following conditions should be further evaluated by a licensed contractor: The joist hangers appear too small for the joist they're supporting. Load bearing may be an issue. These conditions were noted in the following area(s): Under the Living room.

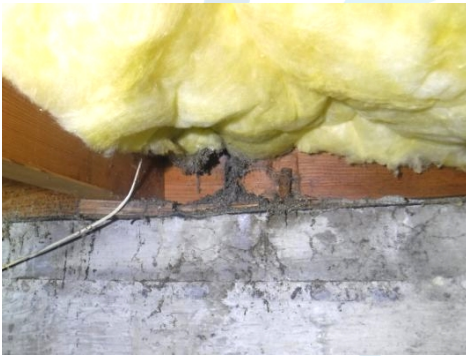
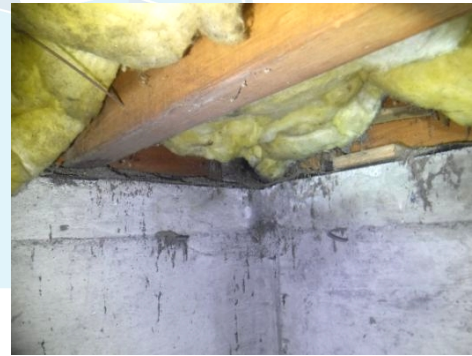
- A moisture ant gallery or tube formation is observed. No live insects are seen, no damage is perceived and the immediate area does not appear wet or damp. It is likely that the previous condition which facilitated the infestation is no longer present, the condition has been corrected and/or professional treatment was performed. The seller should be contacted to determine if any other history is available, particularly with regard to professional treatment. Regular and periodic pest inspections are always advised. There are no treatment recommendations. This observation was made in the following area(s): See WDO Diagram. Note: A Washington State licensed applicator should be called to provide chemical treatment for Moisture Ants for the comfort of workers who will need to perform repairs. A licensed tradesperson should be called to identify and remediate the source of the moisture. In addition, hidden or concealed spaces in and around the vicinity of the colony should be exposed sufficiently enough to reasonably identify and repair any hidden damages.

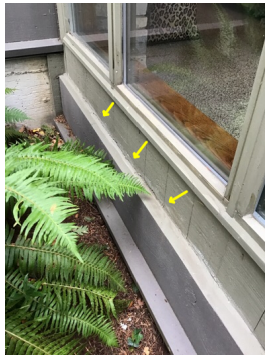
- Damage/decay present on the lower siding. Be aware hidden conditions may exist. This was seen in the following area(s):Rear.

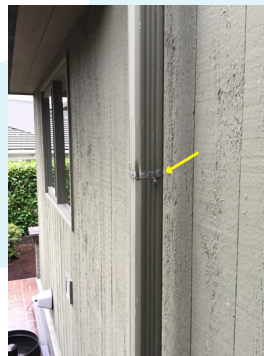
1. Downspouts

- A downspout is becoming disconnected from itself. Downspouts should be properly reconnected and secured. This was noted in the following area(s): Front.

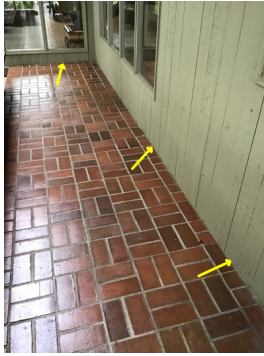
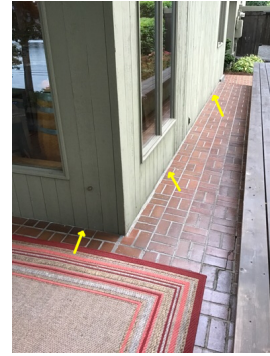
- The exterior siding is in contact with a concrete, masonry or asphalt surface. This may allow decay to occur to the siding as well as to the wood members behind it. Even if the area in question is covered by a roof structure, placing potted plants nearby and watering them may cause decay to occur. A contractor may be able to suggest some measures, such as caulking, to prevent water penetration. Be aware that on used structures, particularly older ones, hidden damages may exist and are outside the scope of inspection. This condition was noted in the following area(s): Rear and left side.

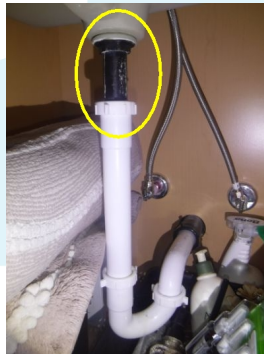
1. Bath Sink

- The bath sink drain line is leaking. A licensed tradesperson should be called to make repairs. This was noted in the following area(s): Master bath.

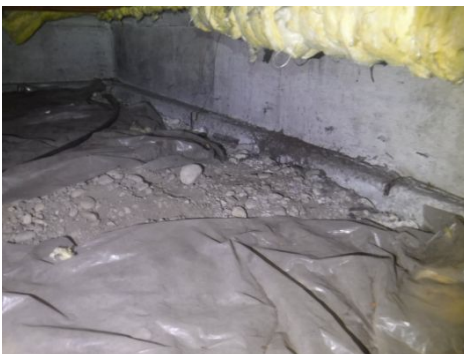
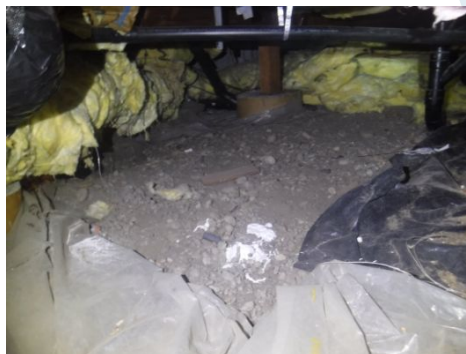
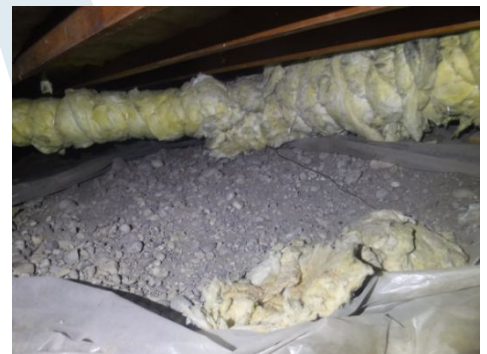
1. Vapor Barrier

- The crawl space has inadequate and/or damaged vapor barrier coverage. Spread existing crawl space vapor barrier as able and install additional 6 mm black plastic vapor barriers as needed to meet current building requirements with provision for appropriate overlap at seams, (12 inches). This was noted in the following area(s): Scattered.

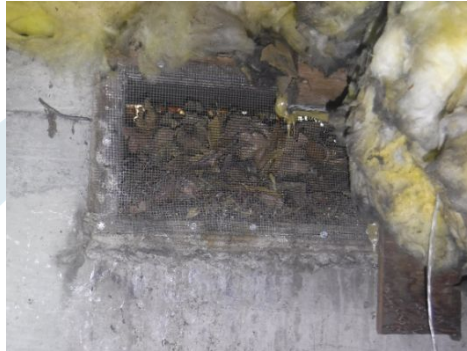
2. Ventilation

- Foundation vents are blocked. Unblock any and all foundation vents which have been either purposefully blocked and/or are blocked by landscaping material or dirt. Repair any damaged screen with 1/4 inch, non-louvered, galvanized hardware cloth. If vent is below grade, a foundation vent well should be installed to keep dirt and landscaping material clear of the vent. This was noted in the following area(s) : Front.
