PROPERTY CONDITION REPORT COPY

123 Main St Olympia WA 98513

> Joe Smith JANUARY 26, 2021

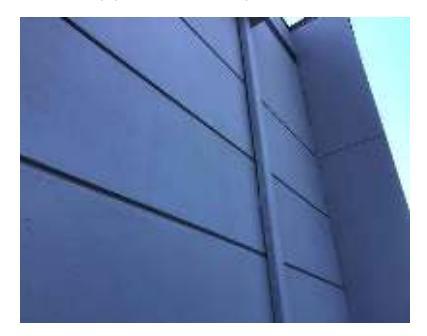
Exterior Cladding & Siding: EIFS Installed

Exterior cladding included an exterior insulation finish system (EIFS). EIFS has historically been prone to failure, especially in damp climates and where manufacturer installation guidelines were not stringently followed. If maintained and installed properly with the proper architectural and flashing details, risk for cladding failures can be reduced. If however, proper architectural details or flashings are absent, installed incorrectly, or features (such as joints, flashings, etc.) are sealed incorrectly, or if there are cracks or gaps in the cladding or at wall penetrations like windows or trim, etc. conditions conducive to moisture intrusion and trapped moisture inside the wall cavities may be created. Prolonged moisture intrusion often results in structural damage and decay to wooden wall structures behind the EIFS requiring extensive and expensive repairs. Moisture intrusion and related damage are often difficult to visually detect even after significant damage has occurred. To determine the full condition of this type of cladding system requires moisture probing, intrusive testing of wall cavities, and additional specialty inspection procedures. These specialty inspection procedures are beyond the scope of the visual inspection process that was performed. The client should understand that inspector performed a visual inspection only, and is not an EIFS specialist. No destructive testing or probing was performed, and the inspector cannot determine the condition of materials inside or behind the EIFS finish. It is common practice for EIFS to be evaluated by a certified EIFS specialist, even when no obvious signs of deterioration or substandard installation are found. The inspector recommends that a certified specialist evaluate further to determine if repairs are needed. Any damage noted or areas noted in need of maintenance should be attended to promptly. Any repairs needed should be made by a gualified and competent contractor who specializes in EIFS application. Inspections and maintenance of this cladding material should occur routinely in the future.

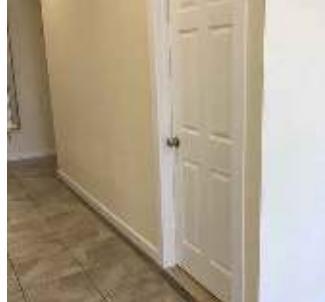
Unit 103: E Room Behind Register

The room was occupied/in-use and was unable to be inspected.

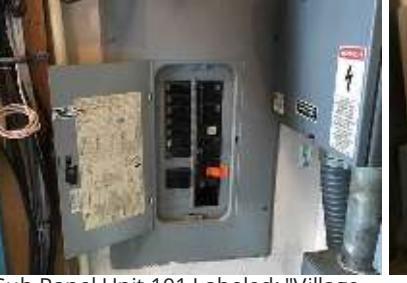
Sub Panel Unit 101 Labeled: "Village Manor Storage Room"

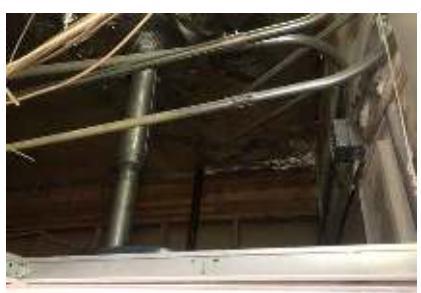
Unit 101 - N Attic Above Client Restroom

Drop down ceiling materials and utility lines/conduits blocked access to the water heater. The Inspector was unable to fully evaluate the water heater.
