# *Bogg's Inspection Services*

## Property Inspection Report

Browns Point Blvd NE  
Inspection prepared for: Sample  
Date of Inspection: 11/14/2018 Time: 2:00 PM  
Age of Home: 1984 Size: 1566  
Order ID: 9399

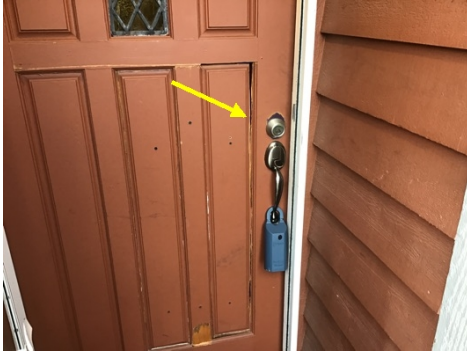
Page 22 Item: 6	Entry Doors	<ul style="list-style-type: none"><li>• Exterior door damaged or deteriorated: Repair or replacement suggested. These conditions were noted in the following areas: Front entry door.</li><li>• Screen/storm door damaged. This condition was noted on the following door: Rear screen slider.</li></ul>
-----------------	-------------	--

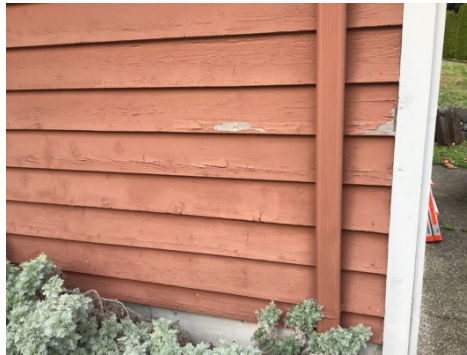
Page 22 Item: 7	Paint defects	<ul style="list-style-type: none"><li>• The exterior paint or finish is weathered or deteriorated. Painting is a normal and ongoing maintenance issue and as would be expected, weather sides of the house are the first to show signs of failure. The frequency of repainting depends largely upon the quality of the preparation, the quality of the paint and the quality of the application. Back rolling and back brushing is always preferred to simply spraying on the product. In general, flat paints do not seem to hold up as well as semigloss types. A paint supplier or painting contractor can explain more. It is especially important to maintain good paint coverage on composite wood products to prevent failure, which can happen very quickly without proper paint coverage. At this time, the weathering and deterioration might best be described as: Moderate</li></ul>
-----------------	---------------	--

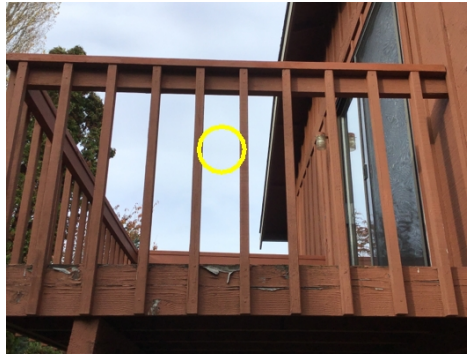
Page 24 Item: 2	Guards :	<ul style="list-style-type: none"> <li>Conditions related to the deck guard rail balusters are seen: Some or all balusters are &gt;4 inches apart. Be aware that more widely gapped stair or handrail spindles may represent some risk to small children who could become stuck or fall through, caution is advised. On taller decks where the risk of injury is greater, correction or modification is advised. These conditions were noted in the following areas: Rear</li> </ul>
-----------------	----------	--

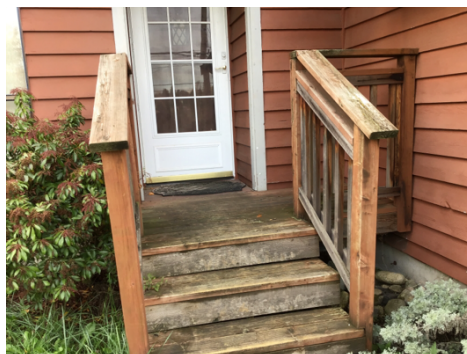
Page 24 Item: 3	Stairs :	<ul style="list-style-type: none"> <li>Conditions related to the deck stair handrail are seen: No gripable deck stair handrail is present. Recommend installing for safety. Noted: Front</li> </ul>
-----------------	----------	---

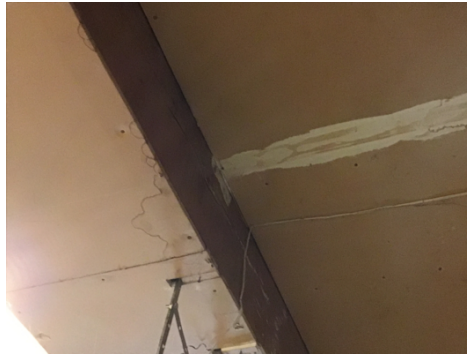
- There are old and dry appearing moisture stains present. Recommend follow up with owner to determine history and if further evaluation by a contractor or roofer is needed. Be aware hidden conditions may exist. Stains were noted in the following area: On the ceiling

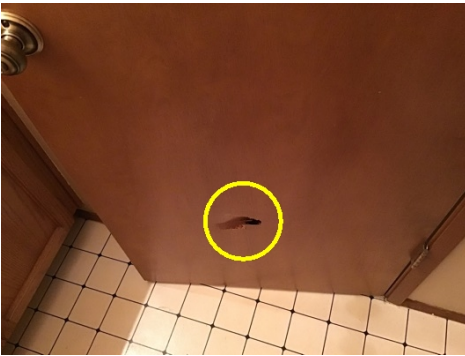
Page 31 Item: 6	Interior Doors	<ul style="list-style-type: none"> <li>Interior door damage viewed: Maintenance repair/replacement is indicated. Damage was seen on the following door(s): Bath off Family room, Front right bedroom</li> <li>Some minor rubbing and/or binding of interior door(s) noted: No recommendations.</li> </ul>
-----------------	----------------	---

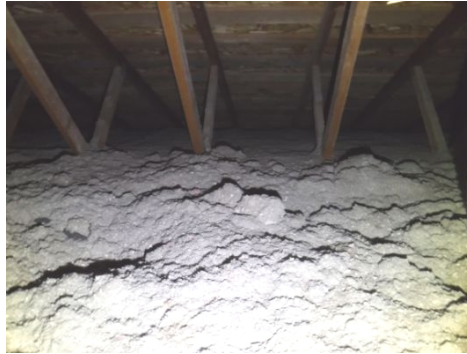
- Attic not insulated to current standards: Recommend improving for energy savings.

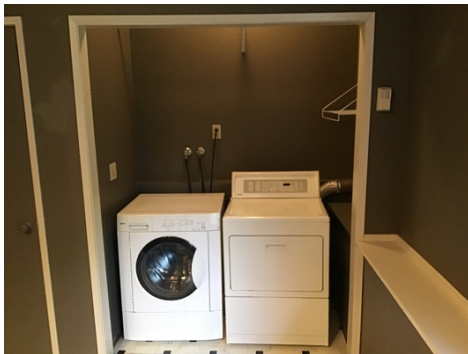
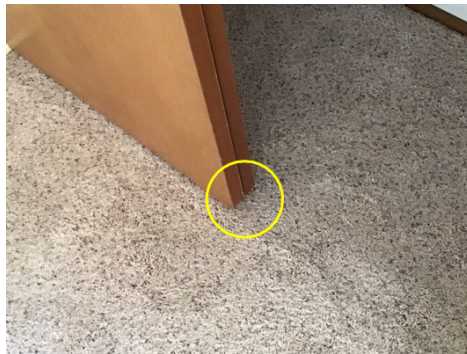
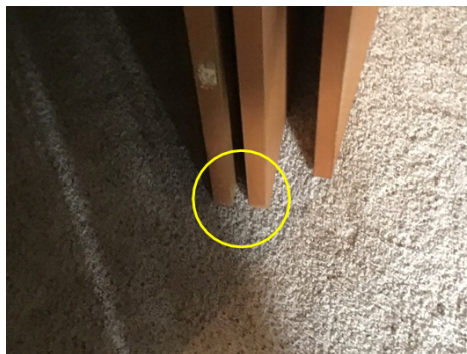
- The closets are missing floor guides. Recommend installation for added safety. Noted: Front left bedroom
- Missing closet doors noted. Recommend replacement. Noted: Utility closet, Front left bedroom.

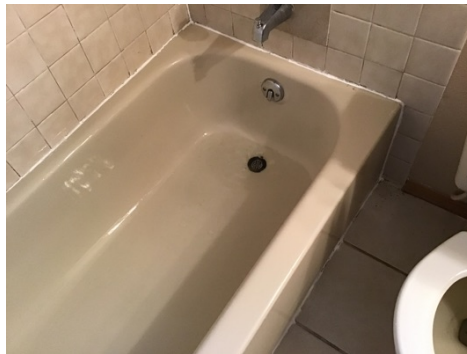
- The tub/shower drains poorly: If usual homeowner remedies are not effective, recommend follow up with plumber. Noted: Second floor hall bath.

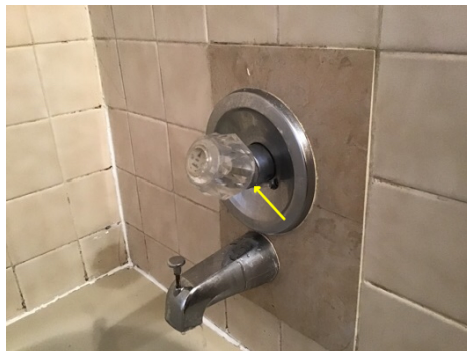
- Tub/Shower faucet control leaks during use: Maintenance repair is indicated. Noted: Second floor hall bath

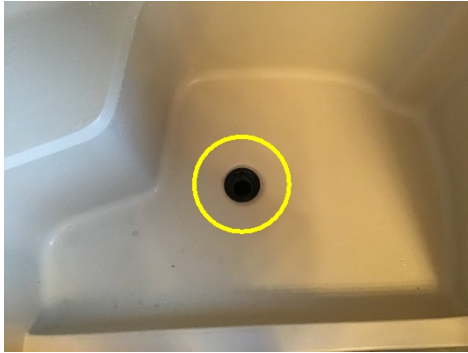
Page 37 Item: 2	Tub/Shower General	<ul style="list-style-type: none"><li>• Damage/Deterioration is seen in the tub/shower: Repair/replacement indicated. If leaking has occurred hidden conditions may exist. Noted: Master bath.</li></ul>

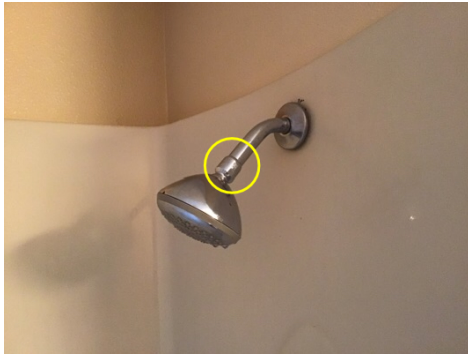
Page 37 Item: 3	Tub/Shower Fixtures	<ul style="list-style-type: none"><li>• Showerhead leaks during use: Maintenance repair is indicated. Noted: Master bath</li></ul>

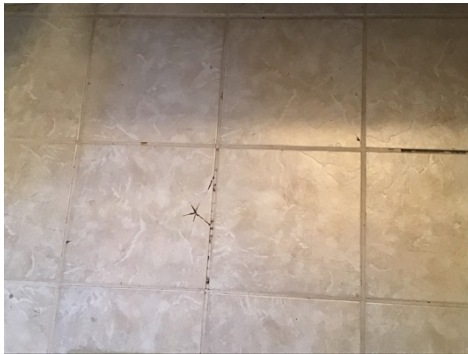
Page 37 Item: 4	Bathroom Flooring	<ul style="list-style-type: none"><li>• Conditions related to the tile or slate/stone/masonry bath floor exist: Damage is seen. Recommend evaluation by a licensed flooring contractor. Noted: Master bath</li></ul>

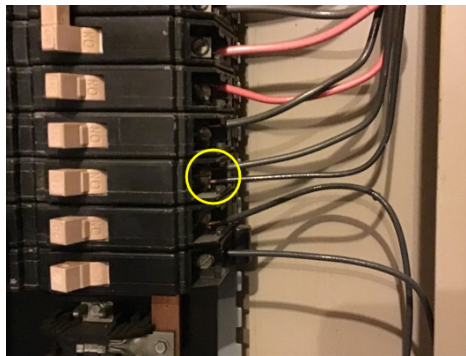
- Multiple lugging present in the electric panel: This refers to the improper practice of connecting two or more wires to a breaker which is only rated for one wire. While perhaps somewhat of a lesser concern, this also may apply to two or more neutral wires or neutral and ground wires connected under one terminal on the neutral bus. This may allow connections to work loose and overheat. Further evaluation is recommended at least to ensure connections are secure if not in need of correction. Noted: Garage.

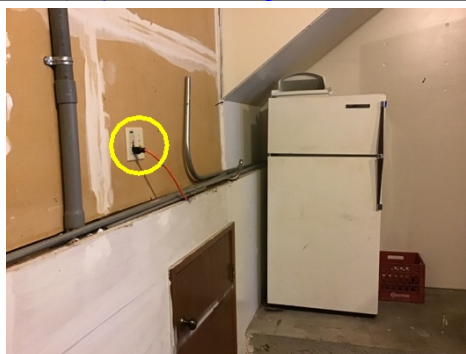
- The refrigerator is on a GFCI outlet. Recommend installing the refrigerator to a none GFCI outlet to prevent accidental power loss. Noted: Garage
- GFCI outlet protection is incomplete or absent: Ground Fault Circuit Interrupter (GFCI) outlets are currently required for the following areas: Exterior, Garage, Bathrooms, Kitchen, Spas, Hydromassage tubs, Pools, Fountains, Crawl Spaces, and Unfinished Basements. They should be considered as a safety upgrade for homes which predate the current requirement. The presence of complete GFCI outlet protection could not be confirmed in the following area(s). Noted: Kitchen
- Loose electric outlets are seen: Loose outlets should be properly secured to prevent damage. Noted: Front left bedroom

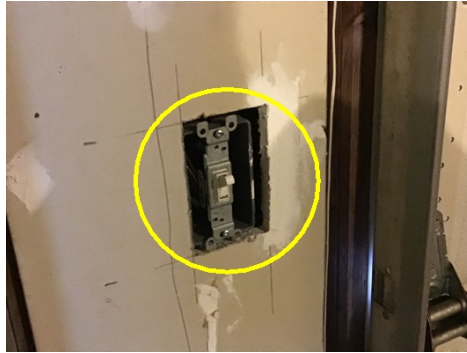
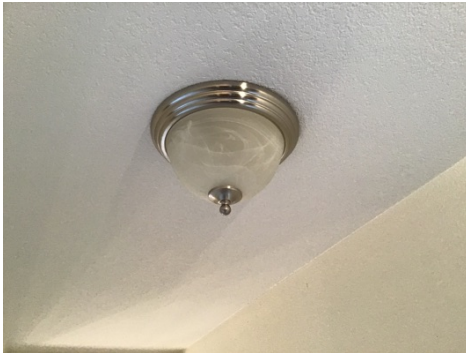
Page 40 Item: 5	Lights	<ul style="list-style-type: none"> <li>Lights are missing a cover or globe: Replacement indicated. Noted: Exterior front, Second floor hallway.</li> <li>Some missing or damaged switch cover plates noted: Recommend correction. Noted: Garage</li> <li>Lights are not operational in some areas: This may occur simply due to a bad bulb. Recommend having the seller check and install a new bulb for any light which does not work. If this does not correct the condition, an electrician should be consulted. Noted: Family room bath, Second floor hallway, Kitchen</li> </ul>
-----------------	--------	---

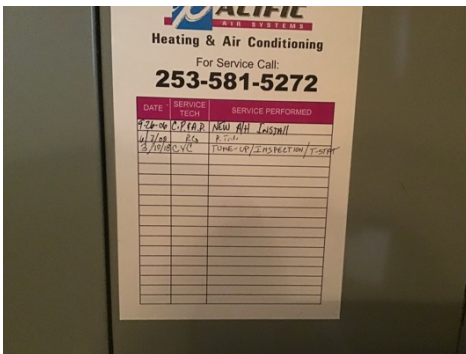
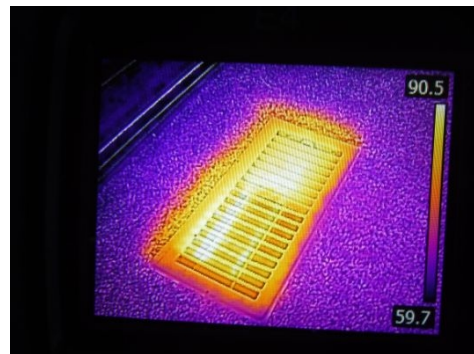
Page 41 Item: 2	General Condition	<ul style="list-style-type: none"> <li>The service record on the appliance indicates it was serviced within the last year. Should any issues occur after taking possession, contact the servicing company as warranty service may be available. Date of service was: 03/17/2018</li> <li>At the time of inspection when testing the heating unit the temperature was noted at 90.5 deg F</li> </ul>
-----------------	-------------------	---

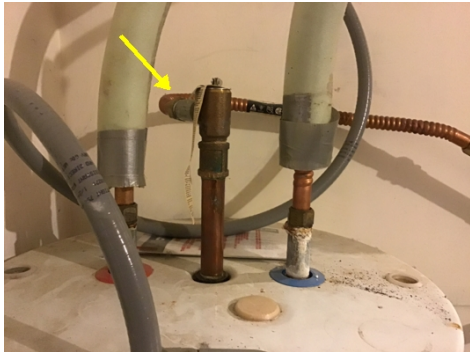
Page 43 Item: 4	Water heater TPR :	<ul style="list-style-type: none"> <li>Conditions related to the water heater TPR line exist: For safety, the manufacturer's installation requirements of the temperature and pressure relief line from the water heater are very specific: The inside diameter of the line should never be downsized; The line should always be sloped downhill; the line should terminate at an elbow pointing downward close to the ground; there should not be more than four elbows in the line. Any conditions noted should be corrected for safety. The following conditions were seen: The pressure relief line is improperly sloped. Water heater location: Garage.</li> </ul>

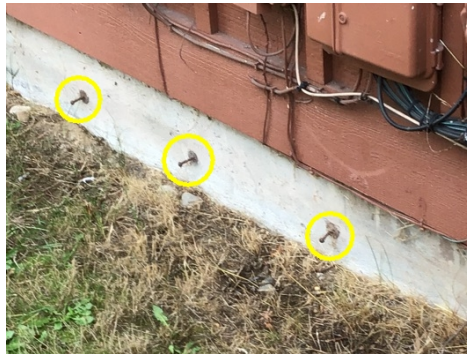
Page 45 Item: 2	Foundation	<ul style="list-style-type: none"><li>• Other foundation conditions exist: Exposed snap ties recommend removal for safety. Noted: Right side.</li></ul>
-----------------	------------	---

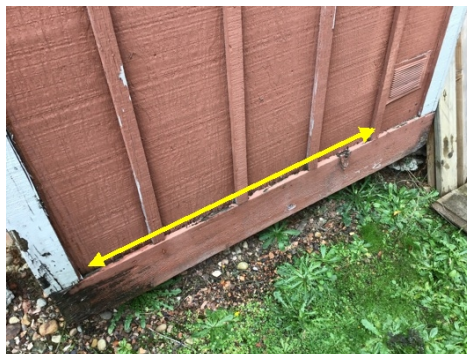
Page 50 Item: 1	Exterior Siding	<ul style="list-style-type: none"><li>• There is damage noted to lower siding. Be aware hidden conditions may exist. This was seen in the following area: Left side</li></ul>
-----------------	-----------------	---

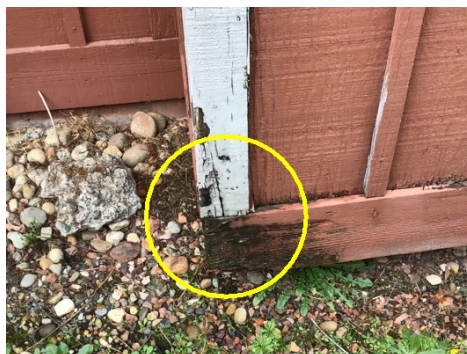
Page 51 Item: 2	Trim	<ul style="list-style-type: none"><li>• There is decay seen in the trim. This was noted in the following area: Left side</li></ul>
-----------------	------	--

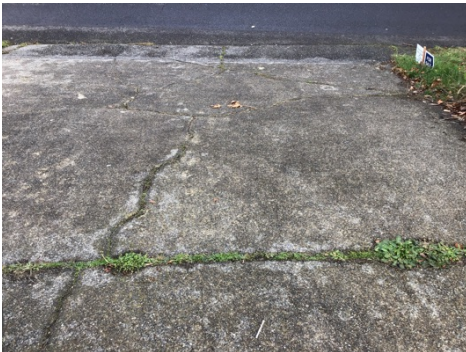
- Erosion and/or settling of driveway is present: Follow up with a licensed contractor specializing in driveway installation and repair is advised. Depending on severity further evaluation by an engineer may be needed at contractor's discretion.

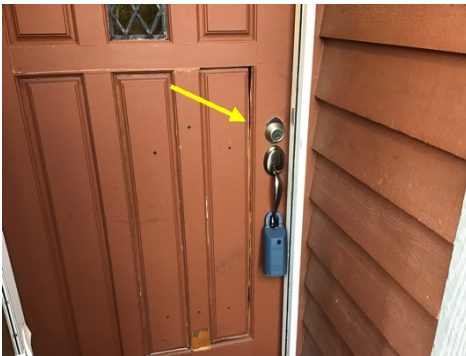
- Exterior door damaged or deteriorated: Repair or replacement suggested. These conditions were noted in the following areas: Front entry door.
- Screen/storm door damaged. This condition was noted on the following door: Rear screen slider.

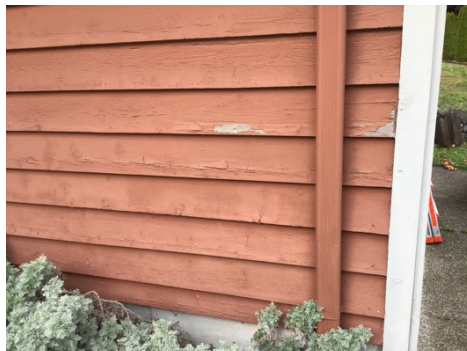
- The exterior paint or finish is weathered or deteriorated. Painting is a normal and ongoing maintenance issue and as would be expected, weather sides of the house are the first to show signs of failure. The frequency of repainting depends largely upon the quality of the preparation, the quality of the paint and the quality of the application. Back rolling and back brushing is always preferred to simply spraying on the product. In general, flat paints do not seem to hold up as well as semigloss types. A paint supplier or painting contractor can explain more. It is especially important to maintain good paint coverage on composite wood products to prevent failure, which can happen very quickly without proper paint coverage. At this time, the weathering and deterioration might best be described as: Moderate

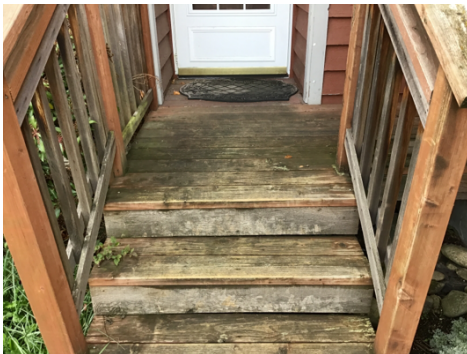
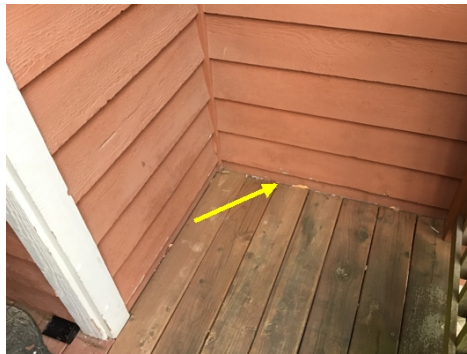
- The wood deck lacks a flashing detail where it attaches to the structure. A flashing detail should be installed to protect the deck ledger board and siding behind it from moisture. Be aware that on older structures hidden conditions may exist. Noted: Front, Rear.

- Exposed lifting nails seen. Recommend repair for added safety. Noted: Rear.

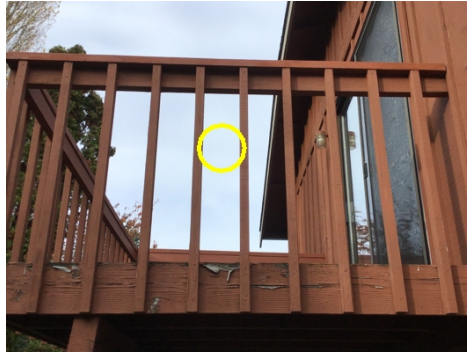
- Conditions related to the deck guard rail balusters are seen: Some or all balusters are >4 inches apart. Be aware that more widely gapped stair or handrail spindles may represent some risk to small children who could become stuck or fall through, caution is advised. On taller decks where the risk of injury is greater, correction or modification is advised. These conditions were noted in the following areas: Rear

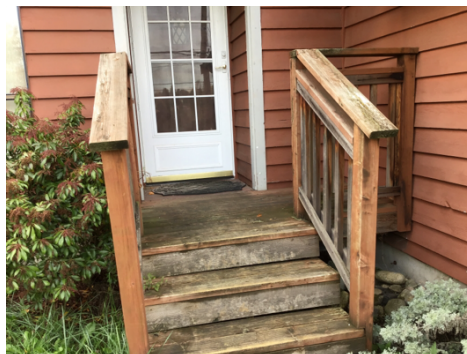
- Conditions related to the deck stair handrail are seen: No gripable deck stair handrail is present. Recommend installing for safety. Noted: Front

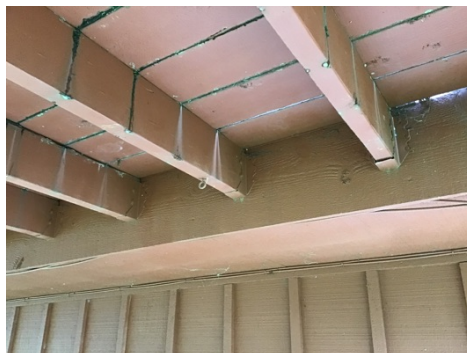
- The deck is not attached via a ledger board: The ledger board is critical to deck installation as it offers resistance against downward and lateral forces when installed properly with lag screws. Further, exterior sidings are not rated to have deck joists or hangers directly attached to them. Recommend evaluation by a licensed contractor. These conditions were noted in the following areas: Rear

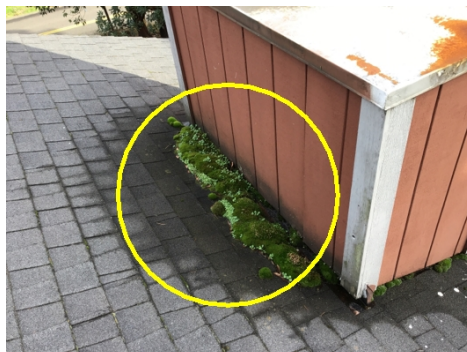
- The chimney cricket is missing. A cricket is designed when the chimney width is greater than 30 inches to allow water to divert away from the chimney. Further review is recommended. Noted: Primary structure.

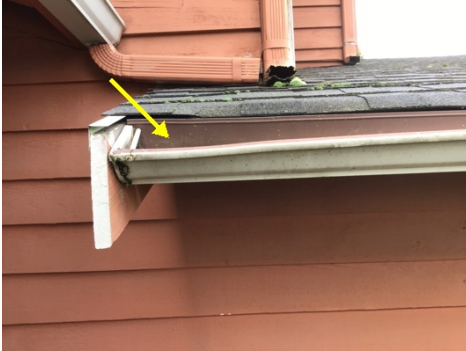
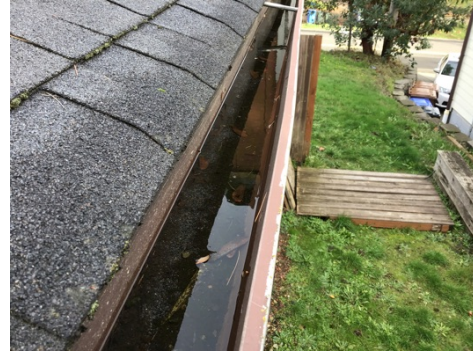
- Gutters sagging or pulling away from house. Recommend repair. Noted: Front
- Gutter is sloped improperly and holding water. Recommend correction. Noted: Left side

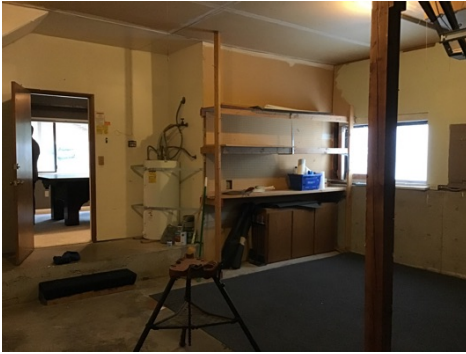
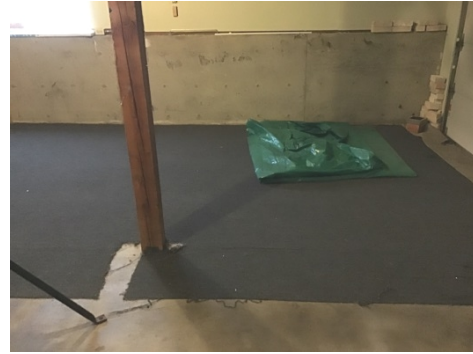
- Stored personal items present: Access and visibility limited. Determining the condition of the concrete slab beneath stored items is outside the scope of inspection.
- Finished floor coverings are installed over the concrete: Determining the condition of the concrete slab beneath floor coverings is outside the scope of inspection.

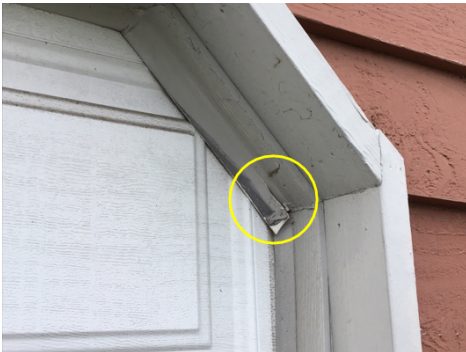
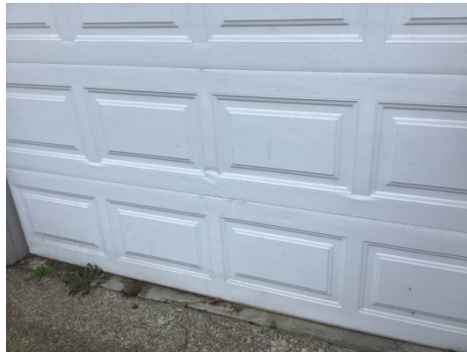
- Weather strip on the vehicle door(s) is damaged or missing: This should be repaired as part of normal maintenance. This observation was made on the following door(s): Right door
- The vehicle doors have minor cosmetic damage: This observation was made on the following door(s): Both doors.
- Vehicle door spring damaged: Recommend follow up with door installer for service and repair. This observation was made on the following door(s): Left door
- Automatic vehicle door opener(s) not operational: Repair/replacement indicated. Noted: Right door

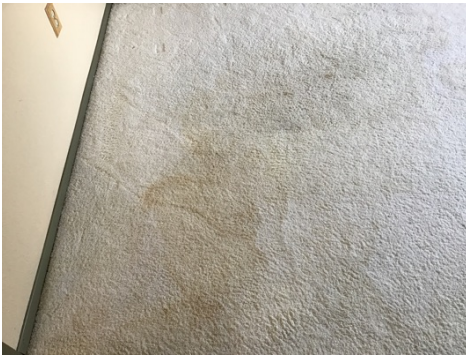
- There is staining of the carpet. A professional carpet cleaner should be called to evaluate. This was noted in the front right bedroom
- Use related floor wear was noted: The existing floor wear may best be described as: "Normal" and minor appearing wear and deterioration.

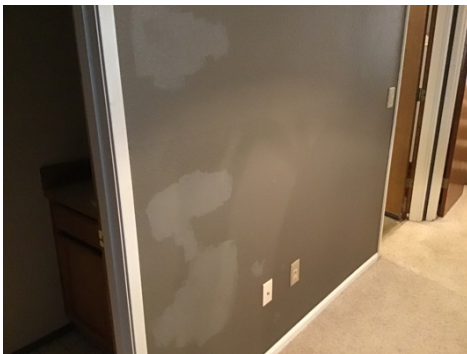
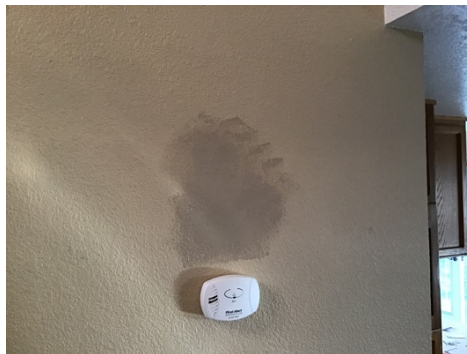
- Interior painted surfaces showing signs of wear: Painting is part of normal maintenance. Paint wear may include thinning, nicks, gouges, cracking, peeling and loss of luster to name a few. At this time, the amount of wear might best be described as: Minor.
- Conditions exist regarding the interior paint: The interior paint coverage appears very thin with noticeable brush/roller marks and nonuniform color.

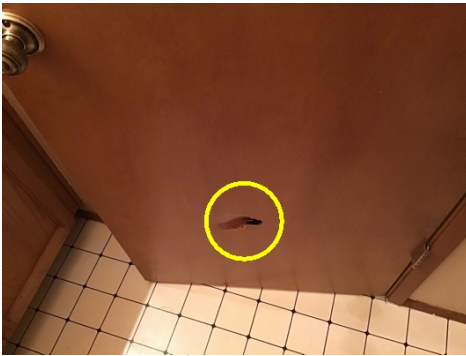
- Interior door damage viewed: Maintenance repair/replacement is indicated. Damage was seen on the following door(s): Bath off Family room, Front right bedroom
- Some minor rubbing and/or binding of interior door(s) noted: No recommendations.

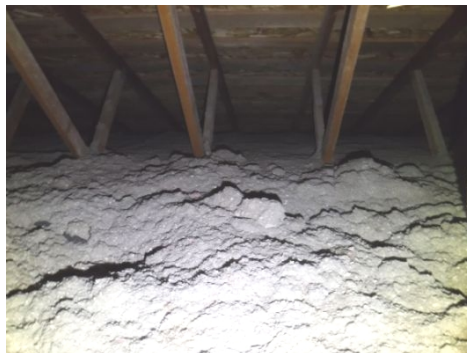
- Attic not insulated to current standards: Recommend improving for energy savings.

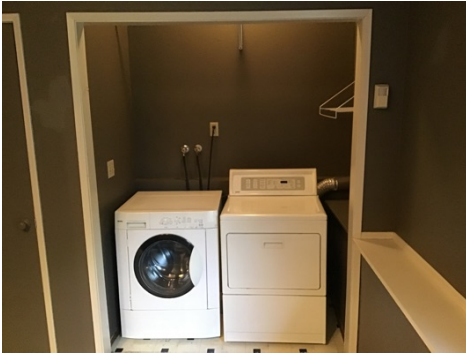
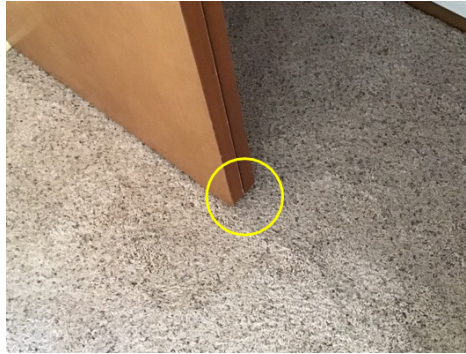
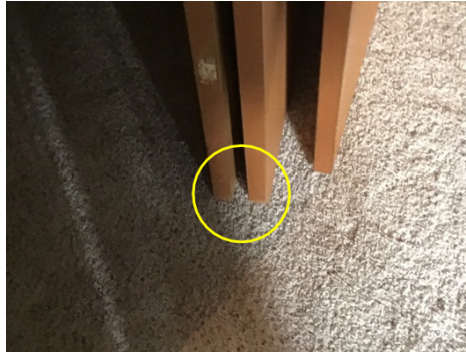
- The closets are missing floor guides. Recommend installation for added safety. Noted: Front left bedroom
- Missing closet doors noted. Recommend replacement. Noted: Utility closet, Front left bedroom.

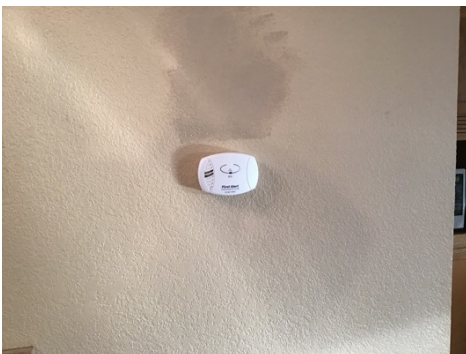
- Where a fuel burning appliance is installed and there is no Carbon Monoxide (CO) detector present, it is strongly recommended you purchase a CO Detector and install it according to manufacturer's recommendations. For safety, your home may require more than one device normally one on each level outside the bedroom area. It is outside the scope of inspection to test CO detectors. Missing family room.

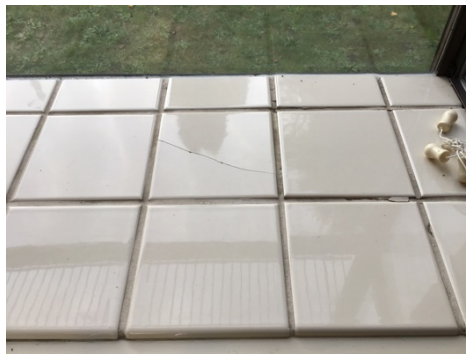
- Typical use related kitchen countertop wear is seen: This may include various cosmetic damages, dings, scrapes, deterioration and worn finish. At this time the typical wear noted might best be described as minor.

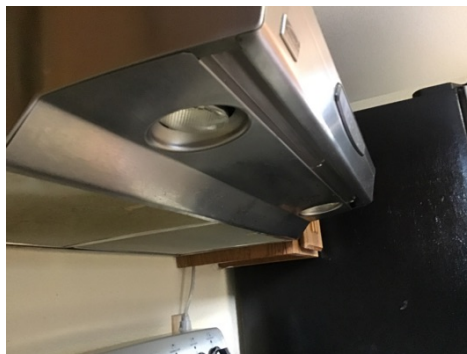
- Kitchen fan recirculates only: This is a common finding on older homes which predate current requirements. Recommend installing a kitchen fan which exhausts to the exterior as a future upgrade if possible or reasonable to do so.
- Kitchen exhaust fan light did not operate: If replacing the bulb does not correct the condition a professional evaluation may be needed.

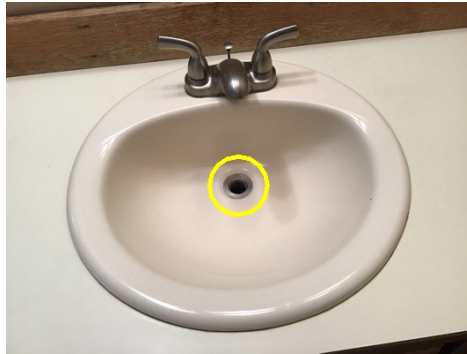
- Sink stopper is missing or did not operate properly: Maintenance repair/replacement is indicated. Noted: Second floor hall bath

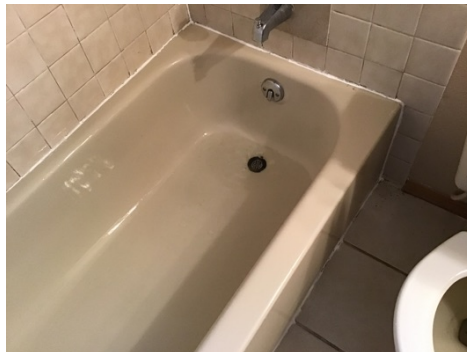
- The tub/shower drains poorly: If usual homeowner remedies are not effective, recommend follow up with plumber. Noted: Second floor hall bath.

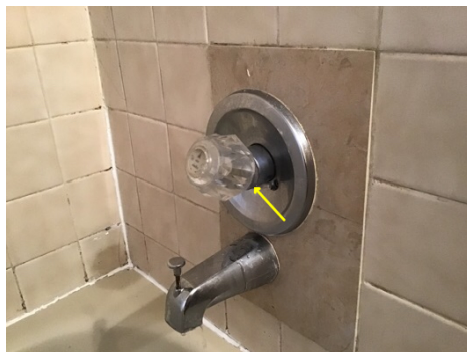
- Tub/Shower faucet control leaks during use: Maintenance repair is indicated. Noted: Second floor hall bath

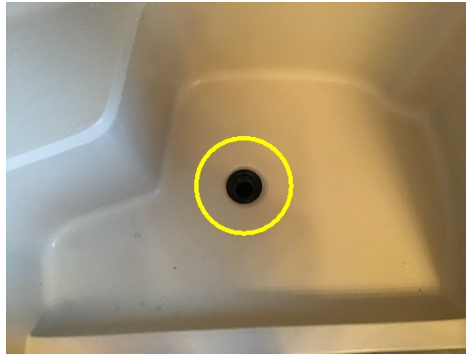
- Damage/Deterioration is seen in the tub/shower: Repair/replacement indicated. If leaking has occurred hidden conditions may exist. Noted: Master bath.

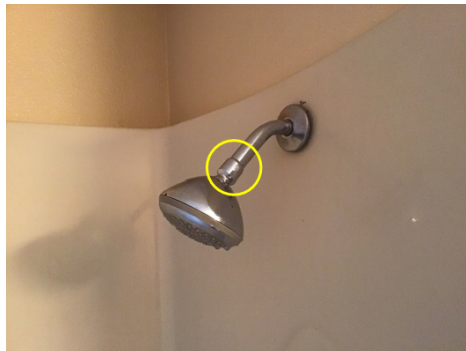
- Showerhead leaks during use: Maintenance repair is indicated. Noted: Master bath

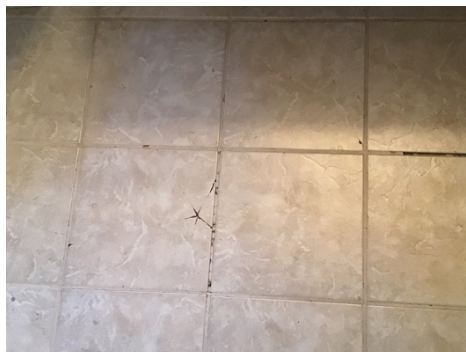
- Conditions related to the tile or slate/stone/masonry bath floor exist: Damage is seen. Recommend evaluation by a licensed flooring contractor. Noted: Master bath

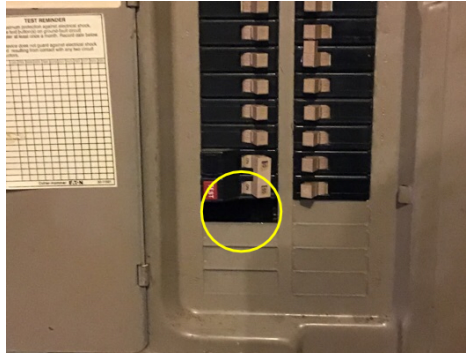
- Unprotected Openings: The electric panel has unprotected openings. For safety, any unused breaker openings or other gaps in the panel should be properly closed. Noted: Garage.

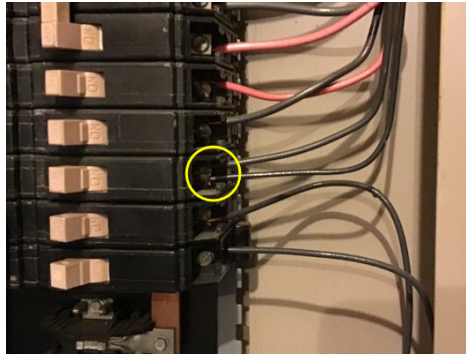
- Multiple lugging present in the electric panel: This refers to the improper practice of connecting two or more wires to a breaker which is only rated for one wire. While perhaps somewhat of a lesser concern, this also may apply to two or more neutral wires or neutral and ground wires connected under one terminal on the neutral bus. This may allow connections to work loose and overheat. Further evaluation is recommended at least to ensure connections are secure if not in need of correction. Noted: Garage.

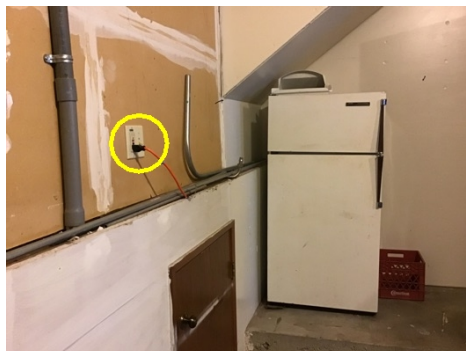
- The refrigerator is on a GFCI outlet. Recommend installing the refrigerator to a none GFCI outlet to prevent accidental power loss. Noted: Garage
- GFCI outlet protection is incomplete or absent: Ground Fault Circuit Interrupter (GFCI) outlets are currently required for the following areas: Exterior, Garage, Bathrooms, Kitchen, Spas, Hydromassage tubs, Pools, Fountains, Crawl Spaces, and Unfinished Basements. They should be considered as a safety upgrade for homes which predate the current requirement. The presence of complete GFCI outlet protection could not be confirmed in the following area(s). Noted: Kitchen
- Loose electric outlets are seen: Loose outlets should be properly secured to prevent damage. Noted: Front left bedroom

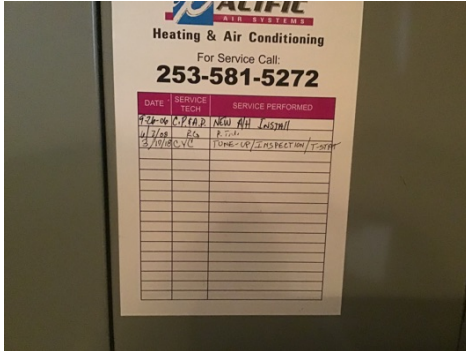
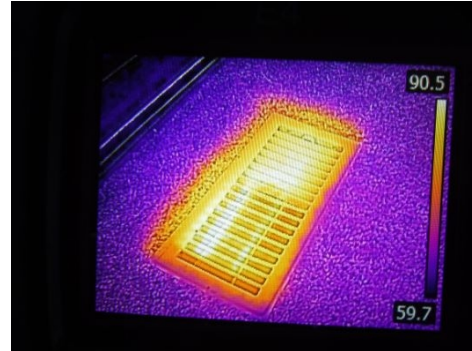
- The service record on the appliance indicates it was serviced within the last year. Should any issues occur after taking possession, contact the servicing company as warranty service may be available. Date of service was: 03/17/2018
- At the time of inspection when testing the heating unit the temperature was noted at 90.5 deg F

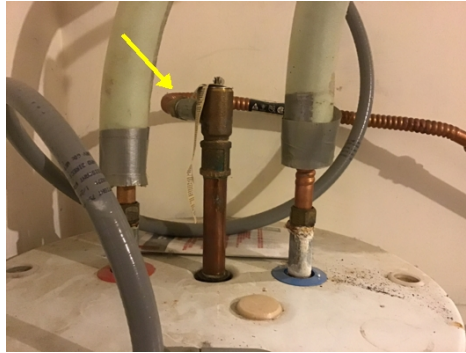
- Conditions related to the water heater TPR line exist: For safety, the manufacturer's installation requirements of the temperature and pressure relief line from the water heater are very specific: The inside diameter of the line should never be downsized; The line should always be sloped downhill; the line should terminate at an elbow pointing downward close to the ground; there should not be more than four elbows in the line. Any conditions noted should be corrected for safety. The following conditions were seen: The pressure relief line is improperly sloped. Water heater location: Garage.

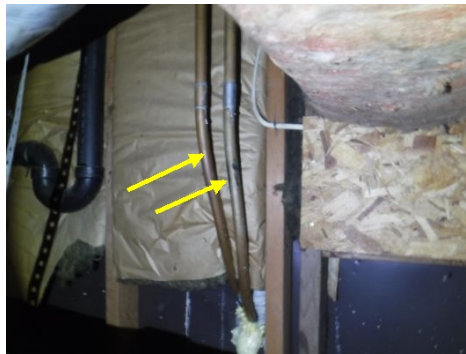
- Some plumbing supply line insulation is damaged or missing: Maintenance repair is indicated. Crawlspace
- A note about old pipes: Galvanized and copper pipes have been standards in the industry for years and usually last for decades. However, their life span largely depends upon the acidity and mineral content of the water, both of which are outside the scope of inspection to determine. Either type may develop buildup inside the pipe, especially if high levels of calcium are present. Galvanized pipe may also rust from the inside out as it ages. Copper is particularly susceptible to acid and in areas where water is acidic, and it may corrode or develop pinhole leaks within just a few years. A water treatment specialist can perform further testing and determine if there is any need for remediation. Also be aware that any older pipe may need replacement at some point in time.

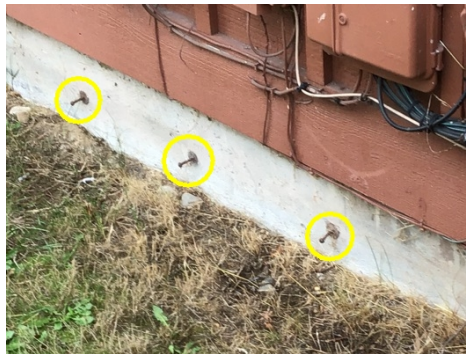
- Other foundation conditions exist: Exposed snap ties recommend removal for safety. Noted: Right side.

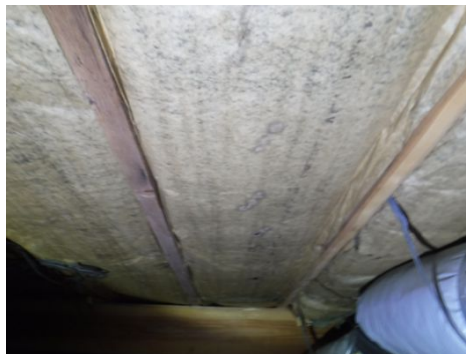
- The sub floor insulation has been installed incorrectly: Installing sub floor insulation with the vapor barrier facing the wrong way, (not toward the heated side). may lead to condensation within the joist spaces. An insulation contractor will be able to suggest a proper remedy.

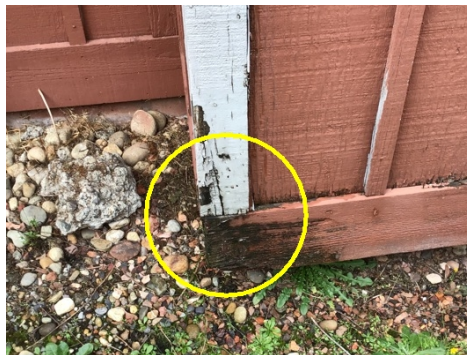
- There is decay seen in the trim. This was noted in the following area: Left side

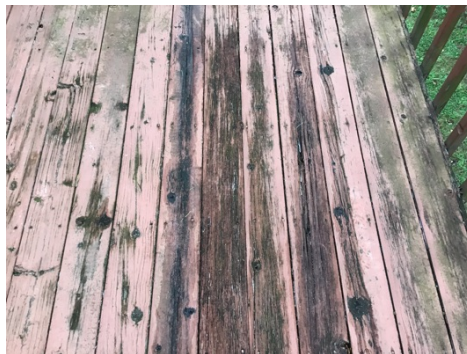
- There is decay seen on the decking material. This was noted in the following area: Rear

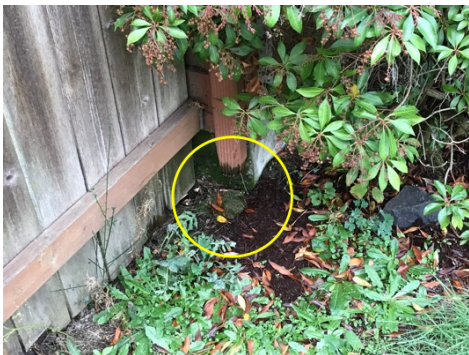
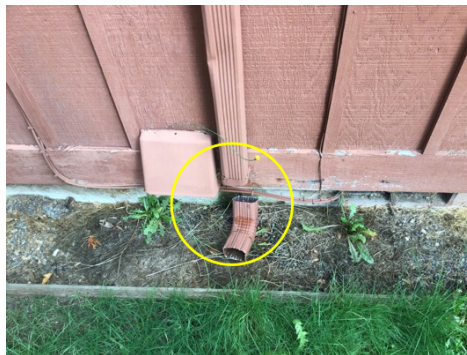
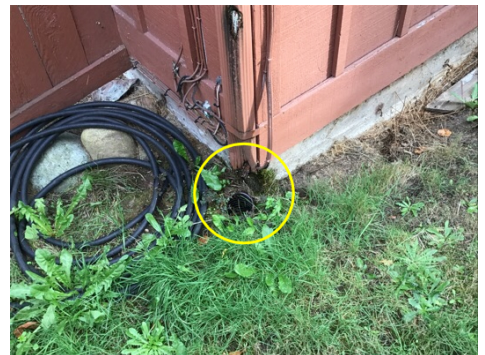
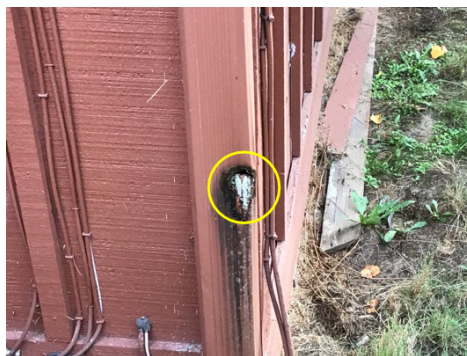
- Downspouts lack adequate diversion away from house. Downspouts should have elbows and splash blocks to direct water away from the house. Any poor or damaged connections to existing drain lines should be repaired. Unique conditions where a splash block may not be viable and no drain line exists may need to be referred to a licensed drainage contractor for evaluation. This was noted in the following area: Front, Rear
- Downspout is damaged. Repair is recommended to ensure proper function. This was noted in the following area: Rear.

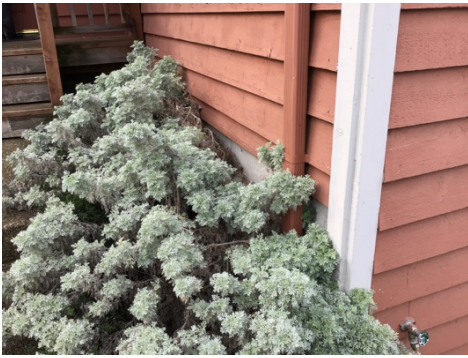
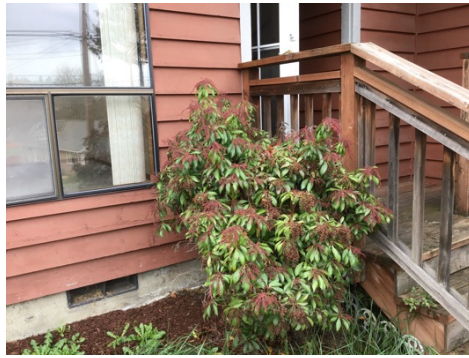
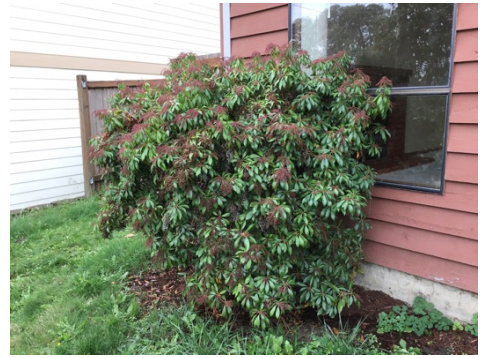
### 2. Foliage

- Foliage should be maintained so it is at least 10 to 12 inches away from house as it may cause mechanical damage to the siding and promote high moisture conditions and/or infestation. Where foliage is dense and access limited, hidden conditions may exist which should be reported to the inspecting firm if discovered. Where there is decorative, established foliage against the structure such as climbing vines, cutting the foliage back may be detrimental to the aesthetic appearance of the home. If the foliage is left in place, be aware that infestation and high moisture conditions may occur. Regular and periodic inspections are suggested.

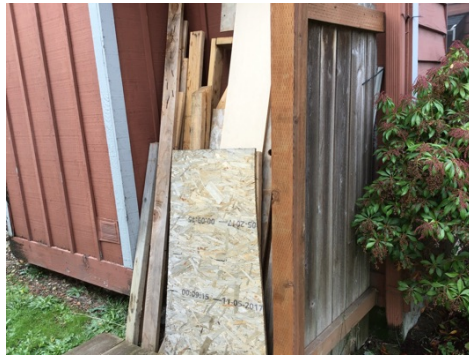
### 3. Other

- Other exterior conducive conditions are seen: There is wood or debris against the structure. Removal of all wood away from the structure by at least ten feet is recommended to prevent access to the structure by wood destroying pest. Noted: Left side

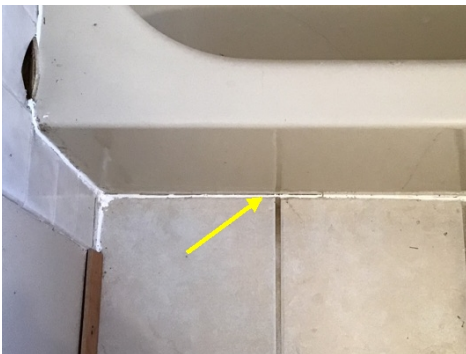
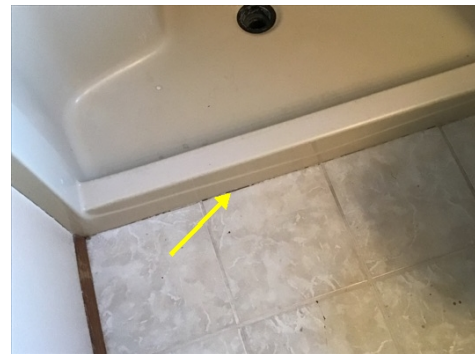
### 1. Flooring by Tub/Shower

- The caulking on the floor in front of tub/shower has failed. Failed caulking may allow moisture to penetrate into and decay the underlayment and should be repaired. This was noted in the following area: Second floor hall bath, Master bath
